Underpinning of foundations in collapsing soils

Juan Pedro Compagnucci

Geotechnics at National Technology University, Bahía Blanca, Argentina.
Compagnucci Diaz SRL, Geotechnical and Foundations Consultancy, Neuquén, Argentina

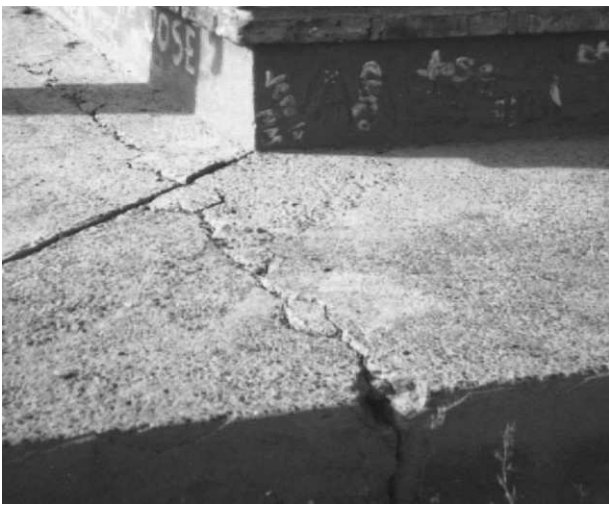
After some time, differential settlements caused damage to the structure and there appeared traction diagonal fissures, shearing vertical fissures displacement areas, descent of walls, carpentry affected with deformation in frames, explosion on linings, cracked footpath and cavities on the floor.

Figure 2. Cracked footpaths.

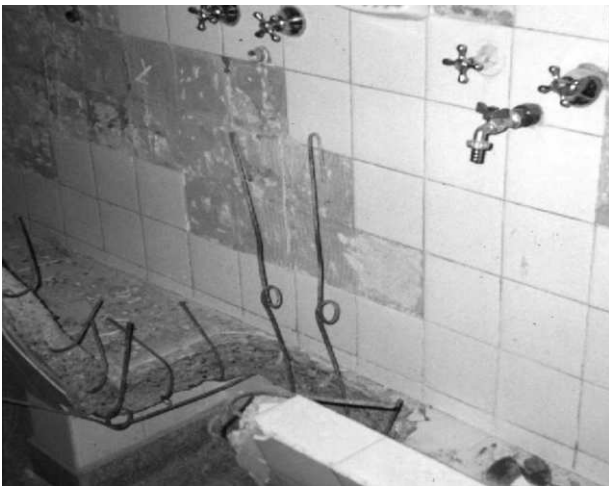
Figure 3. Explosion in sanitay linings.

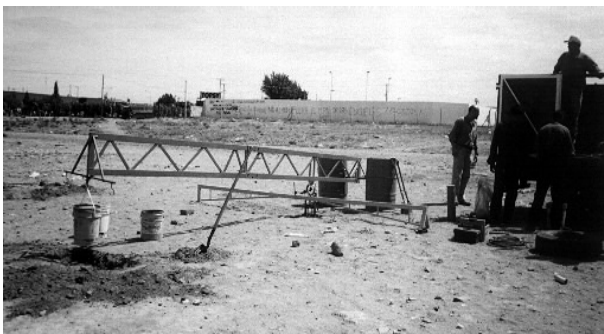
The basic equipment used is shown in attached by photographs (Terzariol and Abbona, 1997) it presents a few modifications that allow applying pressures of up to 100 KPa.

Fig. 7: Equipment general view.

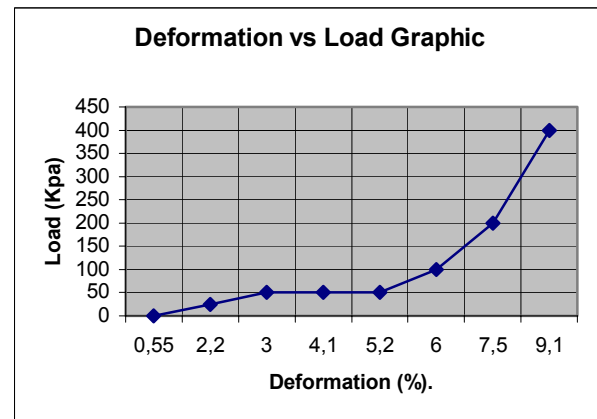
Odometer tests were performed following one of the pressure increase and soil saturation sequences used in the field.

The moistening process was carried out with a 50 Kpa load and the undisturbed samples were taken in 10 of the 15 tested sites.

Two representative tests can be seen in Fig. 8 and 9:

Figure 9. Odometer test n° 6.

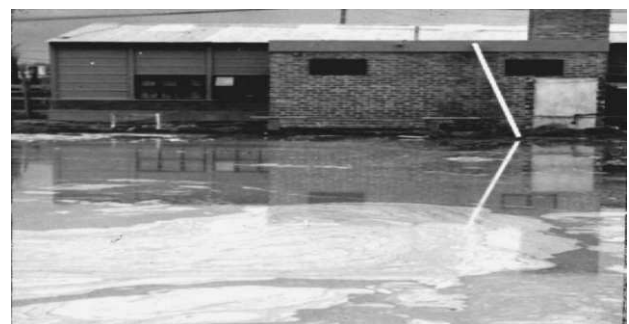
In our cases, we treated an inundation typical area like example, and there, we measured a settlement of 12 cms when the soil completed a great percentage of the saturation collapse process, a few days later.

Fig. 10: Inundation test in process.
