Lanslide in a shale slope in Kabylie

Hocine Bendadouche

After soil settlements caused in great mass by the building of shop premises, an important landslide has affected the limb of a strongly broken hill at Barbacha village, a locality situated the Kabylie region. During these soil settlements, the resulting disaster has involved to downstream the embankment and the altered shale. To build a school play-ground a large platform was first realized. Thus great quantities of fill were deposited on a very inclined ground. For the construction company, it was not judged useful to drain the superficial water flowing on the slope.

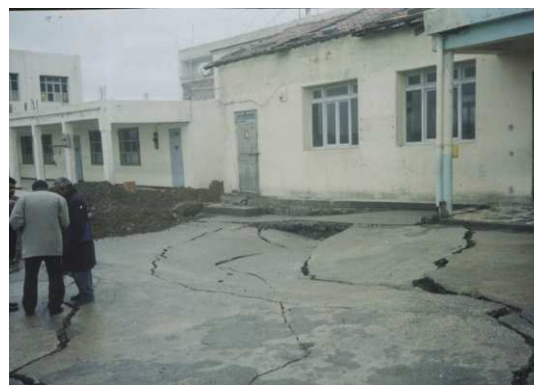
Figure 1. Sight on the course fissured

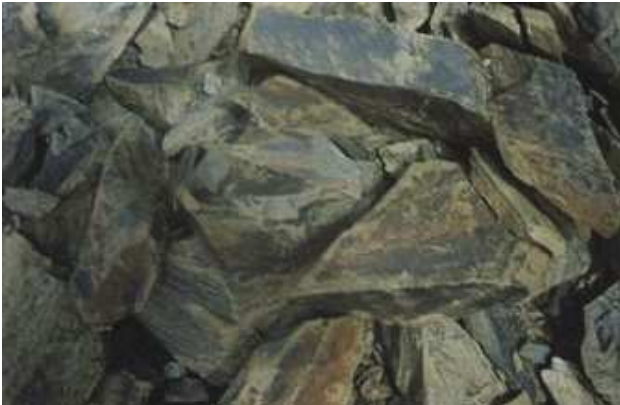
After prospect ion and analyses geological formations places from there, it arises that the ground is made up primarily of schist. The analysis of the schists on the spot reveals a ground very sensitive to water. This characteristic corresponds to evolutionary grounds. Various factors were combined to start this slip, one will quote:

Figure 2. a shale échantillon. Kabylie

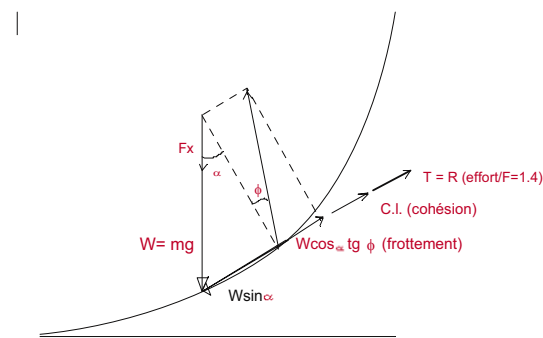
Three (3) profiles on the slip were established starting from the topographical survey. The absence of tests at the time of the slip does not make it possible to know the actual values of C and ϕ . A first approach was to fix the parameters of shearing the angle of friction ϕ and cohesion C in order to check a minimal stability with a safety coefficient equal to 1 ($F_s=1$).

The parameters of shearing corresponding to $F_s=0.999$ are:
 - Profile 22 - Profile 33
 C = 34 KPa C = 12 KPa
 $\phi = 12^\circ$ $\phi = 12^\circ$

The plan is given on the basis of observation of the cuts geotechnics. Once the determined surface slip, one took again the definition of the total safety coefficient to calculate the efforts of slip to be taken again with an improvement of F_s of 30%.

Figure 3 Study of Stability
