GIS aided slope instability analysis of the highway slope based on shear strength

P. Bhattarai

Deterministic slope stability analysis for 3D potential failure surfaces was done using GIS and the analyses of the potential slope failure area were done for a catchment of 16 Km long highway sector in Nepal. This study provides the guidelines for the use of soil strength parameters in the 3D deterministic analysis and mapping. About 80% of the existing slope failures were observed within the very high and high instability potential zones proposed by this study. Recommendation was done for 10 critical highway locations and 3 critical bridge sites, which are threatened by various types of mass movement activities.

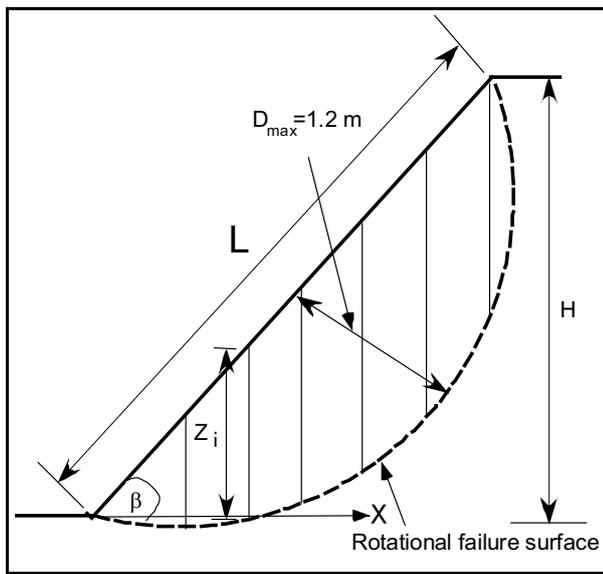
Figure 4 Typical section for the 2D stability analysis

One dimensional stability analysis for a infinite slope is generally done for the deterministic analysis of the slopes. However, the concept of 2D stability analysis for the section as shown in figure 4 was used in this study. In case of residual soil, stiff fissured clays, and non plastic clays and silts, brittleness is close to 1, and fully softened shear strength can be considered as failure criterion (Skempton, 1985). For the saturated soil sample in such conditions, shear envelope passes from the origin. The simplified equation for 2D factor of safety can then be reduced to,

$$FS = \left(\frac{\tan \phi \sum_{ij} (\gamma \cos^2 \beta - m \gamma_w)}{\sum_{ij} \gamma \sin \beta \cos \beta} \right)$$

where, ϕ is remolded peak friction angle, γ is the unit weight of the soil mass, β is slope angle of the terrain, m is the saturation ratio, and γ_w is the unit weight of water.

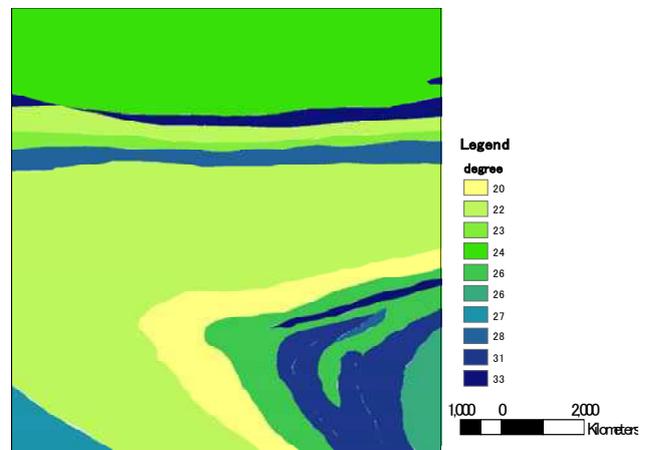
Figure 5 Distribution of residual shear strength based on petrology, similar figure was prepared for the fully softened shear strength too.

Residual soil samples were collected from 100 different locations throughout the study area widely distributed into an area of 140 sq. km., in such a way that at least 8 samples were collected from each petrologic region. Mechanical properties of the soil such as the particle size distribution, the consistency limit and the shear strength properties (both fully softened and residual) were measured in order to study the variation of soil properties in the petrologic regions. The test results showed that there were the similar liquid limits and shear strength of the soil in a petrologic region. Japanese soil testing practice (Japan Geotechnical Society, 1992) was followed for all types of soil testing. Both the simple shear devices as well as ring shear devices were used for the shear testing of the representative specimens. Fully softened friction angle of the samples varied from 20.7 to 35.4° , whereas residual friction angle varied from 19.8 to 33° . Shown in table 1 are the average values of the friction angles (both fully softened and residual) for the tested soil samples. Bhattarai et al. (2004) did deterministic analysis based on the residual shear strength. However, the analysis presented in this study considers fully softened shear strength of the soil. Fully softened friction angle was distributed based on the petrological region in the similar manner as the residual shear strength was distributed as shown in figure 5. A set of 1:25,000 scale topographical maps was digitized to make a DEM of the study area with the help of GIS analysis tools. DEM was used to calculate the slope of the terrain (β). Spatial analyst and 3D analyst tool of a ArcGIS software was used for the entire analysis.

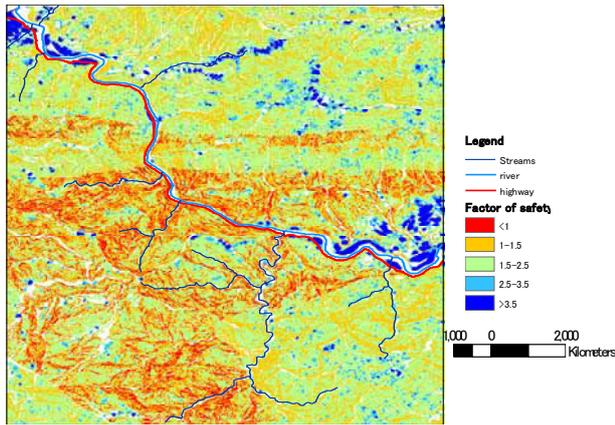
Figure 6 Distribution of hazard potential zones by stability results

An automated algorithm was developed to conduct the 3D slope stability analysis of the critical ellipsoidal sliding mass throughout the area in a given slope unit with GIS as mentioned by Bhattarai et al. (2004). Bhattarai et al. (2004) have divided the entire study area into a number of catchments based on the DEM data, using ArcHydro software of ArcGIS. Then mirror image of the entire topography was created by multiplying the contour value with (-1). The mirror topography DEM was used to make the reverse catchments joining valleys. The catchments with DEM and mirror DEM were dissected with each other to divide the entire area into a number of slope units. The size and the shape of the ellipsoids to have random distribution calculation for slope stability were fixed with the average dimensions of the existing single unit shallow slope failures, recorded in the slope failure inventory that was prepared during the field survey. The value of the automatically calculated factor of safety (FS) of the slopes was used to divide the whole catchments into five different instability zones, as shown in figure 6.

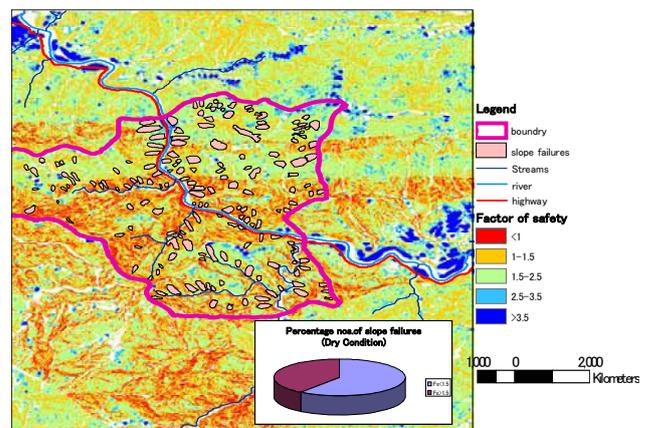
Figure 7 Superimposition of field detected slope failures in the hazard potential map

Distribution of the calculated hazard potential area was compared with the existing slope failures in the areas. Shown in figure 7 are the superimposition of the slope failure areas that were detected during the field survey, on the proposed slope instability map that has been prepared based on this study results. More than 80% of the slope failures that had been marked during the field study, and the slope failures that had been located in the landslide distribution map prepared from aerial photo interpretation, were observed inside the highly instable zones. The main objective of the present study was to identify the most critical highway chainages from slope instability point of view. An entire length of the highway under study was divided into 32 different sections, each section having the length of about 500 m. Each sector was then divided into five different segments of 100 m length. Average value of safety factor for the upstream slope was calculated each 100 m segment. Each segment of each sector of the highway was assigned with a number ranging from 1 to 5 based on the value of average safety factor at that segment. The minimum average safety factor of the assigned lowest safety location of each sector was then compared to prioritize 10 topmost critical sectors based on those safety factors. According to the analysis results, chainages 82.500, 83.000, 81.000 (Jogimara), 76.500 (Krishnabhir), 80.500, 79.500, 82.500, 84.500, 84.000, and 83.500 from Kathmandu were the first 10 vulnerable locations in an increasing order. Table 2 shows the priority of the most critical 10 highway sectors, with the name of the location and
