Mass movements in the “Serra Do Mar” Cordillera, Sao Paulo, Brazil

Milton A. Kanji; Claudio M. Wolle; Faïçal Massad & Paulo T. da Cruz

*Department of Structures and Foundation Engineering, Escola Politécnica
University of São Paulo, Brazil*

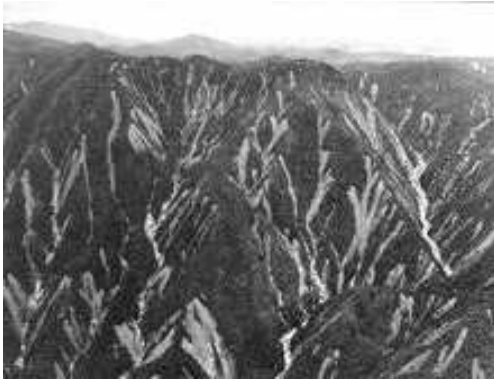
Figure 1: View of the numerous landslides at Serra do Mar in the Cubatão region after the rains of 1985.

In the year 1985 the region of Cubatão was hit by heavy rains of 210mm in 1 day and 380mm in 2 days, following a prolonged period of rains (about 550mm in 30 days) triggering hundreds of landslides (Fig. 1) in the hill slopes along the Mogi river. The vegetation of the hill slopes was very much degraded at that time, due to acid rains caused by heavy atmospheric pollution due to emanations from the industrial complex sited at the toe of the sierra (refinery, steel mill, chemicals, etc.), making the occurrence predictable. Debris flows were triggered along the valley, causing its river bed, initially well defined, to enlarge up to 300m, due to the torrent erosion. The total mass was estimated in about $0,5 \times 10^6 \text{ m}^3$. In 1986 new rains hit the region, but only some isolated landslides occurred.

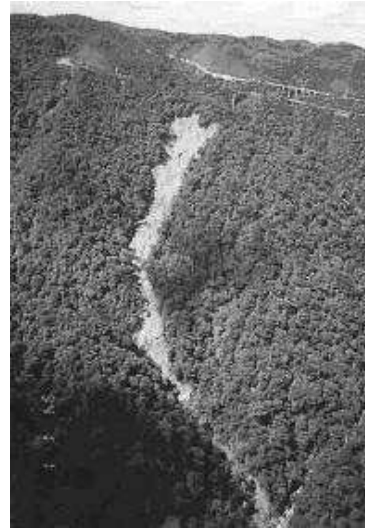
Figure 2: View of the landslide transformed in debris flow at km42 of the Anchieta highway.

In December 1999, again heavy rains caused a landslide very close to the Anchieta highway, forcing the traffic interruption. The slide, involving soil and weathered rock, was of about $0,3 \times 10^6 \text{ m}^3$. The slide developed into a debris flow, running more than 3 km downwards the hill slope, as shown in Fig. 2.

The large slide at km 42 of the Anchieta highway, occurred in December 1999, was conditioned by a series of local geological features for its occurrence: a layer of soil underlain by weathered rock with 3 sets of joints, one of them dipping about 30° to the slope, plus a diabase dike that inhibited drainage after heavy rains, explaining its transformation into debris flow (Wolle et al, 2001).

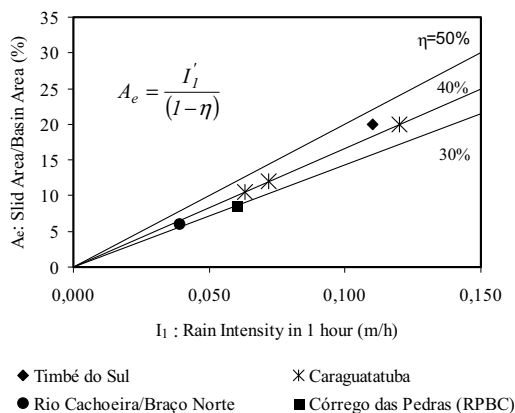
Figure 5: Relationship between slid area as a percentage of total basin area (A_e), rain intensity in 1 hour (I_1) and soil porosity (η).

A relationship between slid area and rainfall has been found by Massad (2002), shown in Fig. 5, considering 1m thick translational slides, as mentioned above.
