Stability analysis and rehabilitation measures of landslide Rebernice

Boštjan Pulko

At the alignment of the highway Razdrto-Italian border, at the section Razdrto-Vipava, in November 2001 a slope failure occurred in the Rebernice area during the excavation of a deep cut. With surveying and geologic geotechnical investigations it was found out that, a widely extended landslide occurred with the total volume of the slid mass about 600,000 m³. The initial data, the data obtained during additional geotechnical investigations, monitoring data and soil and rock properties obtained from laboratory tests formed the basis of a geological-geotechnical model for stability analysis. The verified geological geotechnical model was used for the design of the stabilization measures. An anchored pile wall with an additional anchored grid beam structure was proposed for the stabilization of the landslide.

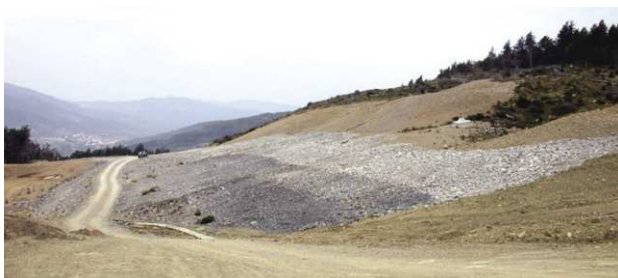
Figure 3. Toe of the landslide after backfilling

In order to temporarily stop the movements of the landslide it was decided to partly backfill the excavated volume using stone material with high shear strength (Figure 3). The minimum amount of the backfill material necessary to reduce the movements was determined by the stability calculation.

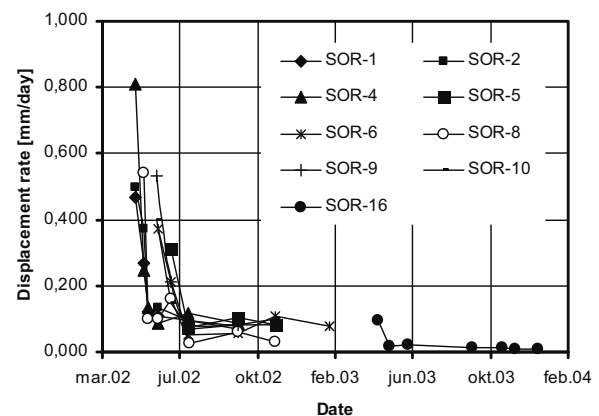
Figure 4. Landslide displacement rate vs. time (inclinometer readings)

During the backfilling of the cut in April and the first half of May 2002 the displacement rate of the sliding mass was greatly reduced to about 0.2 mm/day and this was also the period when additional investigations were performed and inclinometers were installed. The inclinometer measurements indicated a well

defined slip surface and a uniform translational movement of the sliding mass. Most of the inclinometer measurements had to be abandoned when those situated within the landslide area were sheared off at the end of 2002 or beginning of 2003. Since then geodetic measurements have provided data on the ongoing slope movement. Since July 2002, when the temporary remedial measures were completed, a linear decrease of the rate of sliding can be observed from both inclinometer (Fig. 4) and geodetic readings. The inclinometer and the geodetic measurements performed in 2003 and 2004 indicated further movements of the sliding mass with the reduced sliding rate about 0.01 mm/day, clearly showing the beneficial effect of the backfill.
