Progressive failure of slope due to tunnel excavation and its numerical simulation

A. Yashima, F. Zhang & G.L. Ye

Gifu University, Japan

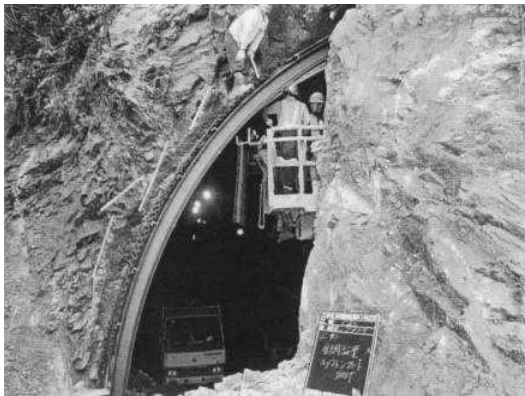
Photo 1 Situation immediately after the entrance was cut through

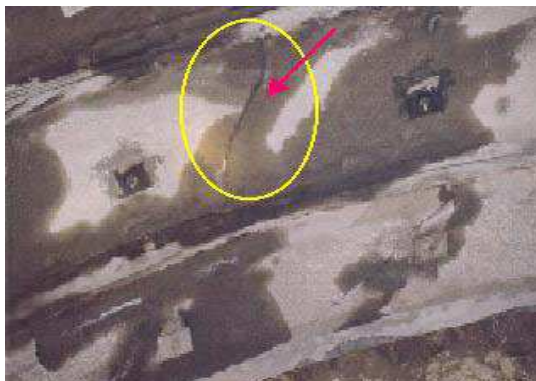
(a) Crack in the shotcrete near entrance

Photo 2 Omen of tunnel collapse

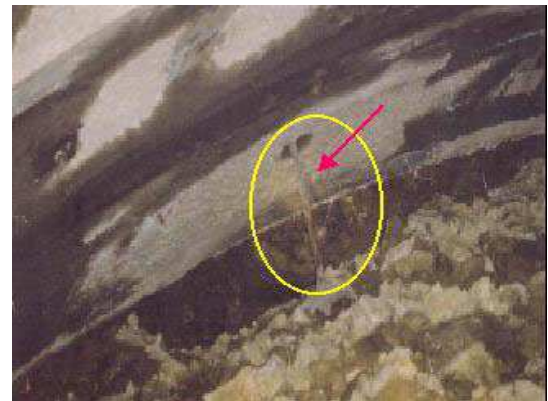
(b) Fallen of rockbolt

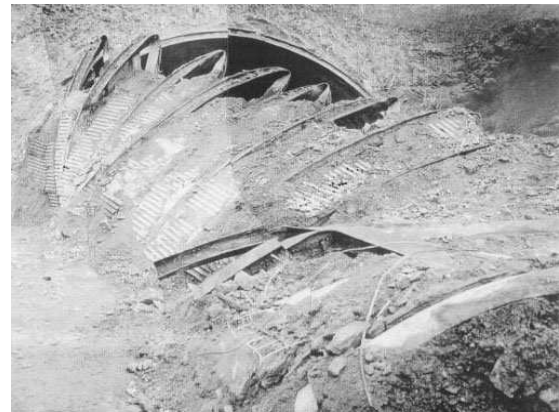
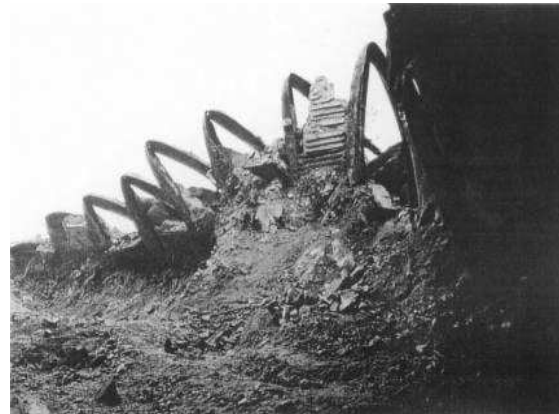
(a) View from outside

(b) View from inside

Photo 3 Failure of steel lining

Figure 2 are usually constructed to resist against eccentric earth pressure acting on lining of tunnel at the entrance of the tunnel before the tunnel is excavated through. In field excavation, however, the engineer at the construction site found that the rock in the surrounding ground of the tunnel was quite good and then decided to excavate throughout the entrance without constructing the retaining reclaimed embankment, as shown in Photo 1. The retaining reclaimed embankment is usually made of reclaimed soil mixed with cement and has a quite strong strength to be able to resist an eccentric earth pressure from surrounding ground. Six days after the entrance of the tunnel were excavated, several cracks appeared in the first lining and then some rock bolts began to fall out, as shown in Photo 2. The cracks in shotcrete developed very quickly. One and half hours after the first crack was observed, the tunnel lining was completely destroyed due to the failure of the slope above the tunnel. Photo 3 shows the failed steel frame after the fallen soils were moved away.

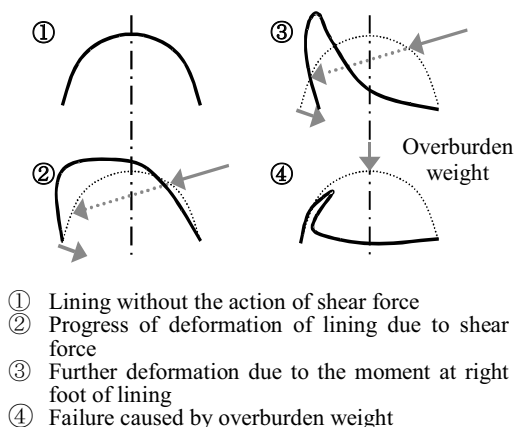
Figure 3 shows the mechanism of the failure of steel lining. According to the weather condition, there was no any evidence of rainfall or underground water movement. It is, therefore, very clear that the failure did not related to any underground water or rainfall. The failure was caused by the excavation of the tunnel, which is obliquely crossed with the slope, with the absence of an retaining reclaimed ground formerly designed to resist the eccentric earth pressure acting on lining of the tunnel. After the excavation of the arriving entrance of the tunnel, large shear stresses generated within the ground. Due to the inherent creep behavior of soft rock and the strain softening characteristics, creep strains developed in the ground gradually. Local progressive failures occurred and finally lead to a total failure of the slope. Therefore, in simulating the progressive failure of the slope, an elasto-viscoplastic model with strain softening is adopted in the finite element method.

Figure 3 Failure mechanism of steel lining

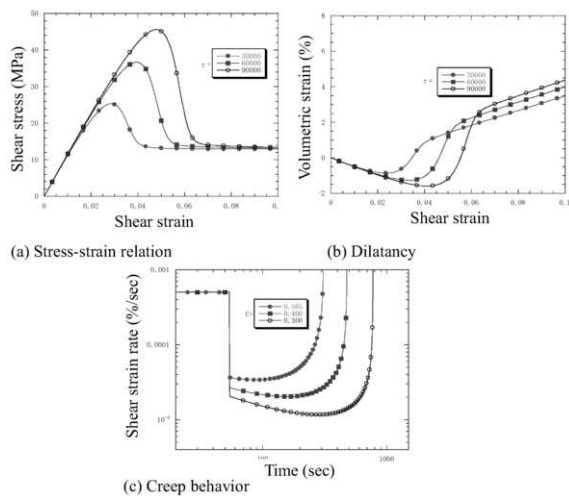
Figure 5 Stress-dilatancy relation and creep behavior of soft rock

Figure 5 shows the stress-strain-dilatancy relation and creep behavior of the soft rock whose values of material parameters are listed in Table 1. The ground shows a typical strain hardening and strain softening and shear dilatant. The creep failure behavior is also clearly described by the model (Adachi et. al., 1994). In the model, parameters τ and C are determined by curve-fitting method based on conventional triaxial compression and creep tests.

Figure 9 shows the time history of shear strains and shear strain rates of ground at different places as shown in Figure 8. In Figure 9a, creep strains at elements A, B and C are plotted in two different cases. It is found that in Case 2, the creep strain did not develop any more due to the resistance effect of the retaining reclaimed embankment. In Case 1, however, the creep strain developed slowly at the beginning and then increased abruptly at certain time and finally reached a failure state, which is defined as a state where the stress ratio of the ground undergone strain softening and reached the residual stress state. Figure 9b shows the creep strain rates of the ground. In Case 1, a typical creep failure curve can be obtained, being almost the same as the curve of element simulation plotted in Figure 5.

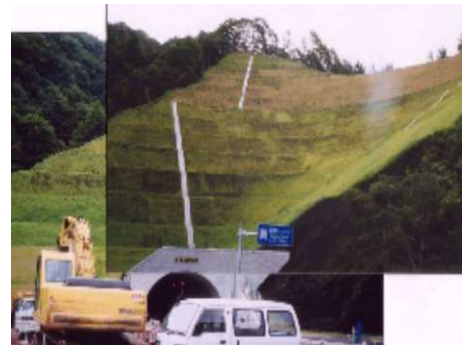
Photo 4 View of the recovery slope

From Figures 7 and 9, a clear conclusion can be given, that is, the retaining reclaimed ground is definitely needed in present case history. If the retaining reclaimed embankment were constructed during the excavation of the tunnel, the larger-scale creep failure of the slope would not happen. Photo 4 shows the picture of the recovery slope. In order to keep a safe slope gradient, the slope was cut with 15 cutting berms, in which $240,000\text{m}^3$ soil was moved away. It took 4 million US dollar to recover the slope!
