Local soil conditions and earthquake damage in the town of Aiquile - Bolivia

R.D.Verastegui & W.F.Van Impe – *University of Ghent, Belgium*
M.Salinas – *Geotechnical center, San Simón University, Bolivia*

ABSTRACT: This paper presents an evaluation of the seismic response of soil deposits in the town of Aiquile (Bolivia), during the earthquake of May 1998, which registered a magnitude of 6.8 in the Richter scale. In-situ tests including electrical resistivity, standard penetration (SPT) and the spectral analysis of surface waves (SASW) were performed after the earthquake. A provisional microzonation map of the area is proposed.

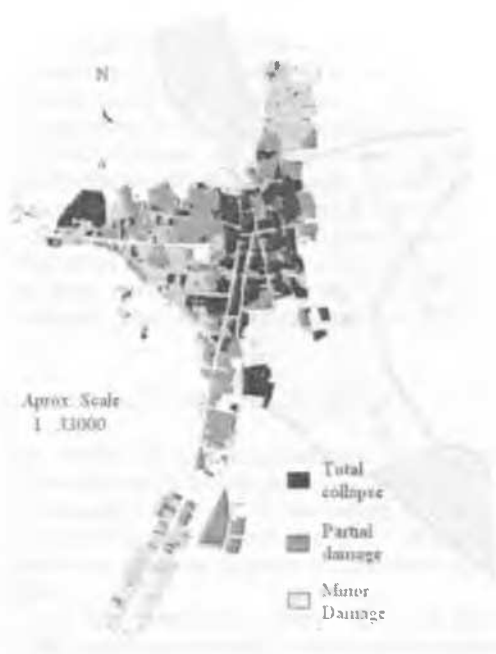
Figure 1. Actual structural damage pattern (DISU, UMSS)

The results are summarized in figure 1. It clearly shows a regular pattern of damage distribution.

The darkest zone reflects the most affected area, houses totally destroyed, surrounded by a less damaged belt and even farther the damage was minor or unnoticeable (yet the construction quality was mainly poor).

The susceptibility distribution from SASW measurements in figure 5 shows good agreement with the actual structural damage distribution (Fig. 1).

One should be aware that figure 5 clearly relates to information directly linked to the soil conditions, while figure 1 implements both soil conditions and structural vulnerability.

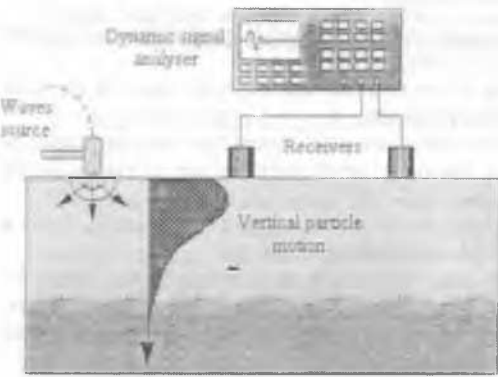
Figure 2. SASW field test configuration

The general configuration of the SASW test is shown in figure 2. Surface waves are generated by applying a dynamic load at the ground surface. The propagation of the surface waves generated is monitored by two receivers or geophones.

The impact of a hammer was used here as source. A symmetrical arrangement was adopted (e.g. the distance from the source to the near receiver is equal to the distance between receivers).

The receivers, Mark L-4A with natural frequency of 1 Hz., were placed consecutively at spaces of 0.5, 1, 2, 4, 8 and 16m. For each spacing, 3 or more signal outputs were averaged from the left and from the right side.

A dynamic signal analyzer, HP 35670A, was used to record the motions at the receivers and finally, the data was transferred to a computer for further interpretation.

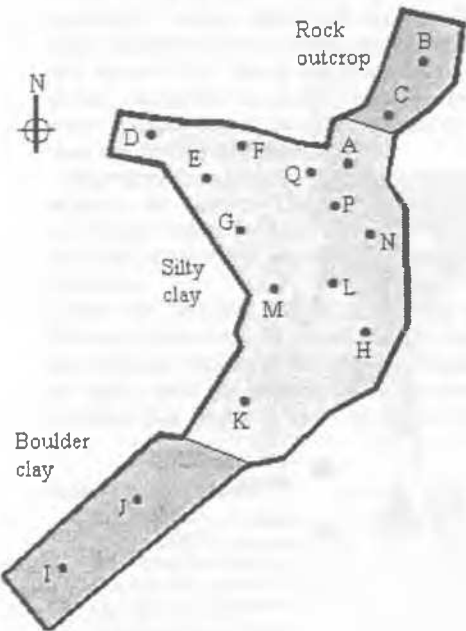
Figure 3. SASW tests location and Geotechnical characterization

Figure 3 describes the geotechnical characterization of the area and the location of the SASW tests. Moreover, table 2 summarizes the average shear wave velocities estimated for each testing point.

To the north, a rock outcrop was found. The measured shear wave velocities (V_s) reach values over 1000 m/s. Samples could not be extracted due to the hardness of the material.

In the center of the town the subsoil corresponds to a clayey and silty clayey deposit of soil, with variable and undetermined maximum depth. The shear wave velocity (V_s) varies from 160 to 400 m/s. Table 3 shows the physical indexes of soil samples extracted and figure 4 shows a typical profile.

Finally, to the south, a stiff and deep deposit of boulder clay was identified. The shear wave velocities ranging from 400 to 1000 m/s. Again, sampling was impossible.

The SASW, a non-destructive method, was employed to estimate shear wave velocity (V_s) profiles. Sixteen tests were performed at points spread all over the area of study (Fig. 3).

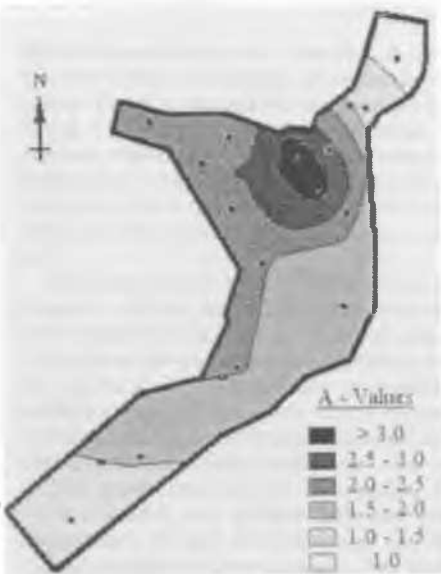
Figure 5. Relative amplification factors in Aiquile

The results of this evaluation are summarized in figure 5. It shows the spatial distribution of the A-values. The amplification factors range from 1, where V_s is maximum, to 3. where V_s is minimum.

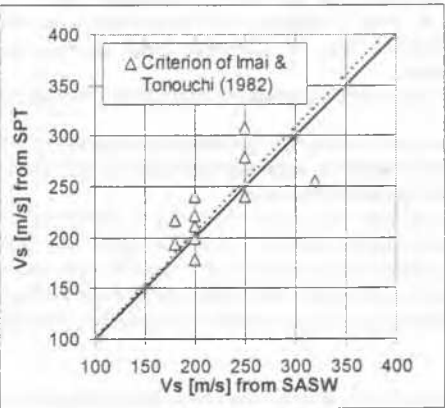
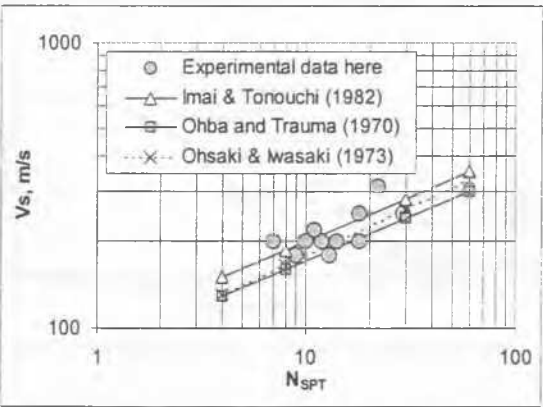
Figure 6. Comparison between V_s correlated from N_{SPT} and V_s obtained from SASW test.

Figure 7. Shear wave velocity (SASW) vs. N_{SPT}

Table 4 shows the values of C and D (equation 2) according to its author and figures 6 and 7 show the results of the analysis.

According to our data, the correlation following the Imai et al. (1982) criterion provides the closest values to the V_s measured by the SASW technique, while the other correlations tend to underestimate V_s , especially Ohba & Trauma (1970).

That fact would allow the employment of Imai et al. (1982) criterion on Bolivian soils. It is a very useful tool to rapidly asses the shear wave velocity since the standard penetration test is commonly practiced for site investigation in Bolivia.
