Settlement of steel tanks in soft clays: Caripito tank farm case history

Iván A. Contreras, Ph.D. P.E. – *Geotechnical Consultant, Caracas, Venezuela*
Juan F. Lupini, Ph.D., P.E. – *Geohidra Consultores, Caracas, Venezuela*
Juan M. Pestana, Sc.D., P.E. – *Geotechnical Consultant, Caracas, Venezuela*

ABSTRACT: The need for increased oil storage as a result of expanded petroleum exploration in eastern Venezuela required the assessment of existing cylindrical steel tanks and the construction of new large capacity tanks. This paper describes the geotechnical investigation conducted at the Caripito Tank Farm and includes a summary of the tank farm's history. The geotechnical investigation included performing field tests (SPT, CPTU, FV, Seismic Cone and Electrical Resistivity); obtaining representative soil samples from borings and CPT soundings for laboratory testing and evaluating liquefaction potential, bearing capacity, and settlement of the new tanks. The results of the geotechnical investigation and the recommended foundation solutions and repairs are also presented and discussed here.

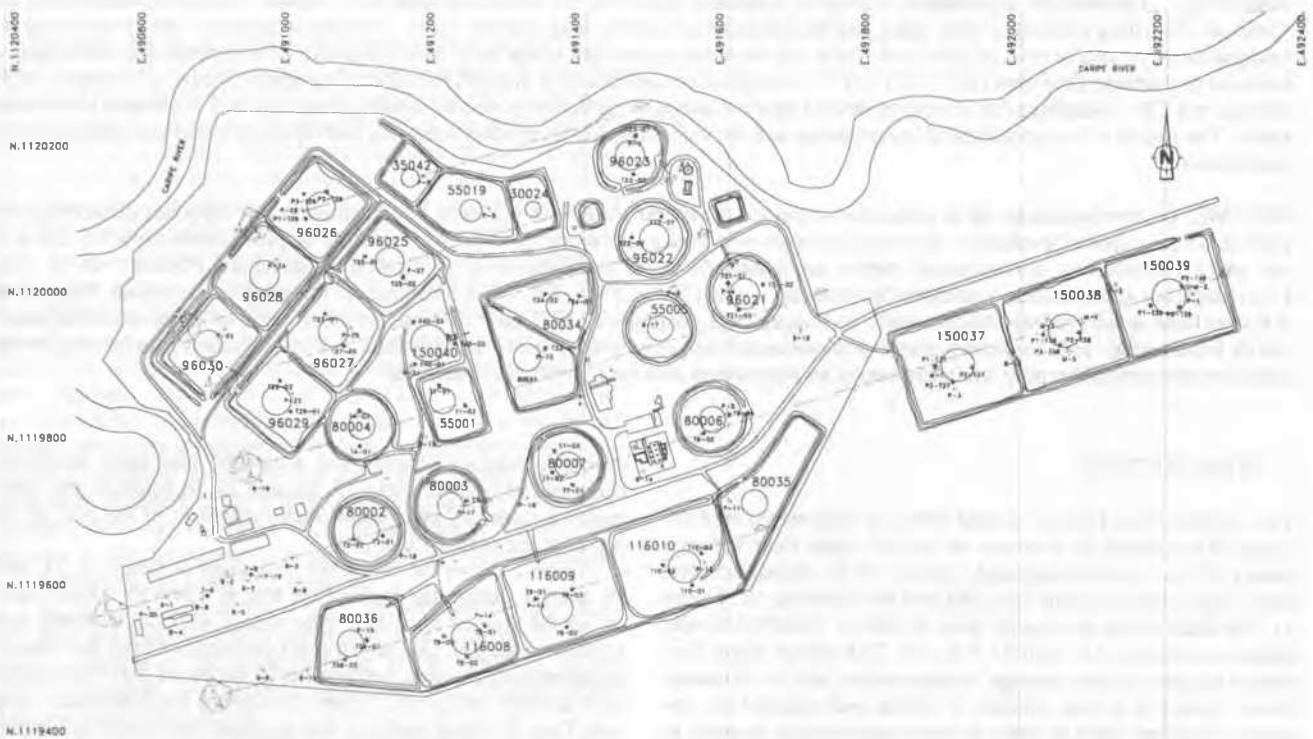
Figure 1. Plan view of Caripito Tank Farm.

The Caripito Tank Farm is located within a wide meander of the Caripe River which is tributary of the San Juan river approximately 3.2 km to the west, and consists of 30 cylindrical steel tanks with a total capacity of 2,762,000 bbl (barrels) (cf. Figure 1). The tanks range in capacity from 30,000 to 150,000 bbl with diameters between 21.3 and 45.7 m. The TAP (Deep Water Terminal) project includes storage, transportation, and oil shipment from Caripito to a new terminal in Güiria and required the upgrade of the tank farm in order to meet larger storage capacity as well as satisfy new construction and environmental standards.

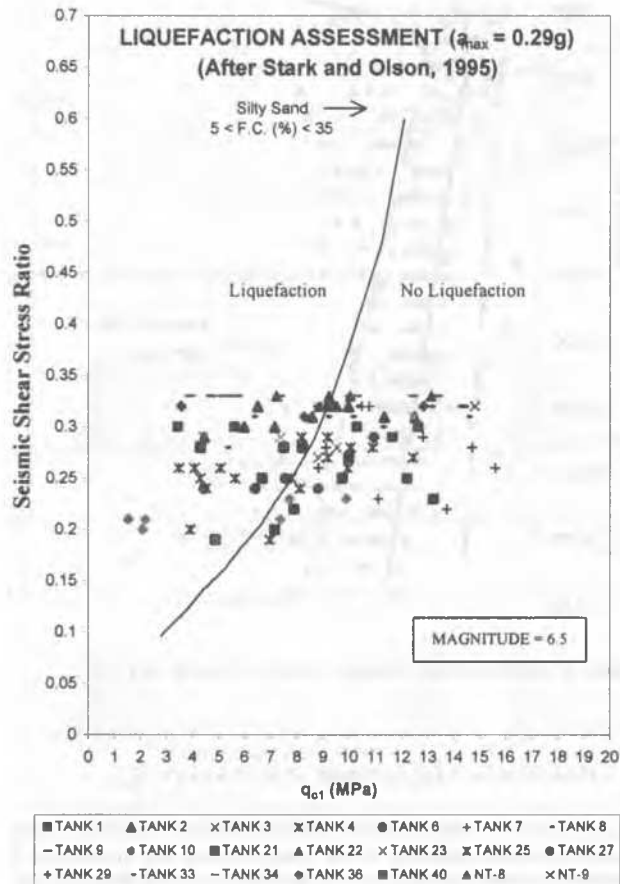
Figure 5. Liquefaction assessment at Caripito Tank Farm using CPT measurements

The boundary lines separating liquefaction and no liquefaction sites for 7.5 magnitude earthquakes were corrected to an earthquake of magnitude 6.5, using the magnitude correction factor c_m proposed by Seed et al. (1985). Figure 5 shows the results of liquefaction potential evaluation using CPT data. The liquefaction assessment, using the three methods, consistently shows many values lying to the left of the boundary line indicating potential liquefaction sites. Therefore, several of the tanks founded on sandy strata were found to be susceptible to liquefaction under an earthquake magnitude 6.5 and surface ground acceleration of 0.29 g.
