Development of internally stabilized earth retaining structures with local materials

S.A.S.Kulathilaka & U.P.Nawagamuwa – *Department of Civil Engineering, University of Moratuwa, Sri Lanka*

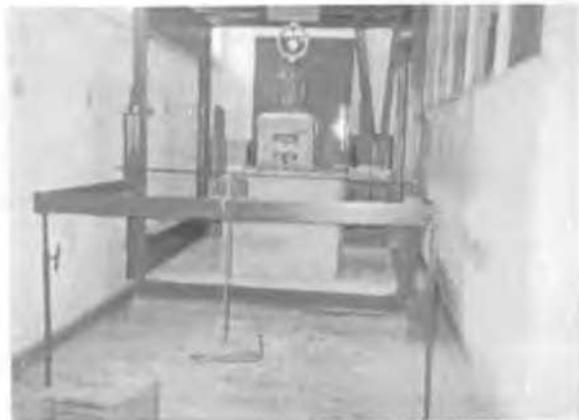
Figure 3 - Pullout Resistance Testing

Pullout resistance of model anchor tyres and bamboo reinforcement meshes were determined in the laboratory. Model tyres / model bamboo meshes were buried within a fill done in a Perspex box. The system was subjected to the required normal loading intensity by jacking up against the self contained loading set up as depicted in Figure 3. An increasing pullout load was applied on the anchor tyre/reinforcement mesh by adding weights to the loading hanger gradually. The outward movement of the anchor tyre/reinforcement relative to a reference frame was measured with each load increment.

In the pullout tests with model tyres, it was connected to the loading hanger through a steel cable. A bamboo mesh of limited width (50 mm) made of only two longitudinal bars and number of cross bars was used and the steel cable was connected to a mild steel bar connected to the longitudinal bars at the front.

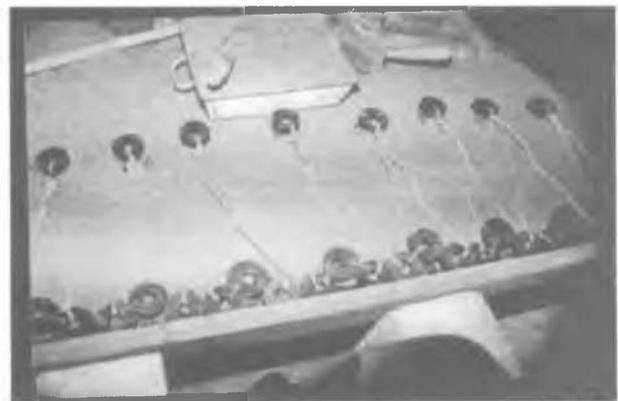
Figure 4 – Construction of the Model

The basic unit in the model structure consists of three facing tyres connected to an anchor tyre. Adjacent facing tyres are connected to each other and the two outer tyres are connected to the anchor tyre. The distance between the facing tyres and the anchor tyre was varied to ensure that the anchor tyre is kept at a sufficient distance behind, in the resistant zone. The construction of the model was done incrementally inside a Perspex-box. The box was fabricated with slotted angle sections

A well graded sandy soil where particles of sizes greater than 3.35mm were removed, was used for the study. Sand was placed in layers at a good workable moisture content of 10% and compacted by a steel roller to have a uniform density throughout. At a given height the basic units corresponding to the particular layer are taken and facing tyres were kept along the desired alignment (Figure 4). The wires connecting the facing tyres to the anchor tyres were stretched by applying a small tension and the sand was filled in between and compacted. Thereafter, sand was placed behind the anchor tyres covering the plan area up to the back wall of the Perspex box and compacted. The sand was compacted to a bulk density of 1740 kg/m³ and had a friction angle of 34 deg. A completed sand model with the loading arrangement is presented in Figure 5. Alternate sand layers were coloured with a black dye to facilitate the identification of failure surfaces.

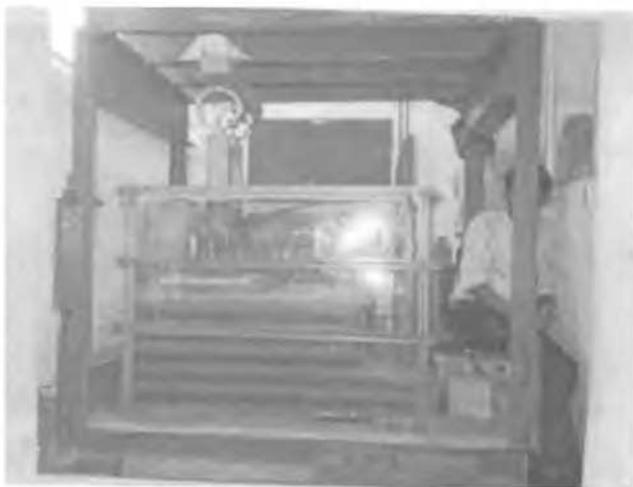
Figure 5 – A Sand Model Loaded Behind the Anchors

The model walls were loaded by jacking up against the self contained loading frame (Figure 5). Number of timber planks were placed on the horizontal surface of the model to ensure a uniform application of the load. Thereafter, two hydraulic jacks were placed on the timber planks, along with the proving rings. The hydraulic jacks were jacked up against the loading frame during the load application. The same load was applied through each jack to ensure a uniform intensity of loading.

Another model was subjected to a loading behind the anchor zone by placing the timber planks and the jacks behind the anchor zone (Figure 5). The loading intensity was applied in increments of 5 kN/m² and the outward movement of the wall facing was measured. When the vertical loading intensity reached 90 kN/m² the wall started to move out at a rapid rate (Figure 7) and the further increase of surcharge was not possible. A wide crack appeared behind the anchors and the wall unit was seen to separate out from the fill as depicted in Figure 8. The stability computation on a rigid wall of similar weight indicated that the wall would have failed by sliding at a loading intensity of 5.7 kN/m².

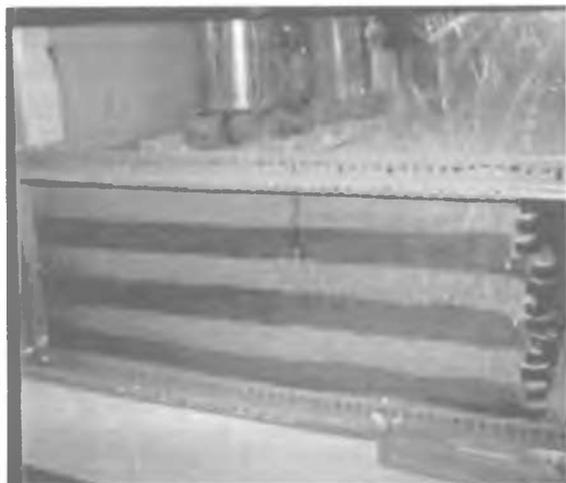
Figure 8 – Separation of the Wall Unit

Another model was loaded behind the reinforced zone in increments of 5 kN/m^2 . When the vertical surcharge was 45 kN/m^2 , a thin vertical crack appeared at the edge of the loading plate. The crack propagated downward with the increasing loading intensity and at a loading intensity of 90 kN/m^2 , wall was moving outward at a rapid rate and further loading was not possible. Thus, the wall is deemed to have failed at the loading intensity of 90 kN/m^2 .

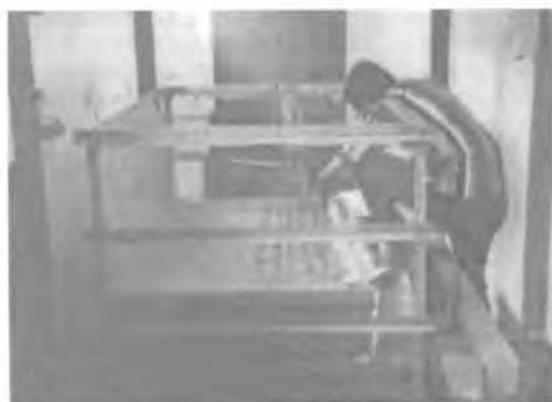
Figure 9 – Construction of Bamboo Reinforced Walls

Model bamboo structures were constructed using 10 mm diameter bamboo rods. Bamboo rods were placed in a 50 mm grid in both directions. Meshes were placed at a vertical spacing of 75 mm. An Aluminum foil used in ventilation work was taken as the facing material. Aluminum foil was used instead of model tyres due to the connection difficulties. Each layer of Aluminum foil was folded back by 50 mm and tied to the bamboo reinforcements. Model studies were done both with the sandy fill and the lateritic fill. The construction stages of a bamboo reinforced model is depicted in Figure 9.

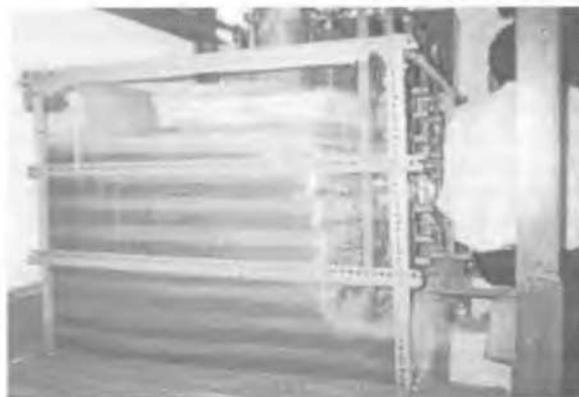
Figure 10 – Loading the Bamboo Reinforced Model Wall

Next, a larger model of height 500 mm, length 1150 mm and cross sectional width 400 mm was constructed inside the large Perspex box. The model consisted of six bamboo mesh reinforcement layers. Displacements of the wall facing were measured at load increments of 20 kN/m^2 . The arrangement is shown in Figure 10. The vertical surcharge could be increased to an intensity of 260 kN/m^2 without any indication of failure.

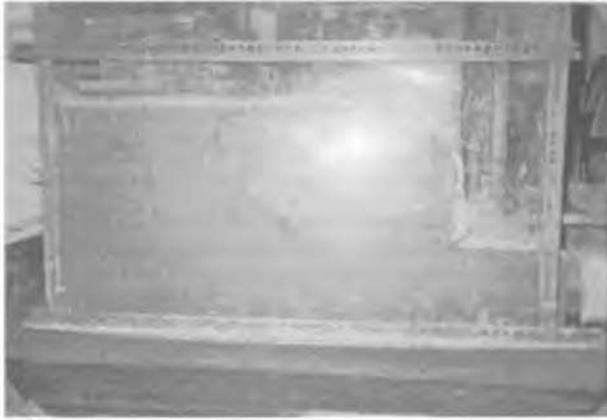
Figure 11 – Failure of the saturated Bamboo Reinforced Model Wall Loading Behind the reinforced zone

When a saturated model was tested a crack appeared at the end of the reinforcement zone at a loading intensity of 200 kN/m^2 . When the loading intensity increased to 220 kN/m^2 the crack has propagated to the full depth of the wall and further loading was not possible (Figure 11). This is an indication that wall has failed.
