Observational method ensuring the stability of a deep excavation in a clayey slide mass

P.Kudella – *Institute of Soil Mechanics and Rock Mechanics, University of Karlsruhe, Germany*

ABSTRACT: The Ursulaberg tunnel in Pfullingen/Germany is constructed as an open cut in a sensitive weathered Middle Jurassic side-hill. The use of the observational method was not planned originally, but it proved to be very useful after unexpected deformations of the deep anchor wall were recorded. Owing to additional measurements, a satisfying mechanical model could be established, by which the deformations endangering serviceability and for the design of temporary struts were evaluated.

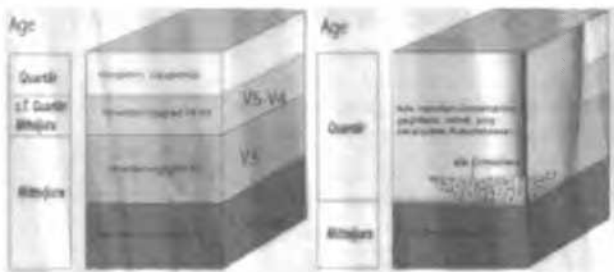
Figure 2. "Undisturbed" (left) and "disturbed" (right) weathering profile

In some locations, the hillside debris shows clear indications for repeated redeposition. In some cases, not only the hillside loam, but the complete weathering profile has been partially eroded and replaced by alluvial gravels or turned completely upside down by a paleo-landslide (Fig. 2).

Problems started, when the excavation approached the section with "disturbed" weathering profile (see Fig. 2) which corresponded unfortunately to the maximal wall height (17 m). Within five months, both lateral and vertical deformations accumulated to 120 mm, firstly accelerating and then slowing down in relation to the excavation progress, eventually turning into a constant creep even in periods without any further construction activity. More alarming, the actual extension zone enlarged far beyond the extension of the anchorage. At the same time, cracks developed in neighbouring houses.

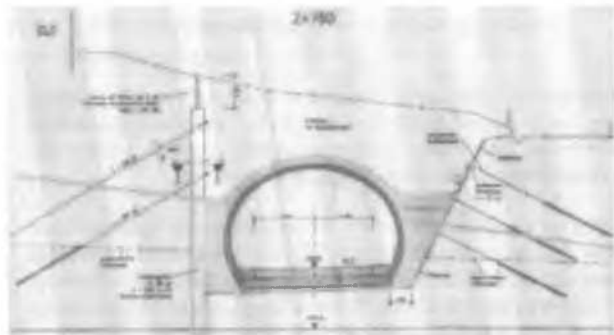
Figure 3. Standard cross section (tender) with pile (left) and anchor wall (right), design phreatic line and backfill

For abt. half the tunnel length, the retaining construction for the pit excavation uses an anchor wall (in the tender planned with 60° inclination, see Fig. 3, but later steepened to 85°) with a shotcrete shell of 25 cm. Depending on the excavation depth, between 3 and 7 layers of prestressed anchors with an approximate spacing of 2 meters and with loads of 300 kN were required. Only the lowest 1-2 layers with 450 kN reach into the solid claystones. The others, with lengths of 10 to 14 m, act like a soil block nailing. For those, it had been very cumbersome to reach the high design loads requiring at least 2 phases of re-grouting. On the other hand, all individual anchors were subject to pull-out tests with an unusually high safety factor of 1.4.

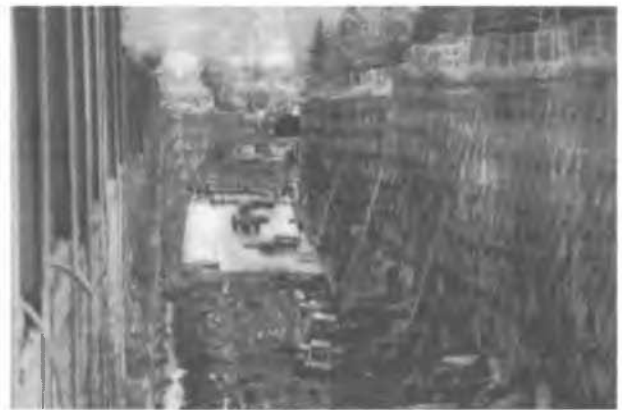
Figure 4. Excavation pit with soldier piles (left) and anchor wall (right)

Bored soldier piles with deep anchors and shotcrete filling were used in the remaining areas where existing buildings were closer than 20 meters.

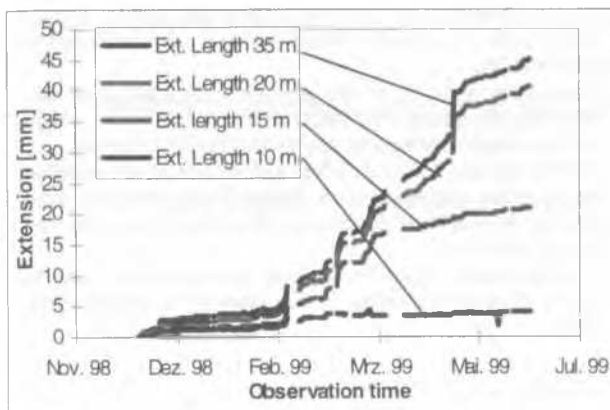
Figure 5. Recorded extensometer extensions

Deflections of the two wall heads using prism reflectors had been first monitored following an advice of the supervising engineer as a compensation for the impossible proof of individual anchor failure. Alarmed by unexpected movements of the anchor wall head during initial measurements, the section of the disturbed weathering profile had then been equipped with additional settlement points and 3 extensometers. These extensometers were installed parallel to the soil anchors to monitor the extension between shotcrete wall and reference points 10, 15, 20 and 35 m in the ground.
