# Strength conditions of Dutch dikes

A. Bizzarri, P. Blommaart & M. Ketelaars – Ministry of Public Works, Delft, the Netherlands

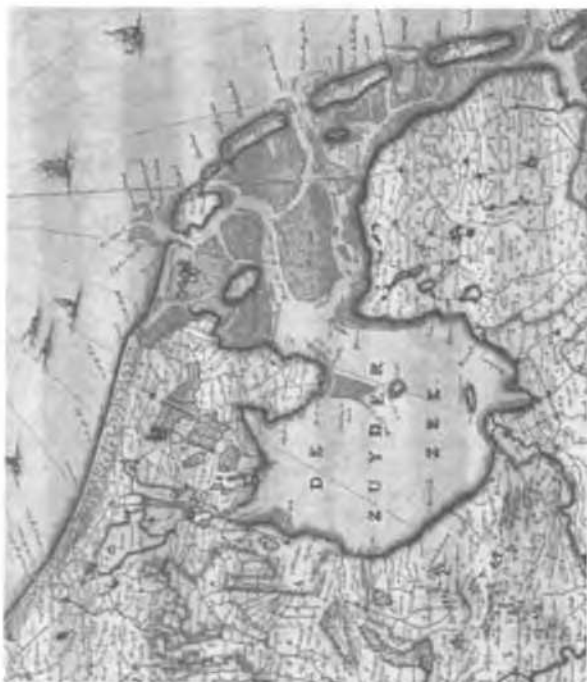
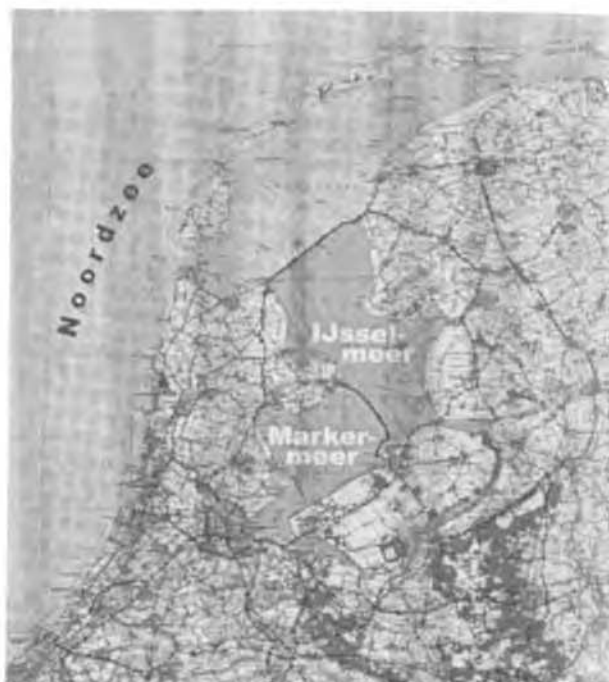
Figure 1. Zuiderzee (1681) and IJsselmeer / Markermeer (present).

The "Markenmeer" belonged before 1932 to the "Zuiderzee". Before the construction of the "Afsluitdijk" (closing dike) and successively the "Houtribdijk" dike, several storms have taken

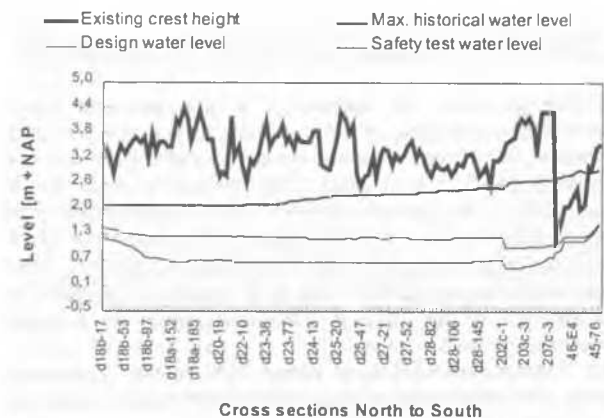
The duration and the high water-levels along the analysed dike’s sections have been reconstructed by means of archival data. The actual designed water level has also been defined. As shown in Figure 2, the resulting designed water level is lower than the highest historical water level.

Figure 2. Levels along the former Zuiderzee coast of the Markermeer.

The actual geometry of the different dike’s sections were compared with the profiles before 1932 in order to determine the influence on the geotechnical stability of the modifications that occurred. It could be concluded that 62 of the 78 analysed profiles can be considered comparable to the historical profiles and therefore, according to the methodology of “proven strength”, the geotechnical stability can be considered sufficient.

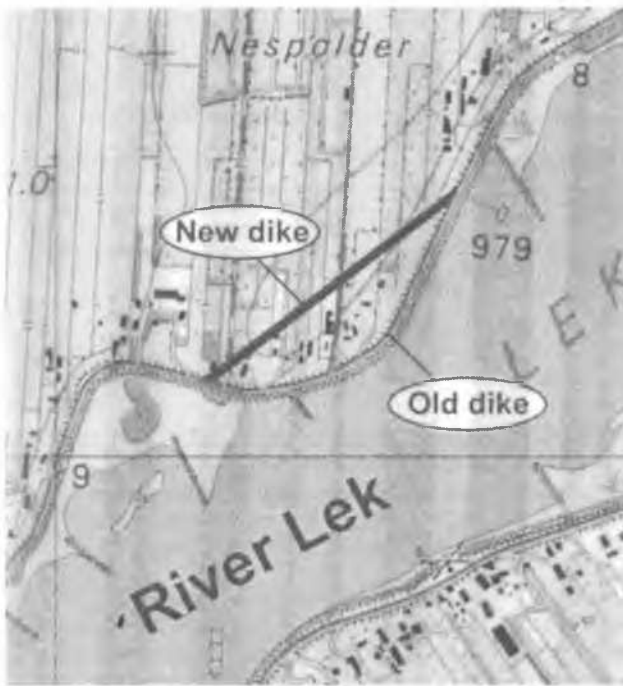
In order to widen the bed of the river, a turn of the river Lek, nearby the village Bergambacht, has been cut by building a new dike behind the old one (Fig. 3). Because the protection of the region behind the dike is now guaranteed by the new construction, the possibility has arisen to use the old dike to perform several tests in prototype scale. The purpose of the experiments is to investigate the “actual strength” of real dike and increase knowledge about the behaviour of dike under conditions which are comparable to the design conditions. In particular three tests will be performed:

Figure 3. Test bank along the river Lek.

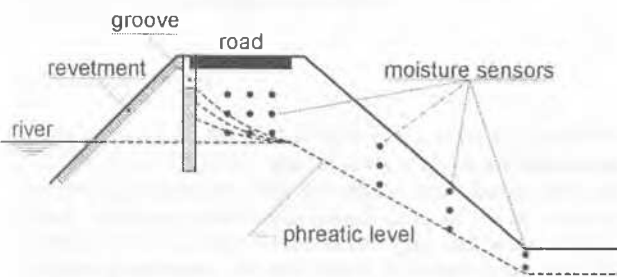
Figure 4. Phreatic line test.

A schematic view of the phreatic line test is shown in Figure 4. A groove will be dug along the outer border of the crest and filled with coarse material. The influence of the high water level in the river on the position of the phreatic line will be simulated by increasing the water level in the groove. The monitoring will take place by means of water pressure sensors which will be placed at different heights in the dike profile.

- influence of the high (prolonged) river water level on the stationary position of the phreatic line
- fall of the high water level and influence on the phreatic line
- the determination of the phreatic surface from a phreatic zone

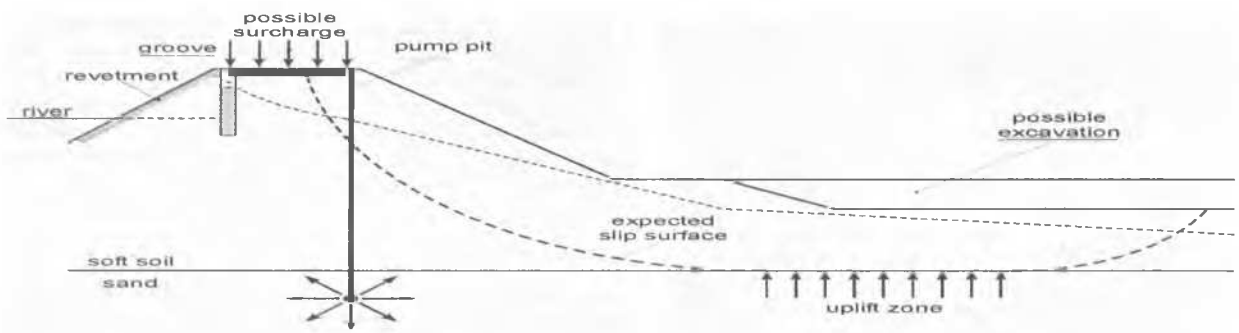
The deformation test is shown in Figure 5. During the test the dike will be forced to deform according to the up-lift mechanism. Like many river dikes in the Western part of the Netherlands, the dike in Bergambacht is build on a soft soil layer of about 13 m thick on top of a sand layer. Under normal conditions with average water level, the dike is partially supported by the soil behind the dike. The horizontal force resulting from the sliding soil mass in the active zone will partially be transferred to the sand layer by shear in the passive zone and partially to the ground beyond the passive zone by horizontal pressure. At high water level in the river, the ground water head in the deep sand layer increases, causing a reduction of the effective stress and therefore also of the shear stress at the boundary between the sand and the soft soil layer. This process can lead to local uplift of the soft soil layer and a reduction of the shear stress to zero. The soil in the up lift zone will then act as a horizontal compression bar in order to transfer the horizontal force resulting from the sliding soil mass to the confining zone. This mechanism will induce failure of the dike according to a deep slip surface.

During the test, water will be pumped into the deep sand layer to produce the high water head. In order to induce the loss of stability, the first 1.5 m of the clay layer will be removed in the region behind the dike at a distance of 8 m from the toe. Because of the high estimated strength of the dike, it will be probably necessary to add a load on the crest to induce failure.

Figure 5. Deformation test.

The test will be monitored by measuring the water pressures and the deformations. The position of the phreatic line inside the dike as well as in the region behind the dike is very important for the analysis of the test. The monitoring of the horizontal as well of the vertical deformations will be performed on the surface and inside the body of the dike. Different techniques will be applied including image processing. In order to be able to follow the development of the shear band, the measurements have to be performed at regular interval.

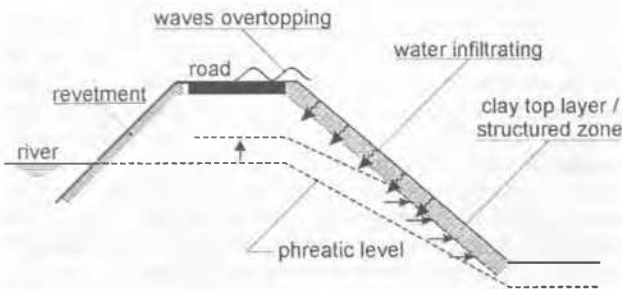
Water will be forced to flow over the crest of the dike to simulate overtopping by waves. The test is depicted in Figure 6. The deformation of the inner slope and the pore pressure inside

Figure 6. Wave overtopping test.

the dike will be measured. Additionally to the test with a constant water flow, it will be possible to vary the flow to simulate the stochastic character of a wave overtopping.

As in the phreatic line test, the purpose of this experiment is to study the influence on the pore water pressure during extreme (design) conditions of the initial position of the water table inside the dike as well as the water content in the region above the phreatic line. The development of the water level inside the dike is in this test due to overtopping of the crest by high waves. The influence of the unsaturated region will be studied.
