Risks and responsibilities of geotechnics in highway-, bridge-, and slope engineering

H. Brandl – *Technical University, Vienna, Austria*

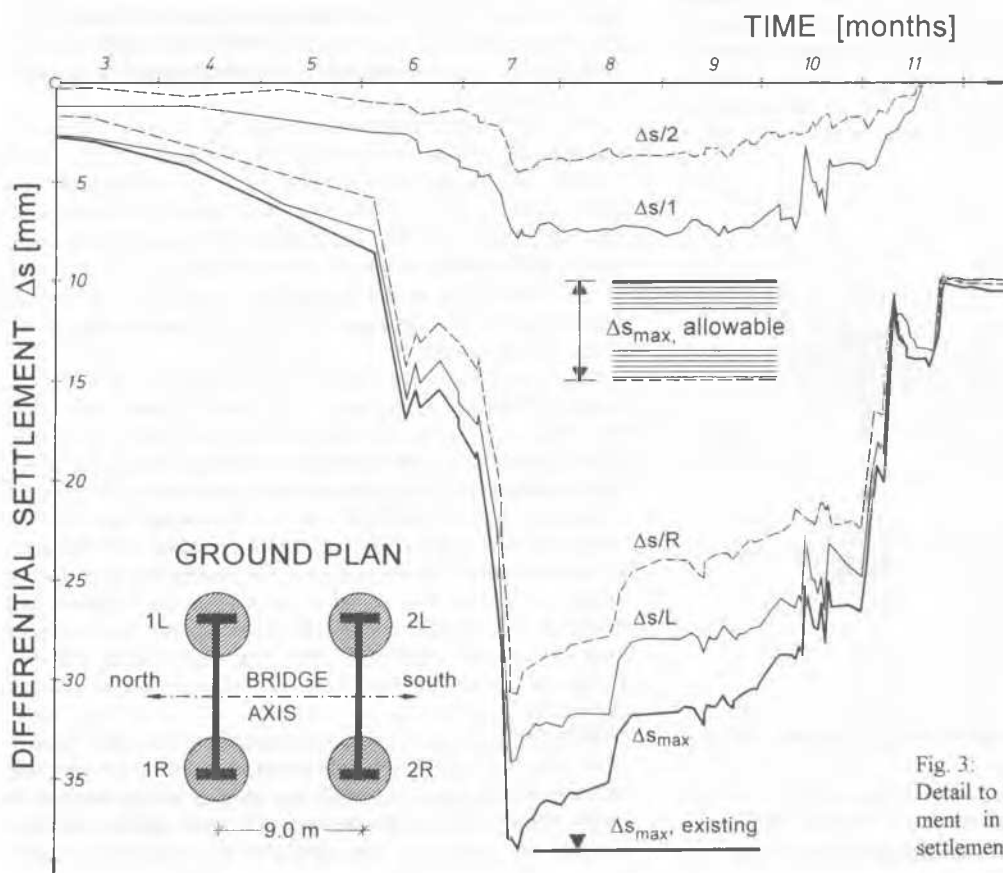
Fig. 3: Detail to Fig. 2, showing the development in time of the differential settlements among the four caissons.

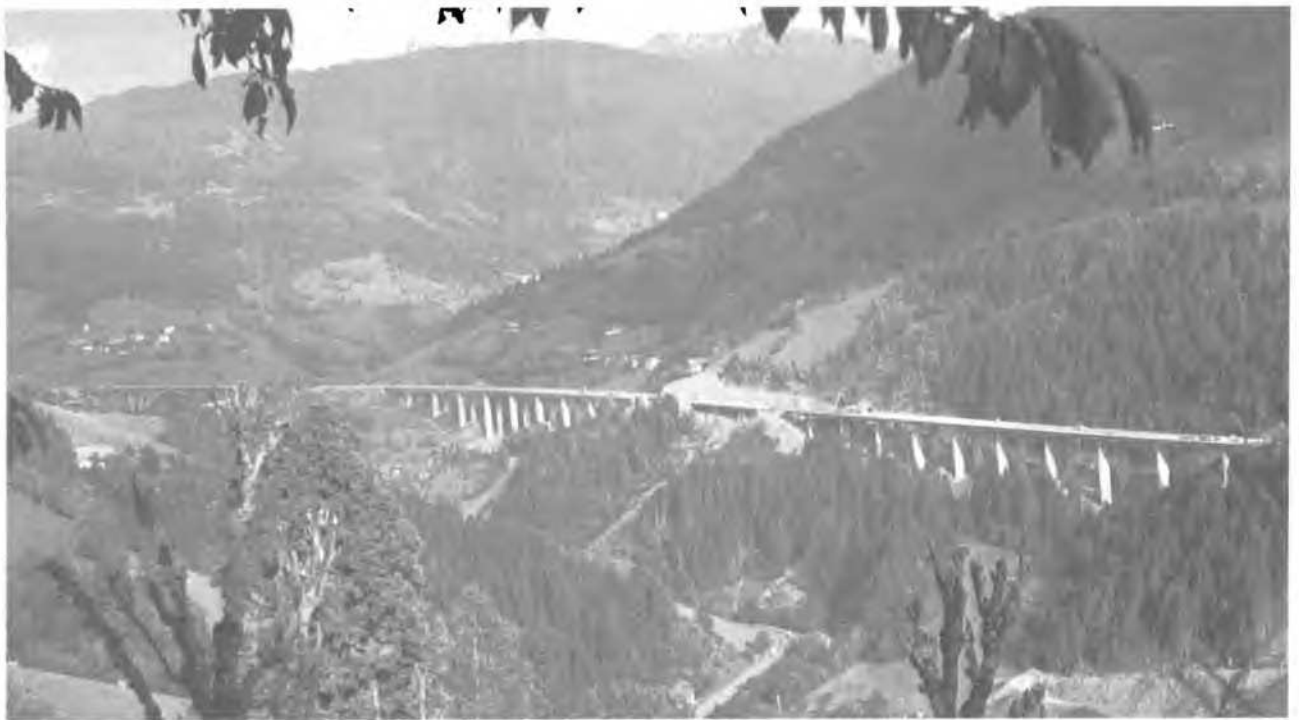
Fig. 10: Partial view of an Alpine highway in Austria, running on steep, slide-prone slopes in a seismic area (up to 10° MS).

Most of the highways in the mountainous region of Austria are running along unstable slopes (Fig. 10). Especially in case of high bridge piers and statically sensitive superstructures, the foundation and structure resp. are very sensible to differential movements. Usually, soil and rock parameters exhibit such a wide scatter that the safety of such slopes cannot be proved by theoretical methods

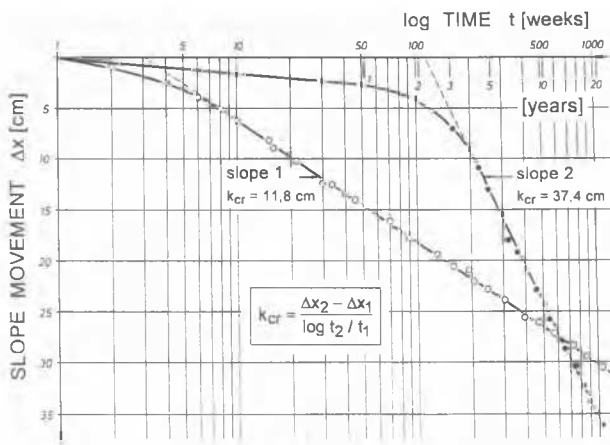
Fig. 14: Regular creeping behaviour of two slope sections. Definition of creeping factor, k_{cr} .

As an example, Figure 14 shows the time-displacements of two slopes which exhibit typical long-term creeping. From such curves, a creeping factor k_{cr} can be deduced which makes a long-term prognosis of future displacements possible. This parameter has proved fairly successful in risk assessment of creeping slopes, but
