VOLUME CHANGE IN CALCAREOUS SOILS DUE TO PHOSPHORIC ACID CONTAMINATION

R.C. Joshi X. Pan R.P. Lohtia

Department of Civil Engineering, The University of Calgary
Calgary, Canada

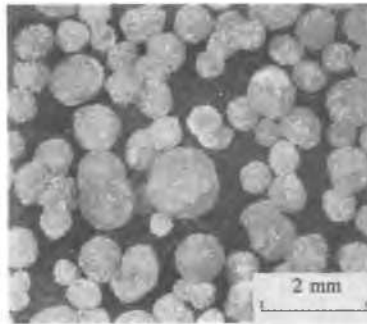
a) crystalline brushite

After two and half months, the sediments were taken out and washed with distilled water to remove excess acid solution. During the washing, some brown pellets varying from 0.5 mm to 2 mm in size were noticed in the samples which had been suspended in 0.5M acid solutions. A magnified picture of these pellets is shown in figure 1. Obviously, These pellets were the product of reaction between the soils and phosphoric acid. Electromicroscopic examination of this reaction product revealed a well crystallized narrow platy structure growing in all directions. The etching and

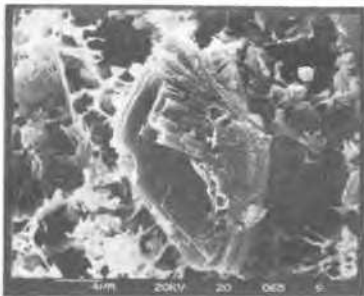
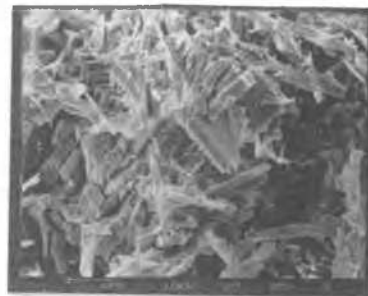
c) etching and breakdown of calcite

Fig.1 Optical and SEM pictures of brushite formed and acid etching of calcite

break down of the calcite or dolomite were evident from the SEM pictures as shown in Figure 1.

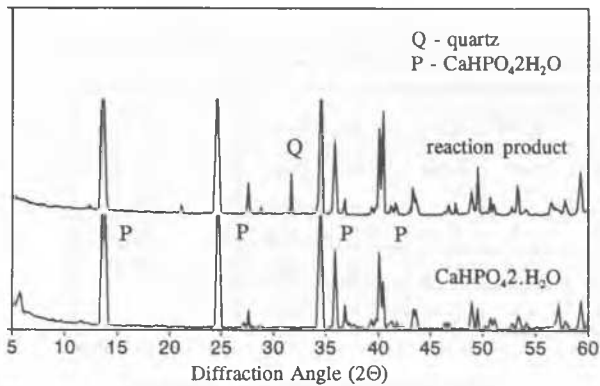
Fig.2 X-ray diffraction patterns of the reaction product - calcium hydrogen phosphate hydrate

X-ray diffraction analysis of the pulverized pellets indicated that major and minor peaks of the reaction product had very good correlation with the peaks of calcium hydrogen phosphate hydrate (CaHPO₄.2.H₂O), also called brushite. Refer to Figure 2. A comparison between the diffraction patterns of the reaction product and of a pure chemical substance of the reaction between calcium carbonate and 0.5M phosphoric acid solution further confirmed that the product was calcium hydrogen phosphate hydrate, as shown in Figure 2. An examination of the X-ray diffraction pattern of the in-situ soils also revealed the diffraction peak at 7.49Å which proved the presence of this crystalline product in the in-situ contaminated soils.

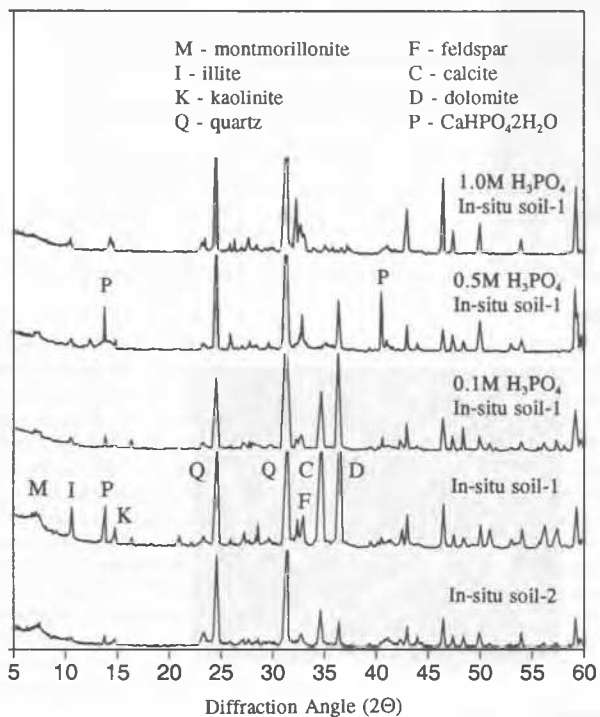
Fig.3 X-ray diffraction patterns of in-situ soils before and after reaction with phosphoric acid of different concentrations

The X-ray diffraction patterns of the in-situ soils and of the specimens from the sedimentation tests on the in-situ soil-1 are shown in Figure 3. From the high intensities of the strongest diffraction peaks of calcite and dolomite, it can be noted that the in-situ soil-1 still contains large amount of these minerals which possibly originated from the adjacent Rocky Mountains. With increasing concentration of acid solution, however, the intensities of the peaks of calcite and dolomite gradually decreased to almost zero in two and half months time, indicating the fast consumption of these minerals by concentrated acid. A further look at the diffraction peaks of the reaction product revealed that the formation of brushite was not proportional to the concentration of the acid solution. The intensity of the major peak of brushite formed in 0.5M acid solution is higher than that formed in 0.1M and 1.0M acid solutions. As a matter of fact, more pellets were observed in the specimen settled in 0.5M solution, while few were found in 1.0M and 0.1M acid solutions. This does not imply that the reaction is slow or incomplete in strong acid solution but manifests that the product dissolves in strong acid solution. Repeated tests indicated that even the originally formed brushite in the in-situ contaminated soil-1 dissolved in 1.0M acid solution as evidenced by the lack of a diffraction peak at 7.49Å.

Table 3 also gives the sedimentation volumes of in-situ soils and UC campus soil in 1.0M acid solution. The smallest sedimentation volume of the in-situ soil-1 was equal to its equilibrium sedimentation volume. The reason for this can be ascribed to the high solubility of the reaction product in concentrated acid solution. This can be explained by the disappearance of the strongest diffraction peak of brushite at 7.49\AA from the sample in 1.0M acid solution. Refer to Figure 3. Even the originally present brushite in the soil was dissolved in the 1.0M acid solution together with the calcite and dolomite. As a result the equilibrium sedimentation volume in 1.0M acid solution was even smaller than that in 0.01N CaSO_4 solution. Differing from that of in-situ soils the equilibrium sedimentation volume of UC soil in 1.0M acid solution was larger than the smallest volume. An examination of the X-ray diffraction pattern of the UC soil sample after being submerged in 1.0M acid solution for two and half months shows the existence of brushite in the

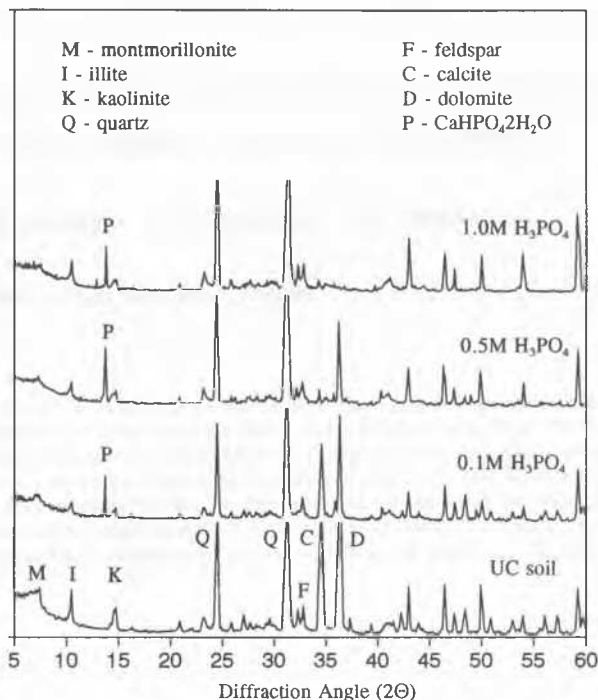
The X-ray diffraction patterns of UC campus soil before and after reaction with phosphoric acid are shown in Figure 4. From the diffraction pattern of the raw soil sample, it is evident that the mineral composition of the UC soil is very similar to that of the in-situ contaminated soils. The only difference is that the UC soil is uncontaminated by phosphoric acid. The data in Figure 4 show that there is the gradual disappearance of the strongest diffraction peaks of calcite and dolomite with increasing concentration of phosphoric acid solution. Moreover, the formation of the reaction product almost followed the same pattern as that observed in in-situ soil specimens. However brushite formed this time did not totally dissolve in 1.0M acid solution. This might be attributed to a higher final pH of the pore water system since the breakdown of calcite and dolomite would neutralize quite a bit of phosphoric acid.

Fig.4 X-ray diffraction patterns of UC soil before and after reaction with phosphoric acid of different concentrations
