Pile driving triggers subsidence Le battage de pieux peut causer l'effondrement du sol

SYNOPSIS: The Civic Regional Building in the downtown core of Sudbury, Ontario, Canada is a five-storey concrete frame building supported on long driven concrete piles. During driving part of the site settled 0.9 m over 48 hours.

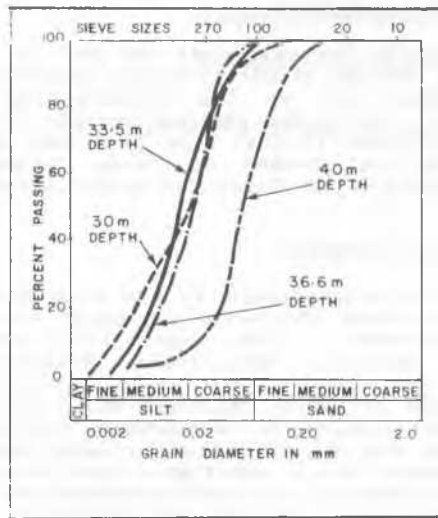
FIGURE 3 TYPICAL GRAIN SIZE DISTRIBUTION OVER ENTIRE DEPTH

Figure 3 indicates typical gradings for representative depths. The groundwater level in the upper fill and alluvium was near old creek level some 2 metres below existing surrounding ground surface. The sand gravel and cobble till at a depth of 46 metres showed a peizometric head at least 1 metre above the existing ground surface, i.e., Elevation 257 metres.

During the first week of March, a local depression around the pile drivers, approximately 36 metres in diameter and 1.2 metres in depth with a volume of 1200 cubic metres was recorded. This depression occurred rapidly, i.e., within 2 days. Elevations taken on catch basins in the depression indicated a settlement of 1 metre below original level. The extent of this subsidence is shown on Figure 1. As this depression was forming driving continued. Silt laden water was noted to be flowing up around some of the piles. An analysis of the silt showed that it corresponded to the grain sizes of the material from the deeper silt strata below 21.5 metres.

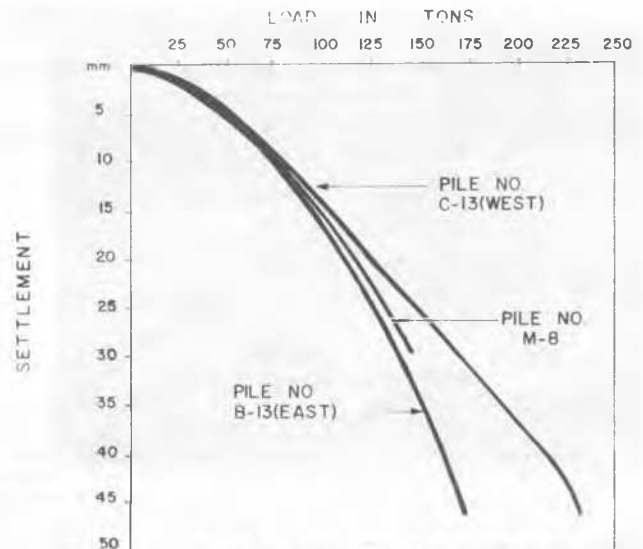
FIGURE 4 PILE LOAD TEST RESULTS

Three piles were selected for testing. The result of these tests is presented as Figure 4. It can be seen that the 300 mm piles were capable of carrying a 1020 kN design load and the 200 mm pile obtained the necessary safe capacity of 620 kN.

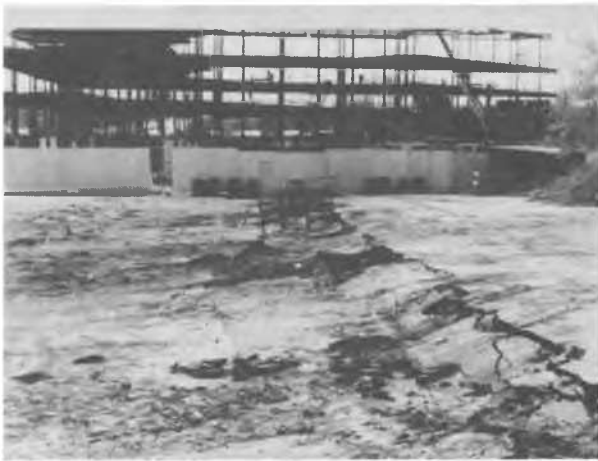
Piles within the depression moved more than 150 mm laterally towards the centre of the zone of influence and there was concern for their integrity. A retapping program carried out on the piles that were obviously affected showed that their original resistance to driving remained unchanged. Figure 5 indicates some of the magnitude of the settlement.

FIGURE 5
SUBSIDENCE VISABLE AFTER PILE CUT-OFF

It was obvious that the pile driving was causing the problem regardless of from where the problem originated. To reduce this effect, the pile drivers were separated to opposite ends of the site and pile driving was restricted to 1 or 2 piles a day per pile group. Piling continued until the 437 piles were in place and little, i.e., less than 25 mm of movement was detected over the remainder of this site. No pattern of movement at depth could be obtained from the settlement points.
