Earthquake-induced settlements in port facilities in Chile

C.J.PORAN, Geotechnical Engineer, Louis Berger International, Inc., East Orange, New Jersey, USA
 J.GREENSTEIN, Assistant Vice President, Louis Berger International, Inc., East Orange, New Jersey, USA
 L.BERGER, Chairman, Louis Berger International, Inc., East Orange, New Jersey, USA

SYNOPSIS: A large earthquake took place on March 3, 1985 in the central region of Chile. The earthquake had a surface wave magnitude of $M=7.8$ on the Richter scale and the epicenter was located in the Pacific Ocean approximately 40 km from the port of San Antonio. The earthquake's intensity in the port was VIII on the modified Mercalli scale and the damage to port facilities was very extensive. Most spectacular were the liquefaction-related failures of portions of a seawall. Also, heavy settlements occurred in many backfill and yard areas. Simplified available procedures have been applied to evaluate liquefaction potential as well as to estimate settlements of sandy deposits using the SPT N-values and the earthquake parameters, and, in several locations, the results show good correlation to actual observations. The authors have also studied

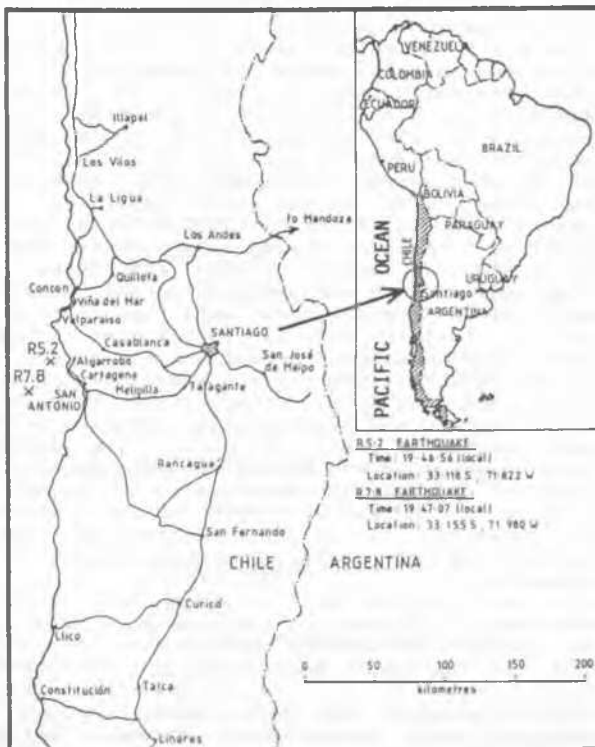
FIGURE 1. THE GENERAL AREA OF THE EARTHQUAKE (AFTER CONNOR, 1985)

The Chilean earthquake of March 3, 1985, became one of the most significant, well recorded, and major earthquakes to date. The main earthquake occurred at 19:47 hours local time. Figure 1 (Connor, 1985) shows the general area affected

by the earthquake, which included San Antonio, Valparaiso, the metropolitan region and Santiago, and many surrounding cities. Significant ground motions were recorded for a relatively long duration. Seismological records indicate that the earthquake actually consisted of two main shocks occurring within 11 seconds of each other as shown in Figure 1, with surface wave magnitude of 5.2 and 7.8, respectively.
