Foundations for the rehabilitation of an ancient building

F. MUZAS, Dr. Ingeniero C.C.P., Rodio, Madrid, Spain
 F. MORENO-BARBERA, Dr. Arquitecto, Madrid, Spain
 A. URIEL, Dr. Ingeniero C.C.P., Agromán, Madrid, Spain

SYNOPSIS The problems are described in connection with a rehabilitation project of a 15th Century building in Burgos (Spain) involving the excavation of three basement levels below groundwater level and having to conserve several parts of the ancient building. An analysis is made of the different problems encountered. The solution finally adopted, at present being carried out, includes a perimeter retaining wall constructed just below two façade walls, by means of the soil freezing technique and the temporary underpinning of the interior walls by means of a reinforcing structure consisting of micropiles.

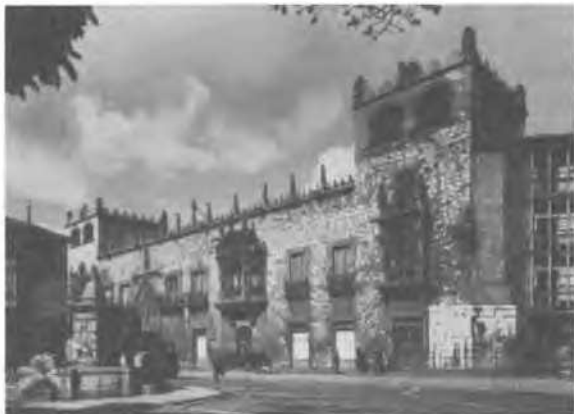
Fig. 2 - View of the "Casa del Cordón" Building

Fig. 2 shows a view of the Building corresponding to the façade onto Calvo Sotelo Square.

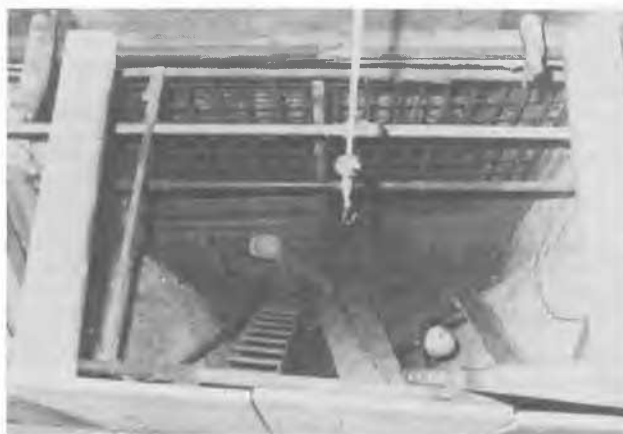
Fig. 8 - Construction of a pier foundation panel inside a frozen soil cylinder.

The works for inner excavation, reinforcement, framework and concreting took about 25 to 30 days per cylinder. Fig. 8 shows the construction of a pier foundation panel inside a frozen cylinder.
