Foundation of a 200 m high chimney on collapsible weak rock

SYNOPSIS The 200 m high chimney of the Almeria thermal power plant is founded on calcareous sandstone of very low density (about $1,55 \text{ T/m}^3$). The shear strength, collapsibility, and deformability were studied by laboratory and "in situ" tests. The maximum allowable pressure was established in 10 daN/cm^2 to have a sufficient safety factor against failure due to shear stress or collapse. The measured settlements closely agree with the results of plate bearing test in horizontal direction.

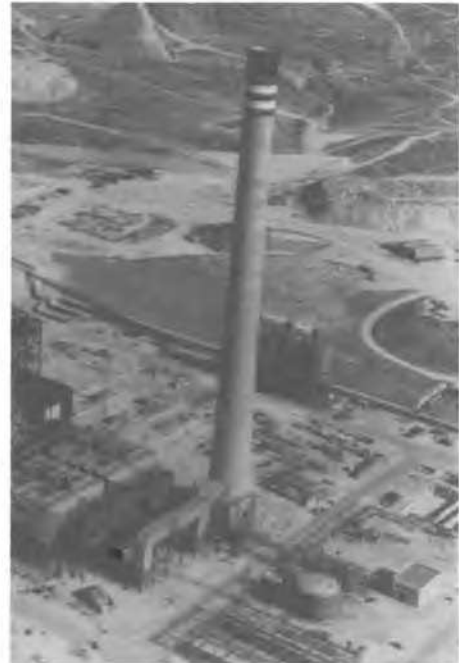
To avoid the land contamination, the smoke is discharged to the atmosphere through a chimney of 200 m high. The cross section of the chimney is circular, with an exterior diameter of 19,50 m at the base and 12 m at the crown (Fig. 1). For the above mentioned nature actions the forces transmitted to the ground are the following:

Fig. 1.- View of the 200 m high chimney

The shovel spoon "scrapes" easily the rock, and the teeth of spoon remain clearly marked in the slope excavation (Fig. 3). Nevertheless, as we shall comment afterwards, is sufficiently high to allow the excavation of 40 m high slopes of 60° with the horizontal. (See the slopes in Fig. 1, behind the chimney).

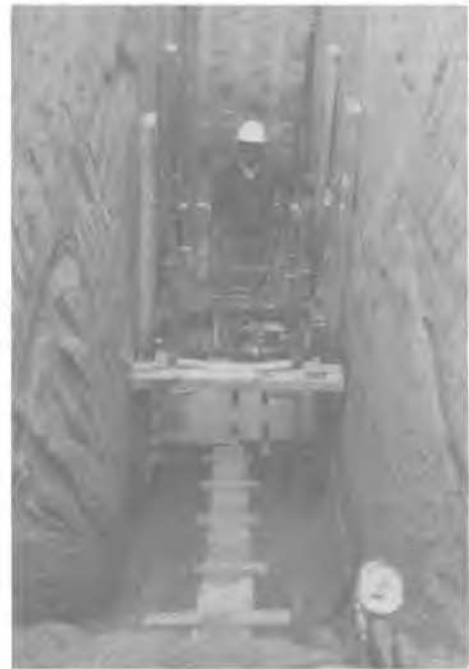
For determining the deformability of the sandstone, several 60 cm, circular plate test were performed, in horizontal direction, on the walls of trenches opened near the location of the chimney (Fig. 6). The load on the plates were increased by steps of 2 daN/cm², till a maximum of 16 daN/cm². After an unloading cycle, nine additional cycles between 0 and 16 daN/cm² were applied. A typical diagram load-deformation is presented in the Fig. 7.

Fig. 6.- Horizontal plate deformability test Ø 60 cm

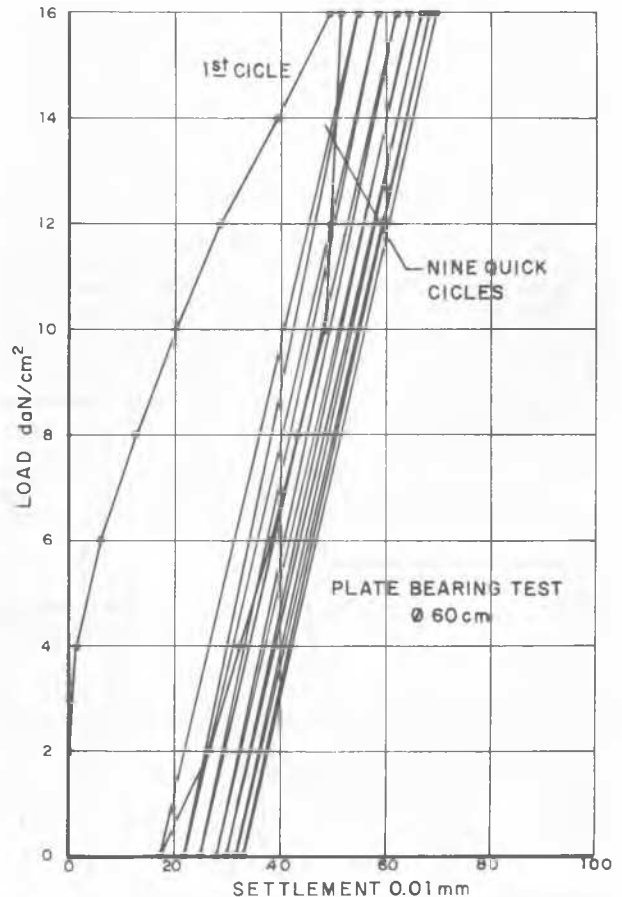
- a) For the first load cycle, the curve stress-deformation presents a small curvature from the origin, but till the maximum pressure applied, the modulus of deformation is high.
- b) From the cycle Nr 7 on, the behaviour of the soil is elastic, and no permanent additional settlement is observed for the following steps.
- c) Under water, systematically, the modulus of deformation is greater than above the ground water level. The average relation between this moduli is about 0,6. Under water the soil is saturated and the test are, therefore, partially drained.

Fig. 7.- Typical diagram of a plate deformability test
