Predicting the performance of residual soil slopes

E.W.BRAND, Head, Geotechnical Control Office, Engineering Development Department, Hong Kong

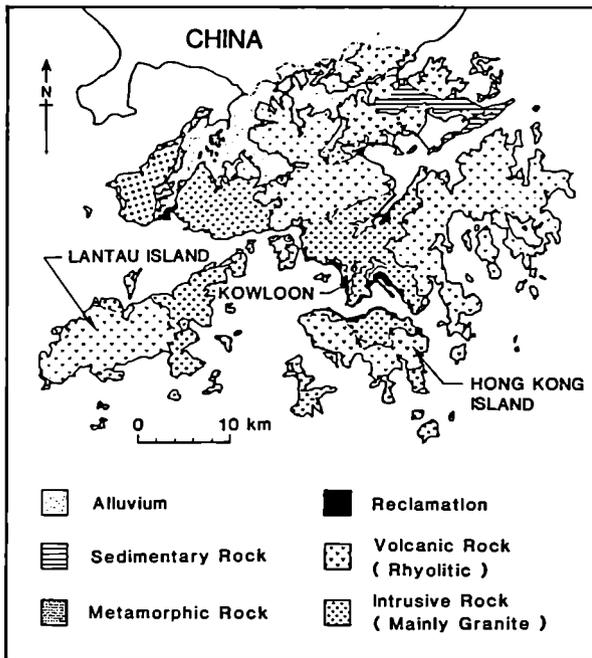
Fig. 1 Map of the Territory of Hong Kong Showing the Geology

The geology of Hong Kong, which is summarised in Fig. 1, has been described by Ruxton (1960) and Allen & Stephens (1971). The main rock types

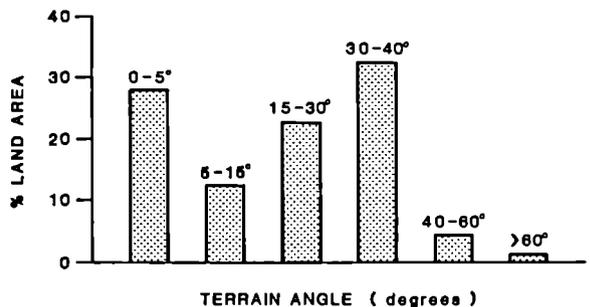
Fig. 3 Distribution of Terrain Angles over Hong Kong Island and Kowloon

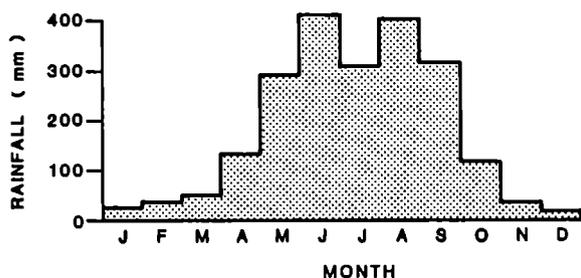
Fig. 4 Average Monthly Rainfalls in Hong Kong

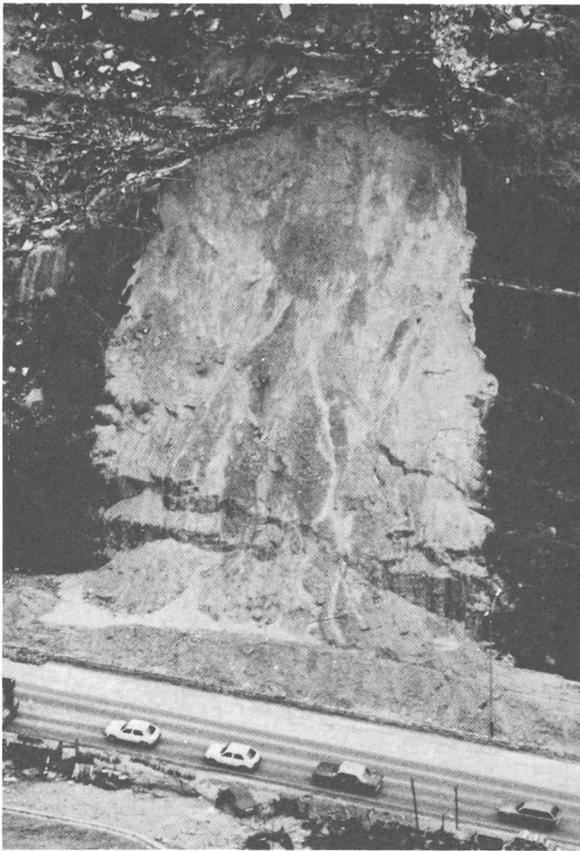
Fig. 5 Typical Hong Kong Soil Cut Slope Failure Caused by Heavy Rainfall

Cut slope failures in soil, or in mixed soil and rock, now constitute by far the most common form of landslide. The volcanic rock profiles are more susceptible to failure than the granite profiles, and colluvium is frequently involved. The failures nearly always occur suddenly during intense rain without prior warning (Brand, 1984, 1985b), and most slip surfaces are shallow, the thickness of the failed zone usually being less than 3 m. A typical example is shown in Fig. 5.

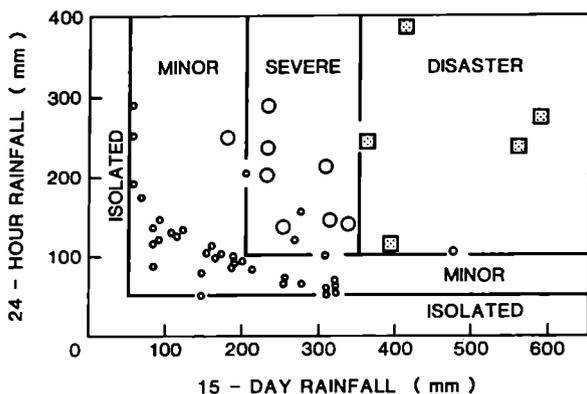
Fig. 6 Relationship between Rainfall and Landslides Established by Lumb (1975)

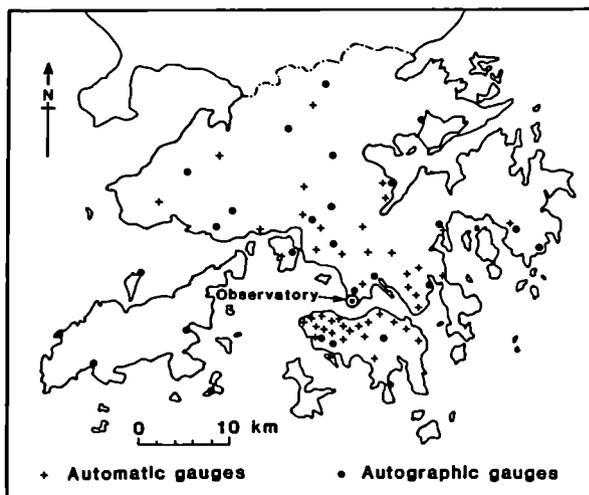
Fig. 7 Locations of Continually Recording Raingauges in Hong Kong, July 1985

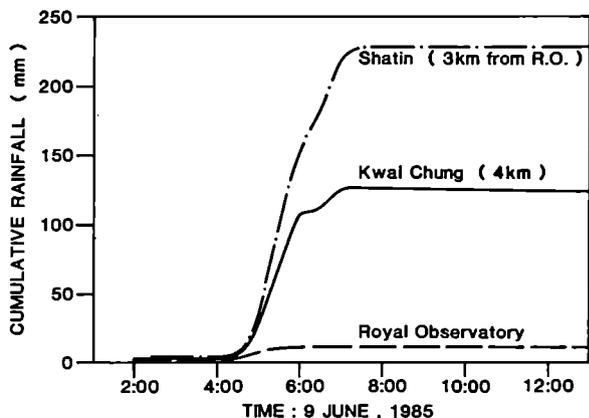
Fig. 8 Example of Large Variations in Rainfall over Short Distances in Hong Kong

Large geographical variations in rainfall occur over the Territory during any rainstorm event, as dramatically illustrated by rainfall records shown in Fig. 8 for three automatic gauges during a very recent rainstorm. These variations are attributable to the effects of topography. A common feature of a Hong Kong rainstorm is that the highest rainfalls occur near the tops of

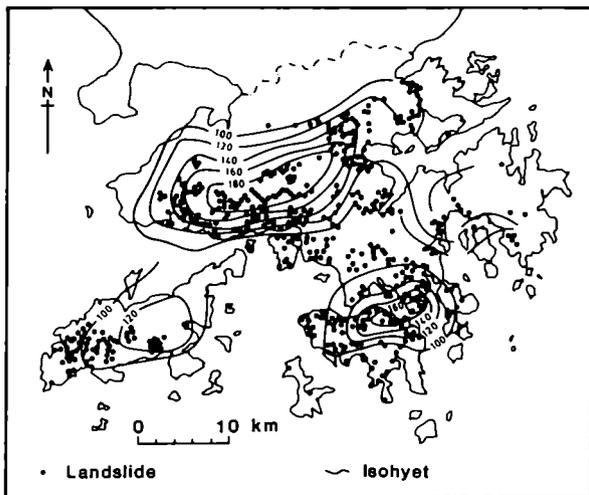
Fig. 9 Locations of Landslides in Relation to the 3-hour Isohyets in the May 1982 Rainstorm

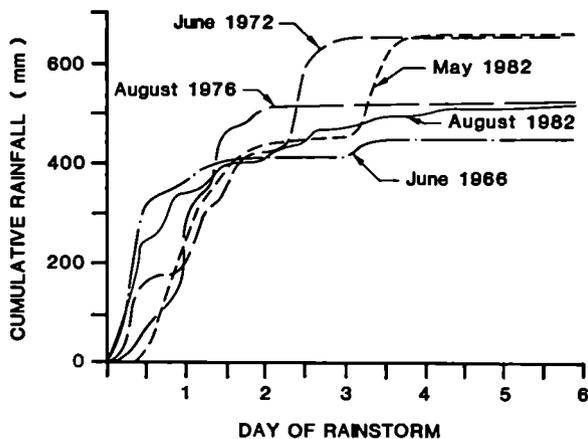
Fig. 10 Hong Kong's Five Severest Rainstorms in 1963-83

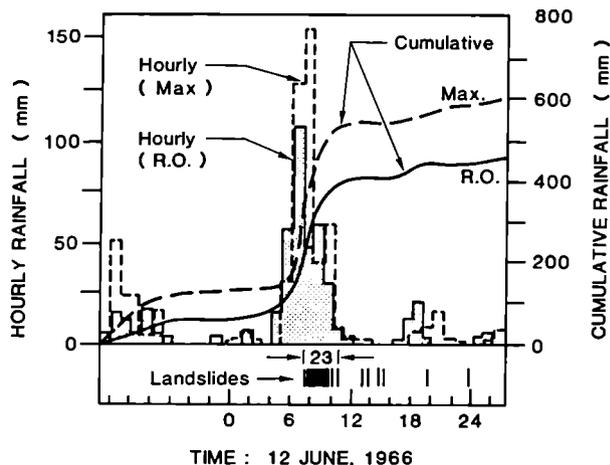
Fig. 11 Occurrence of Landslides in Relation to Rainfall at the Observatory and at Any Location during the June 1966 Rainstorm

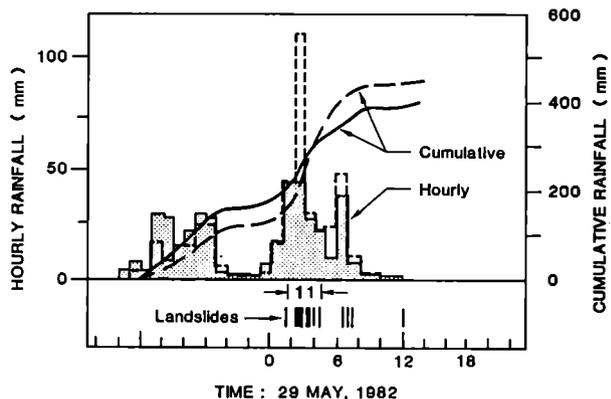
Fig. 12 Occurrence of Landslides in Relation to Rainfall at the Observatory and at Any Location during the May 1982 Rainstorm

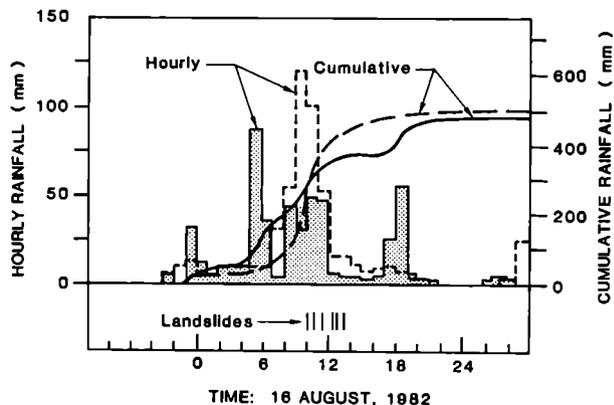
Fig. 13 Occurrence of Landslides in Relation to Rainfall at the Observatory and at Any Location during the August 1982 Rainstorm

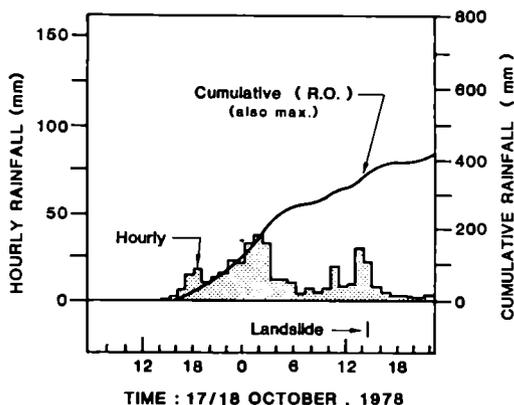
Fig. 14 Occurrence of Landslides in Relation to Rainfall at the Observatory at Any Location during the October 1978 Rainstorm

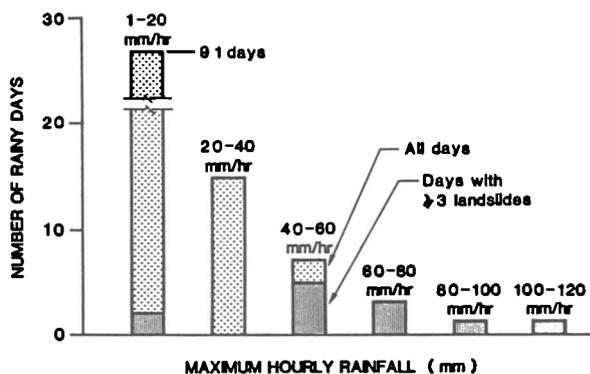
Fig. 15 Correlation of Landslide Occurrence during 1982 with the Maximum Hourly Rainfall Intensity Anywhere

During 1982, 3 248 mm of rain fell in Hong Kong, the highest annual rainfall on record. The distributions of all rainy days and of days with three or more landslides are shown in Fig. 15, plotted against the maximum hourly rainfall anywhere on each day. When the maximum hourly rainfall was less than 20 mm, no slope failures usually occurred. In contrast, failures nearly always occurred on the few days on which the maximum hourly rainfall intensity exceeded 40 mm per hour. The failures that occurred were also found to be in the vicinity of the area that experienced the highest rainfall intensity.

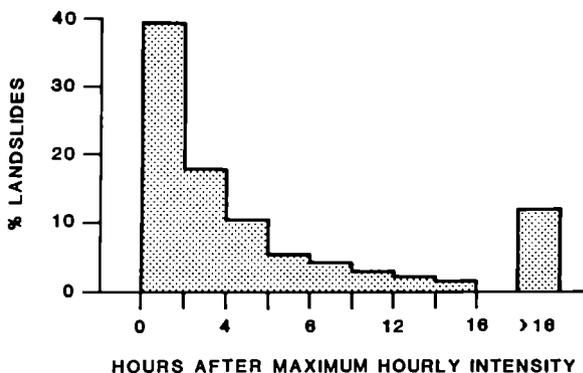
Fig. 16 Times of Occurrence of Major Landslides as Related to the Maximum Hourly Rainfall Intensity, during the Period 1963-83

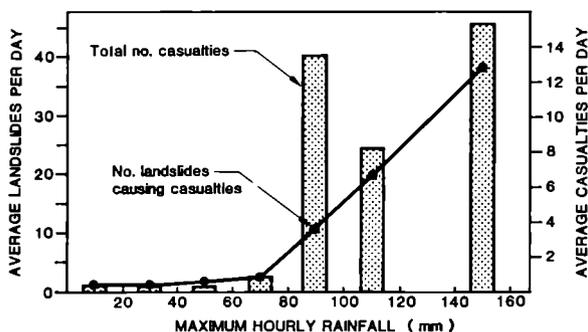
Fig. 17 Correlation of Landslides Causing Casualties and Number of Casualties during 1963-83 with Maximum Hourly Rainfall Anywhere

casualties on hourly rainfall intensity is clearly shown in Fig. 17. Throughout the twenty-year period, the number of landslides that caused casualties was very small unless the maximum hourly rainfall anywhere in the Territory approached 70 mm. Above this figure, the number of landslides with casualties increased sharply with increasing maximum hourly intensity. The actual number of casualties caused by landslides shows a similar but even more dramatic correlation with hourly intensity.

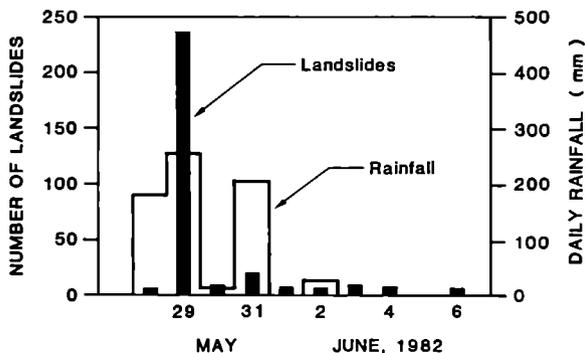
Fig. 18 Relationship between the Daily Rainfall at the Observatory and the Occurrence of Landslides during the May 1982 Rainstorm

For the May 1982 rainstorm, Fig. 18 shows the daily rainfalls at the Observatory for the event, together with the occurrence of all landslides for which the dates of failure are known. This shows that the large majority of landslides occurred on the 29th May, the day of the heaviest rainfall. The few failures that occurred up to a week later were probably caused by delayed

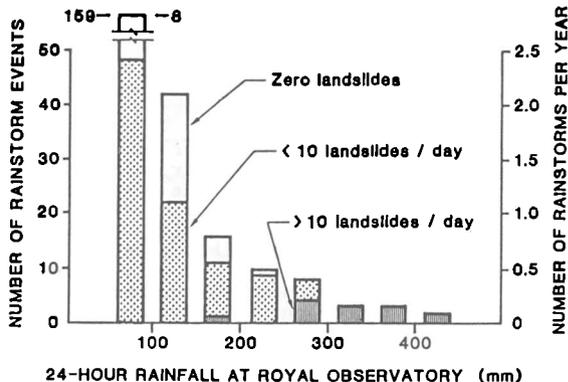
Fig. 19 Correlation of Number of Landslides with the 24-hour Rainfall at the Observatory during the Period 1963-83

Correlations between landslides in Hong Kong and the Observatory 24-hour rainfall are shown in Fig. 19 on the basis of two categories of event. A 'minor' event is one for which there are less than ten recorded landslides in one day, and a 'major' event is one for which there are more than ten landslides in one day. The 'minor' category is identical to that used by Lumb (1975), while the 'major' category corresponds to his combined 'severe' and 'disastrous' categories. Figure 19 demonstrates clearly that, where the 24-hour rainfall at the Observatory is below 100 mm, only a few minor events and no major events occur. With increasing 24-hour rainfall, the proportion of landslide days increases, with major events increasingly dominating at higher rainfalls. When more than 270 mm of rain falls in 24 hours, every rainstorm event results in a major landslide event.

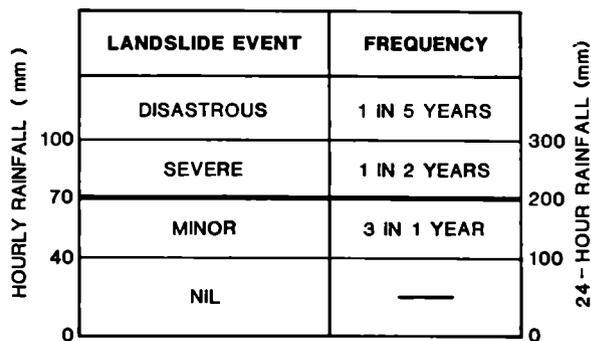
Fig. 20 Approximate Relationship between Rainfall Intensity and Landslide Events in Hong Kong

The results of the rainfall-landslide correlation study are summarised broadly in Fig. 20, which shows the approximate frequency of landslide events (as defined by Lumb, 1975) in terms of

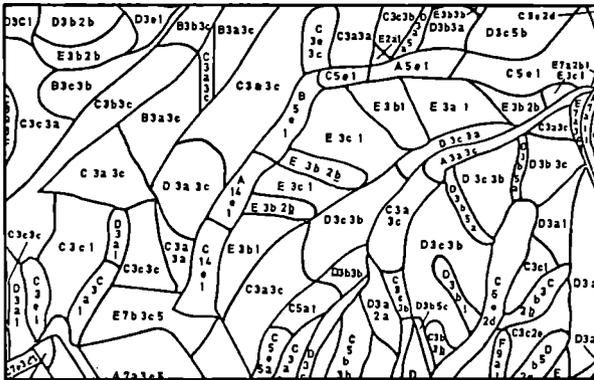
Fig. 21 Example of a Terrain Classification Map (Alpha-numeric denote attribute classes)

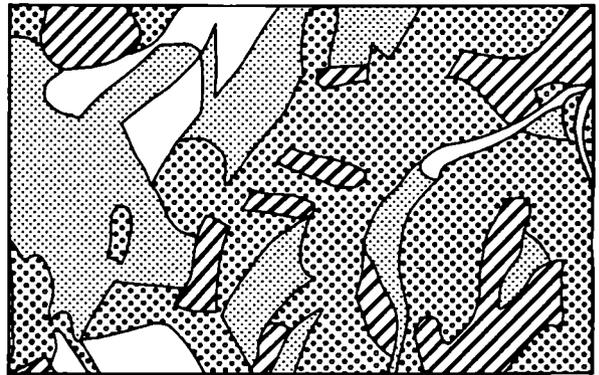
Fig. 22 Example of a Geotechnical Land Use Map (GLUM) for the Area Shown in Fig. 21

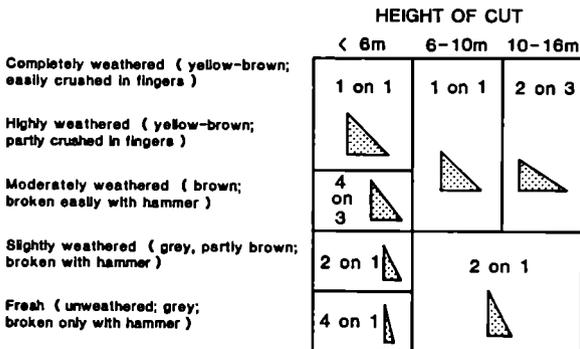
Fig. 23 Simple Empirical Design Rules Developed for Wellington Greywacke by Grant-Taylor (1964)

An example of the simplest type of semi-empirical design rules is illustrated in Fig. 23, which shows the recommended slope angles for different heights of cut slopes on the basis of the degree of weathering of Wellington greywacke (Grant-Taylor, 1964; Taylor et al, 1977). Earlier, Lane (1961) had correlated slope height and slope angle for slopes in clay shales in Montana, North Dakota and Kansas, to produce the plot shown in Fig. 24. The work by Shuk (1965, 1968), summarised in Fig. 25, is of particular note,

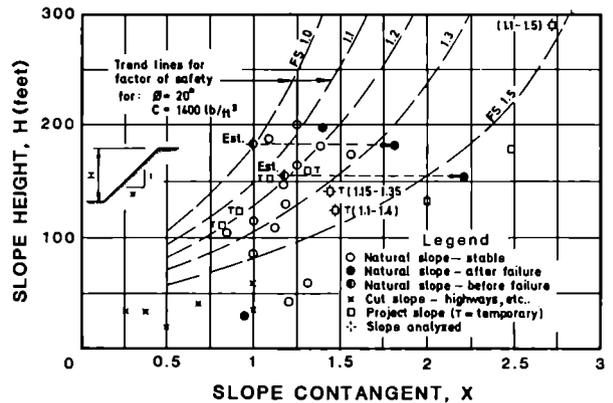
Fig. 24 Design Guidelines Developed by Lane (1961) on the Basis of the Performance of Clay Shale Slopes in Northern USA

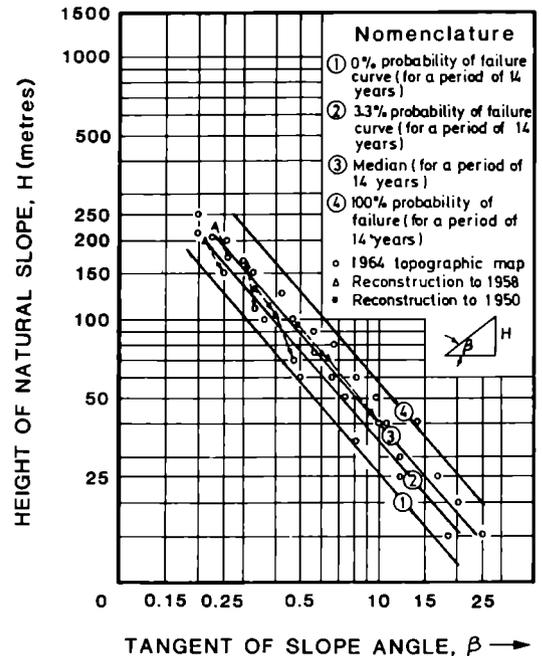
Fig. 25 Design Guidelines Developed by Shuk (1965, 1968) for Clay Shale Slopes near Bogota

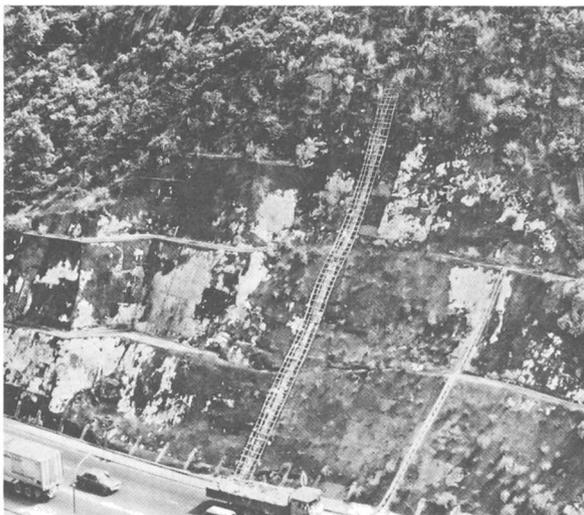
Fig. 26 Typical Stable Hong Kong Cut Slope Included in the CHASE Study (Brand & Hudson, 1982)

A typical CHASE slope is shown in Fig. 26. This is 45 m high and is cut at an angle of about 60° into a steep natural hillside covered with dense vegetation. The material of the slope comprises 5.5 m of colluvium overlying decomposed granite,

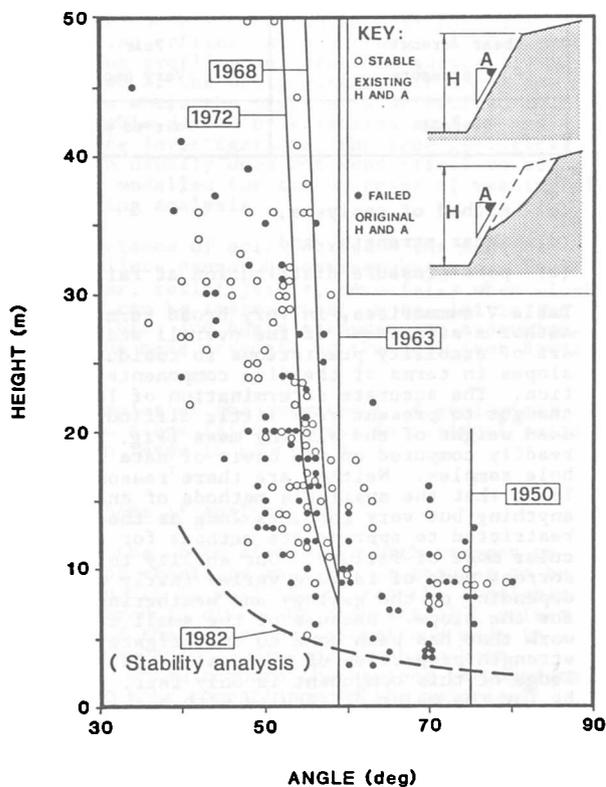
Fig. 27 Relationship between Height and Angle for the 177 Hong Kong Cut Slopes Included in the CHASE Study (Brand & Hudson, 1982)

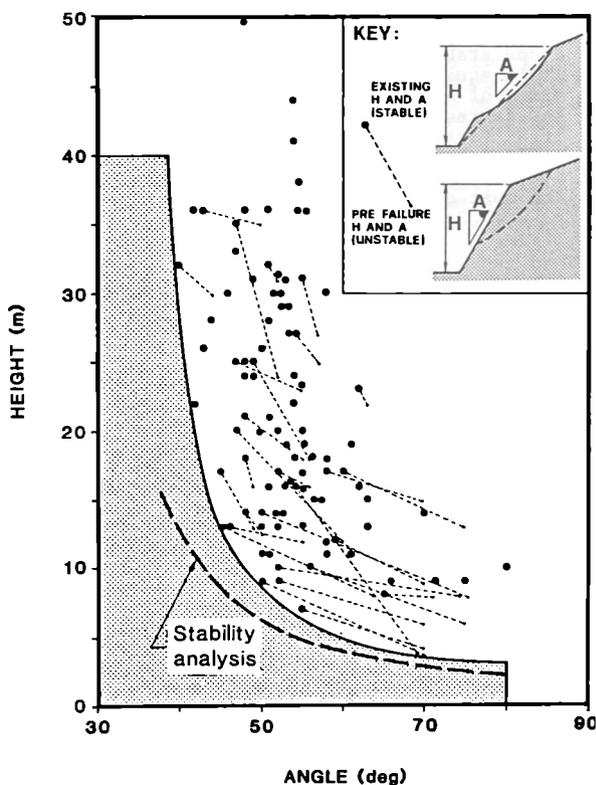
Fig. 28 Relationship between Height and Angle for the 117 Hong Kong Granite Soil Cut Slopes Included in the CHASE Study (Brand & Hudson, 1982)

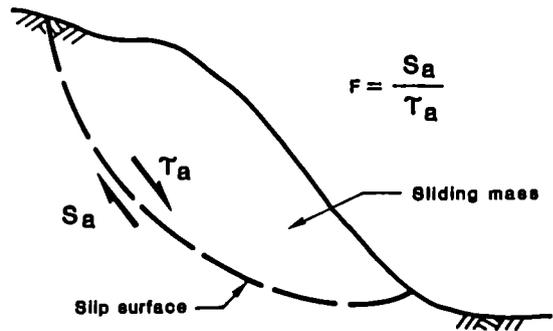
Fig. 29 Basis of the Limit Equilibrium Method of Stability Analysis for Slopes

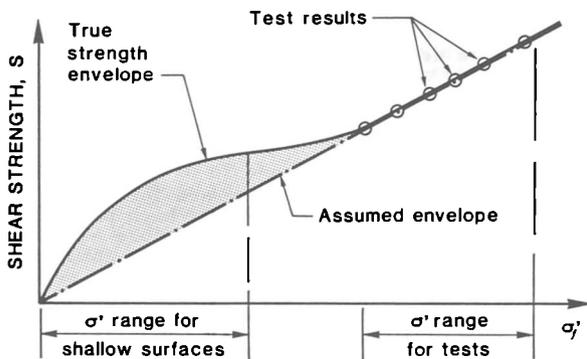
Fig. 30 Underestimate of Shear Strengths because of Incorrect Strength Envelope Deduced from Data Obtained at Too High Normal Stresses

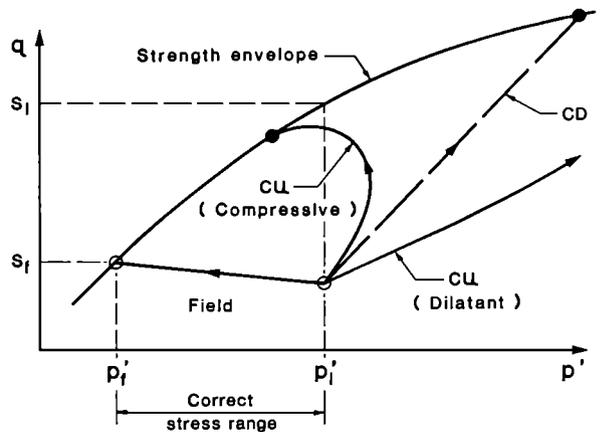
Fig. 31 Comparison between Stress Paths for Rain-induced Slope Failure and Those for Triaxial Tests (Brand, 1981)

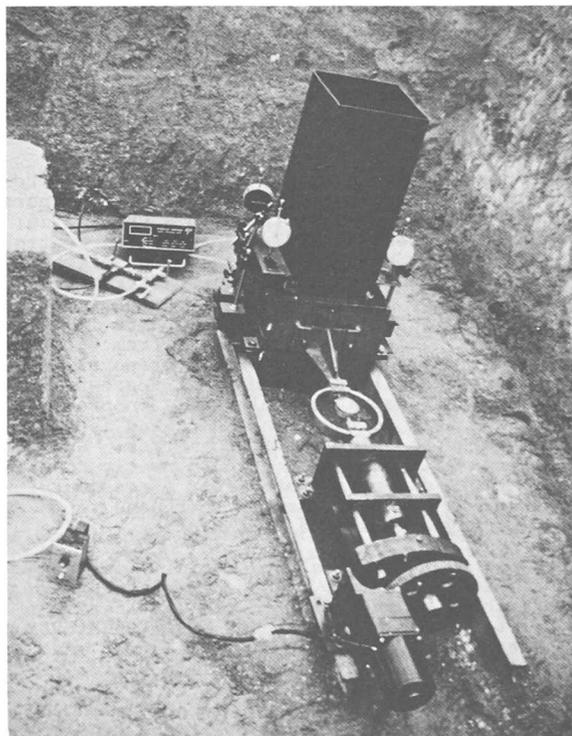
Fig. 32 In situ Direct Shear Test Apparatus Used on Hong Kong Residual Soil (Brand et al, 1983b)

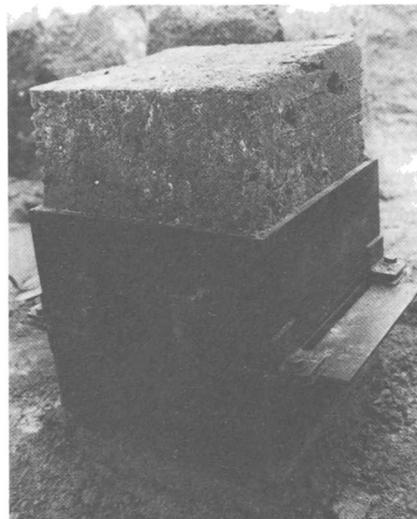
Fig. 33 Block Sample of Grade V Hong Kong Granite Used in the Apparatus Shown in Fig. 32

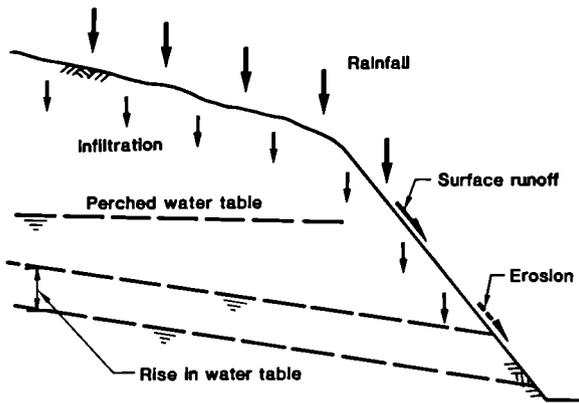
Fig. 34 Diagrammatic Representation of the Effects of Rainwater on a Slope

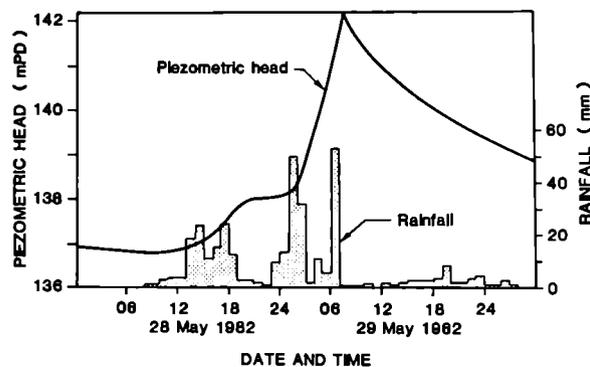
Fig. 35 Rapid Changes in the Groundwater Table Measured in a Hong Kong Slope

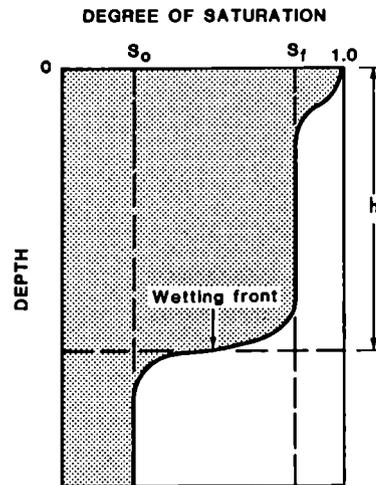
Fig. 36 Representation of the Advance of the Wetting Front as Water Infiltrates into Soil (Lumb, 1962b, 1975)

For the infiltration of water into the horizontal surface of a porous medium, Lumb (1962b) derived an expression for the advance of the 'wetting front' (Fig. 36). On the assumption that diffusion is negligible at the end of an intensive

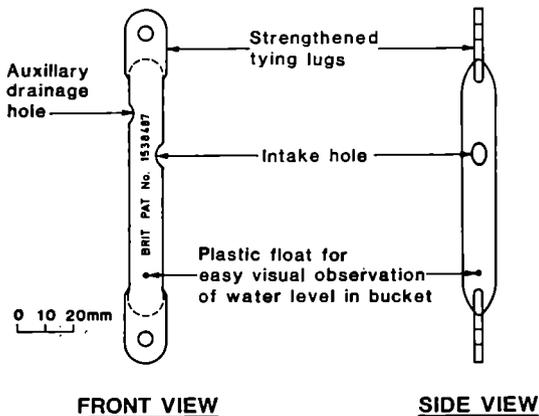
Fig. 37 Halcrow Plastic 'Buckets' Used for Recording the Maximum Water Elevation Attained in a Standpipe Piezometer

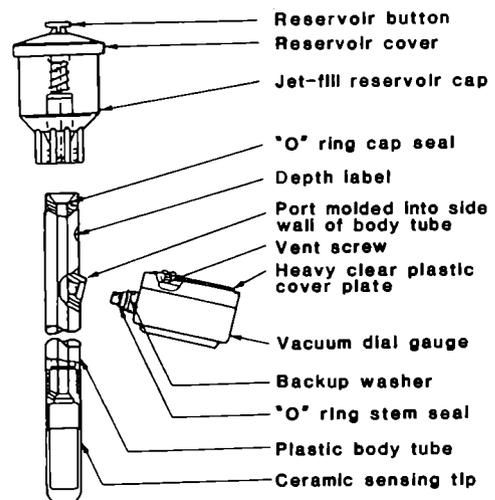
Fig. 38 Agricultural Tensiometer for the Measurement of Insitu Soil Suction

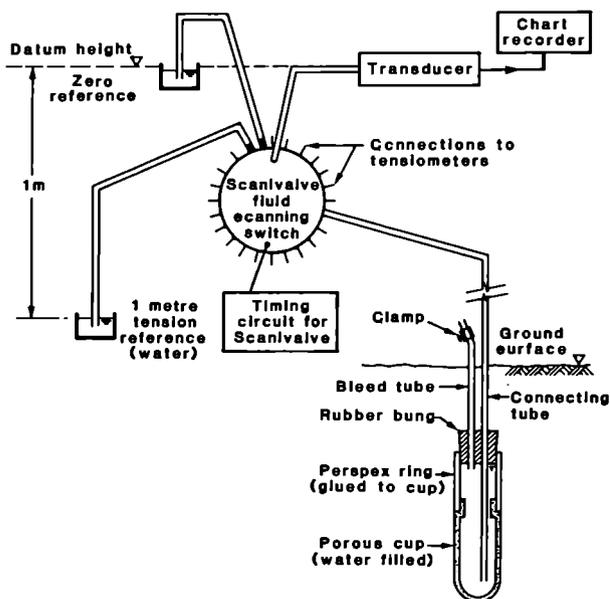
Fig. 39 Automatic Scanivalve System Used in Hong Kong for the Measurement of Positive and Negative Pore Pressures (Pope et al, 1982)

(Pope et al, 1982). This is based on similar equipment designed in the United Kingdom (Anderson & Burt, 1977; Burt, 1978). Small diameter tensiometer tips of high air-entry ceramic are each connected by twin water-filled flexible nylon tubes to a single transducer through a fluid scanning switch (Fig. 39). The switch is analogous to an electrical wafer switch, in that it allows sequential measurement of a number of fluid pressure inputs. A rotating metal valve inside the water-filled wafer (Scanivalve) enables the pressure transducer to be connected to 24 different inputs in turn, two of which are used as reference reservoirs for calibration purposes. The measured pore pressures are recorded on a variety of types of strip-chart recorder, the pressure-sensitive paper type now being regarded as the most reliable. The system is powered by a twelve volt battery, and all measuring and recording components are housed in a water-tight metal box. Although installation and maintenance costs are high, the systems have been found to be reliable for periods of up to three years.

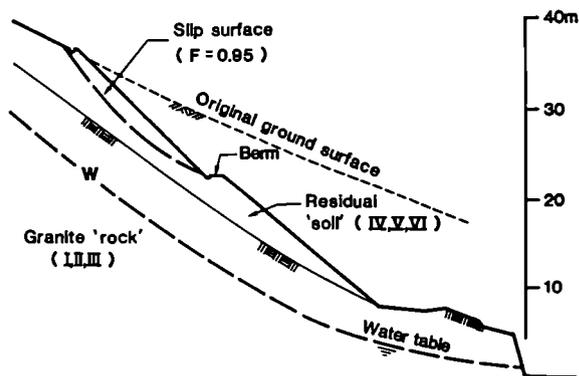
Fig. 40 Case 1: Stable Cut Slope with $F < 1.0$

Case 1 slope is shown in the simplified cross-section in Fig. 40. It has a height of about 36 m from the flat open space below. Deep excavations into the original ground surface left a relatively thin layer of granitic soil (grades IV, V & VI) over the granite bedrock. The slope surface is covered partly by vegetation and partly by lime-stabilised soil ('chunam'). The water table, as determined by piezometer installations, is low even during the wet season, no positive pore pressures having been measured in the soil.

The measured shear strength parameters for the material of the Case 1 slope vary between $c' = 14$ kPa and $\phi' = 45^\circ$ for the grade IV material, and $c' = 0$ and $\phi' = 42^\circ$ for the grade VI material. On the basis of these parameters, the factor of safety for the steep upper part of the slope, above the berm, is calculated to be 0.95, with the critical slip surface being very shallow and passing largely through the grade V material. The detailed cross-section of the 'unstable' part of the slope (Fig. 41) clearly illustrates the importance of the weathering profile on stability predictions for slopes of this kind.

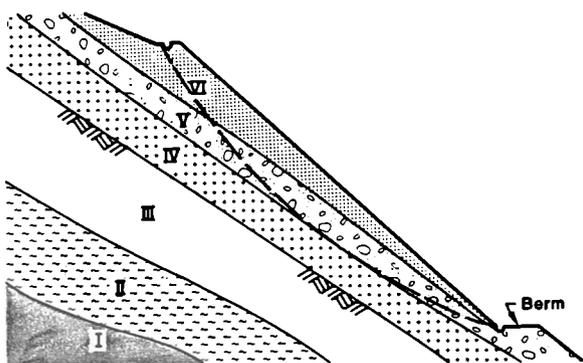
Fig. 41 Detailed Weathering Profile for the Case 1 Slope Showing the Grades IV, V & VI Soil

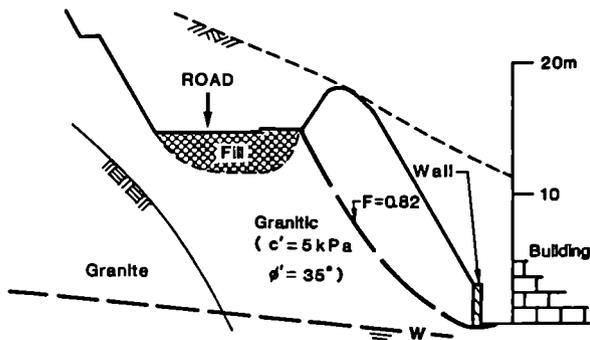
Fig. 42 Case 2: Stable Cut Slope with $F < 1.0$

Case 2 involves a cut slope in granitic soil which was formed as part of a combined site formation for a housing block and a road (Fig. 42). The steep cut slope, which is about 18 m high and coated with chunam, is retained at its toe by a 3 m concrete retaining wall. The very thick deposit of granitic soil is predominantly of grade V, with shear strength parameters of $c' = 5 \text{ kPa}$ and $\phi' = 35^\circ$. The water table remains low throughout the wet season. The calculated factor of safety on the deep critical slip surface shown in Fig. 42 is 0.82

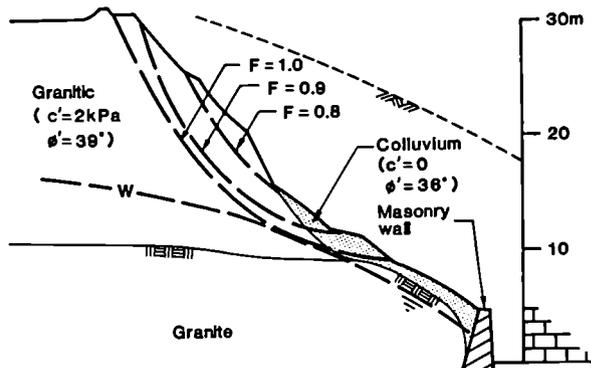
Fig. 43 Case 3: Stable Cut Slope with $F < 1.0$

Case 3 involves a 30 m high slope (Fig. 43) cut in granitic soil with a thin covering of colluvium over its lower half. At the toe of the slope is a 5 m high masonry retaining wall, and above the slope is a road. The surface of the slope is protected partly by chunam and partly by vegetation. The granitic soil varies from grade IV to grade VI, the vast majority being of grade V with strength parameters of $c' = 2 \text{ kPa}$ and $\phi' = 39^\circ$. At its highest, the water table is located many metres below the top of the slope, but it is close to the surface of the bottom part of the slope. The results of the stability analyses are depicted in Fig. 43. Several slip surfaces give factors of safety which are less than 1.0, the critical surface, which is very

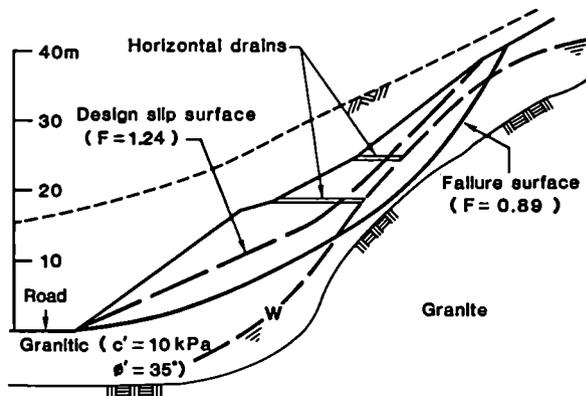
Fig. 44 Case 4: Unstable Cut Slope Previously Predicted as Being Stable ($F = 1.24?$)

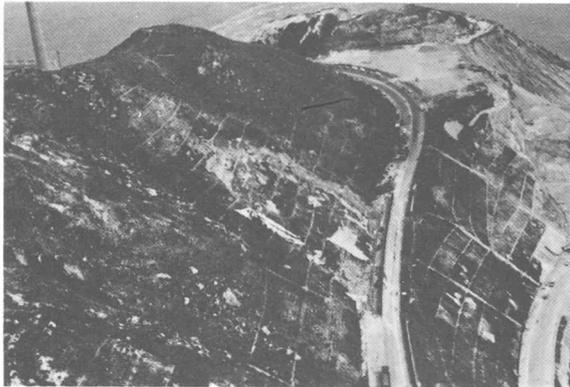
Fig. 45 Aerial View of Case 4 Slope after Failure

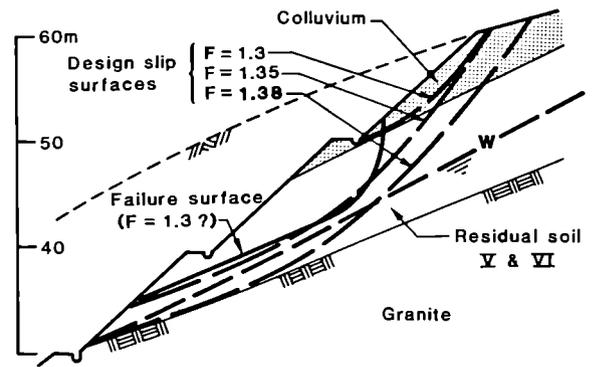
Fig. 46 Case 5: Unstable Cut Slope Previously Predicted as Being Stable ($F = 1.3?$)

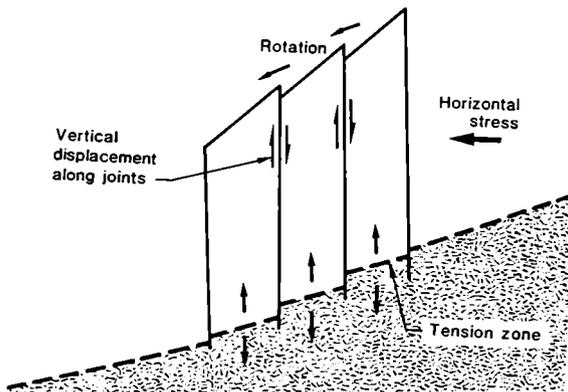
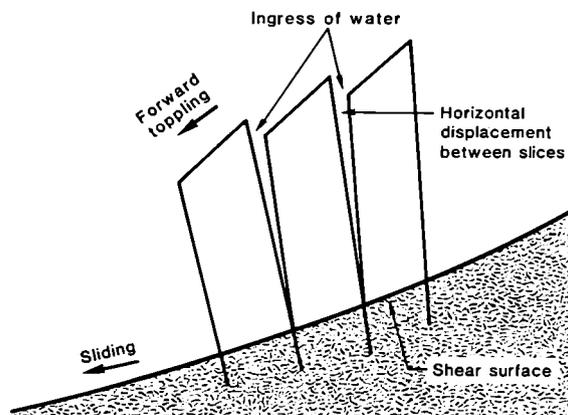
(a) Rotation and Displacement of Joints

(b) Ingress of Water through Open Joints

Fig. 47 Possible Failure Mechanism of Case 5 and Case 6 Slopes

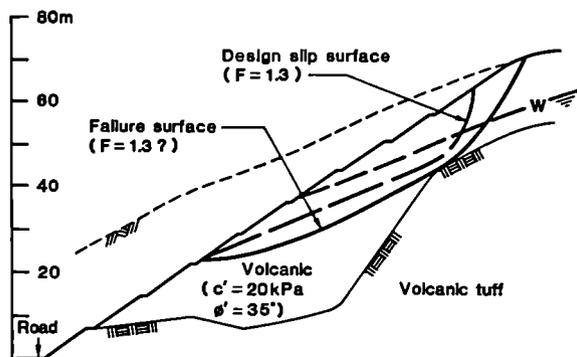
Fig. 48 Case 6: Unstable Cut Slope Previously Predicted as Being Stable ($F = 1.3?$)

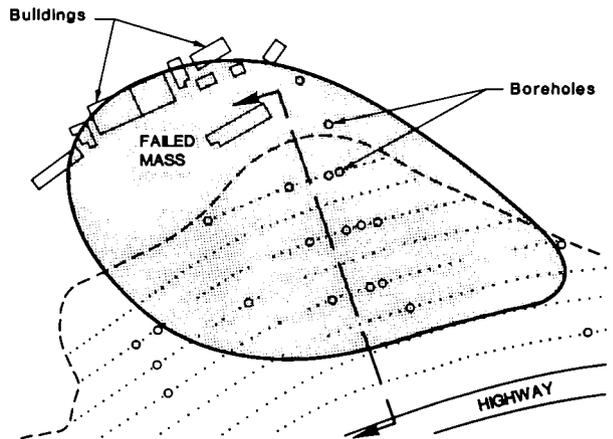
Fig. 49 Plan Showing the Extent of the Case 6 Failure

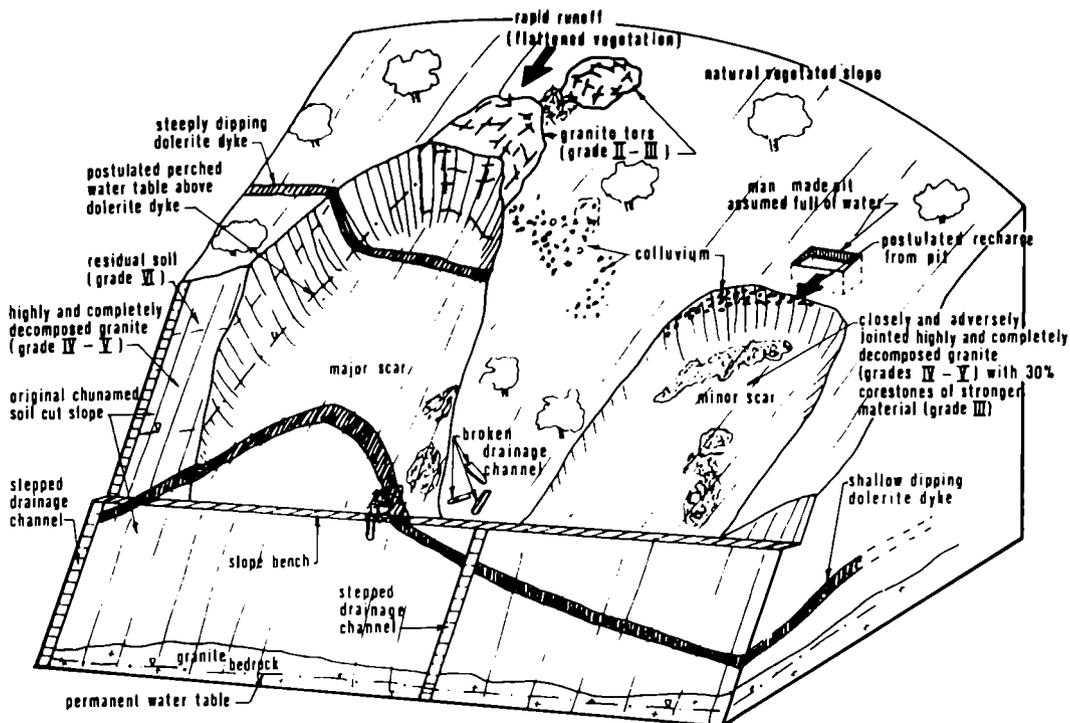
Fig. 50 Diagram Showing the Complex Geological Conditions at the Failure Site Studied by Hencher & Martin (1984)

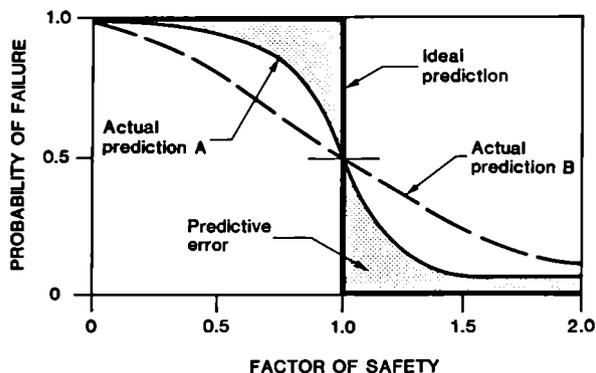
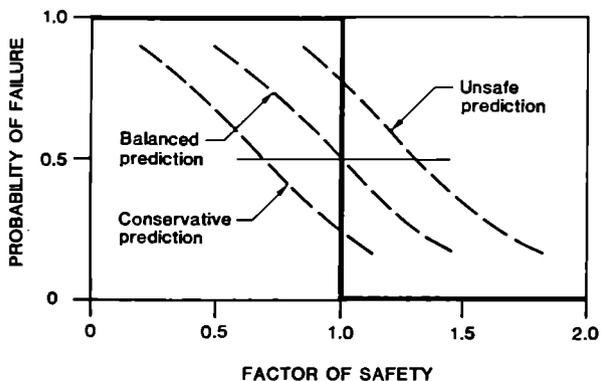
(a) Ideal and Actual Balanced Predictions

(b) Conservative and Unsafe Predictions

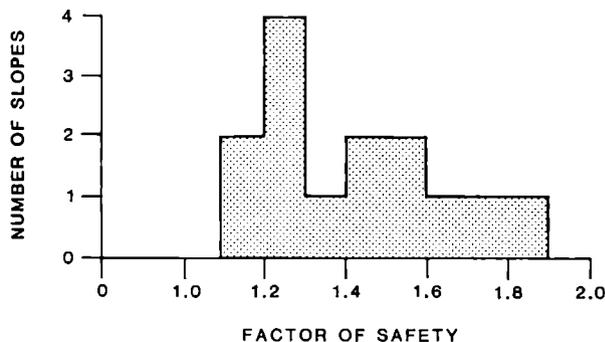
Fig. 52 Distribution of Factors of Safety for the 14 Tuen Mun Highway Slopes Studied in Detail

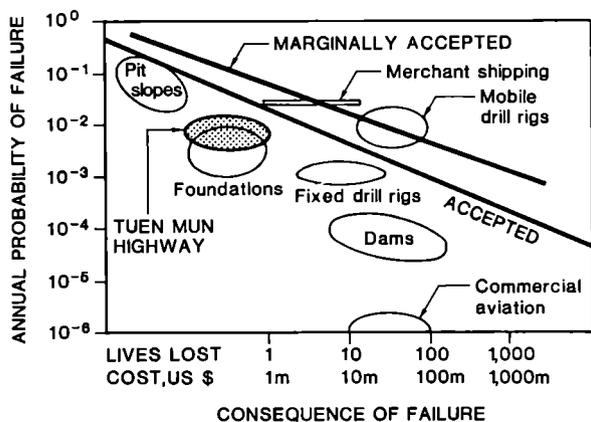
Fig. 53 Annual Probabilities and Consequences of Geotechnical Failures in the USA (Whitman, 1984) Compared with Those on the Tuen Mun Highway
