# The Tablachaca Dam slide N° 5 problem

P.C.REPETTO, Professor of Civil Engineering, Catholic University of Peru, Lima, Peru

Slide N° 5 is an ancient slide of about 13 million m<sup>3</sup> located in Perú upstream of the Tablachaca dam, the main structure of the Mantaro Hydroelectric Plant; whose installed capacity comprises 50% of the country's total capacity. In February 1982 the slide movements accelerated alarmingly, prompting ELECTROPERU to decide to undertake emergency stabilization works simultaneously with the complementary studies and investigations. The emergency works consist of: a fill buttress at the slide toe; treatment of reservoir sediments that form the buttress foundation; prestressed anchors in a stretch adjacent to the dam where buttress size had to be reduced; underground and surface drainage; and excavation of a rock protrusion in the river curve upstream of the slide. At present slide movements have decreased significantly, which indicates the effectiveness of the stabilization works; consequently this can be considered the largest slide in the world whose fall has been avoided by human action.

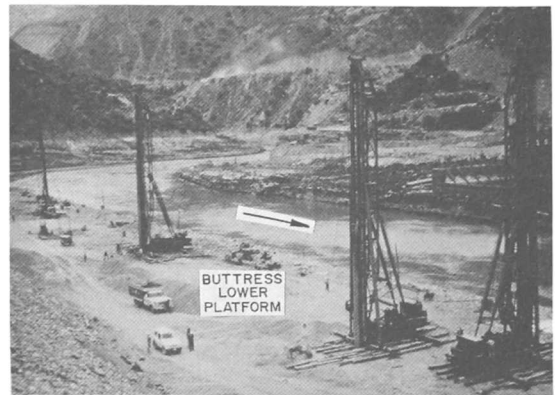
Fig.10 Sediment Treatment - Franki and Vibroreplacement Rigs

In order to speed up sediment treatment, the Franki technique was complemented with vibroreplacement in the areas where sediments are mainly sandy. Figure 10 shows three Franki rigs and one vibroreplacement rig operating on the buttress lower platform. The Franki technique used consisted of driving a 52 cm diameter and 22 m long steel casing through the fill platform and sediments, with a 4 Ton and 6 m drop hammer pounding, inside the casing, a gravel plug formed at the casing bottom. Once the casing was driven to rejection or to its full length, the plug was pounded out and casing lifting started, adding and compacting gravel so that a column of this material with a volume twice that of the casing was formed. The spacing between gravel columns was 2.4 m, center to center. The vibroreplacement technique used a 175 H.P. vibroflot with 2 Ton self weight and 35 cm outside diameter, which penetrated through the fill and sediments by effect of vibration and water jets. Then while the vibroflot was lifted, gravel was introduced and compacted continuously; the spacing between gravel columns was 2.3 m, center to center.

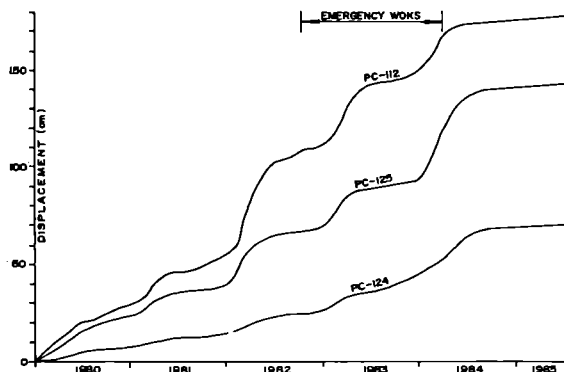
Fig. 18 Surface Displacements

Instrumental measurement records indicate that the deep slide movements have decreased considerably in most cases, and in a few others they remain more or less constant; in no case has acceleration of movements occurred. Similarly, surface movements also show considerable reductions; Figures 18 and 19 show the change in the movements for some deep sliding surfaces and for some surface monuments. However, during the last three
