Environmental Protection of Abandoned Tailings Dams

G.E. BLIGHT ¹	Professor of Construction Materials, University of the Witwatersrand, Johannesburg, South Africa
C.E. REA	Steffen, Robertson and Kirsten, Inc., Consulting Geotechnical
J.A. CALDWELL	Engineers, Johannesburg, South Africa, and Vancouver, Canada
K.W. DAVIDSON	Northern Lime Company, Johannesburg

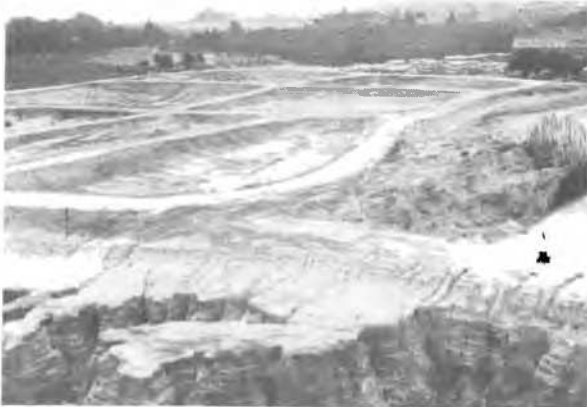
FIGURE 1b Abandoned, badly eroded tailings dam provided with crest and dividing walls.

Figure 1a shows diagrammatically some of the features mentioned above, while Figure 1b shows the crest and dividing walls on the top of a dam.

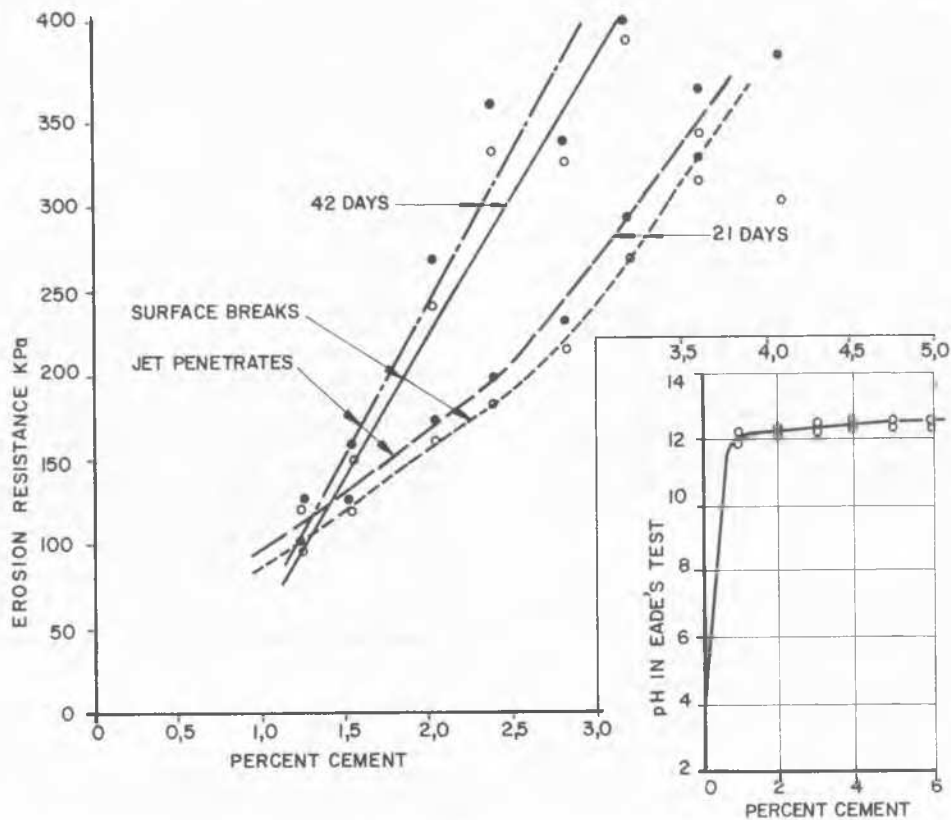
FIGURE 2 Results of experimental stabilization of tailings with Portland cement.

tester in action while Figure 2 shows the measured erosion resistance plotted against percentage cement at times of twenty-one days and forty-two days after stabilizing. It became apparent from these results that (at least at early ages) cement was more effective than lime, and it was decided to stabilize the top surfaces of a number of tailings dams using 3% of cement to a depth of 150 mm and to observe the performance of these surfaces over a number of years. Four tailings deposits have been stabilized in this way. They still have to complete a year of service, but appear to be meeting the requirements of preventing wind and water erosion quite successfully so far. It is also noticeable that wind-born seeds are taking root in the stabilized material and it is hoped that the stabilized surface will ultimately support an appreciable plant cover.

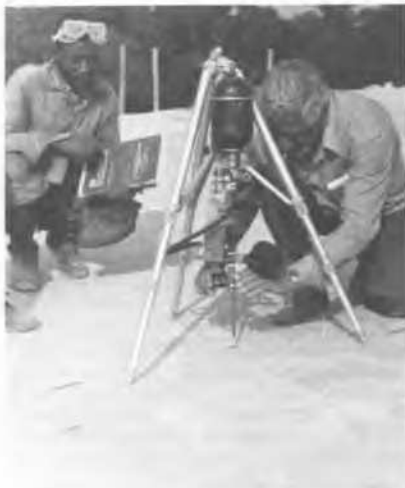
FIGURE 3 'COMET' erosion tester in use on a tailings dam.

surface was assessed using a portable erosion tester that directs a 0.8 mm diameter jet of water at the surface from a distance of 25 mm. The pressure behind the jet is increased at a steady rate until the surface breaks up - the pressure at which the disruption occurs being recorded as a measure of the erosion resistance. Figure 3 shows the erosion

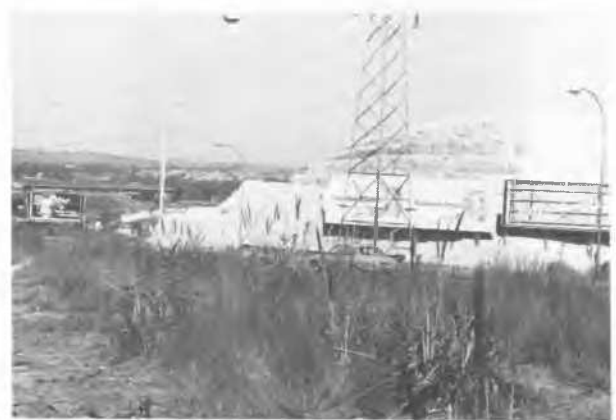
FIGURE 4b Experimental terraced slope in course of terracing. Note surrounding urban development.

are sloped back towards the dam and are subdivided at intervals by cross-walls so that all precipitation on the berms is held and allowed to evaporate. Figure 4a shows a design section to such a terraced slope, while Figure 4b is a photograph of the experimental terraced slope. The effectiveness of this procedure has yet to be tried as the slope shown in Figure 4b has not yet passed through a wet season.

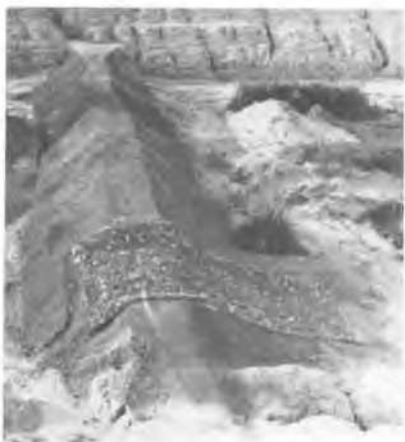
FIGURE 5b Filter dam with emergency spillway

away. Figure 5a shows typical details of such a filter dam. The upstream slope of the dam is underlain by a filter blanket that acts as a collection drain and filter for the polluted water retained behind the dam. After entering the filter blanket, the water drains to the central collector drain and is allowed to escape downstream. Figure 5b shows a photograph of one of these dams together with its emergency spillway protected from erosion by means of a gabion mattress.

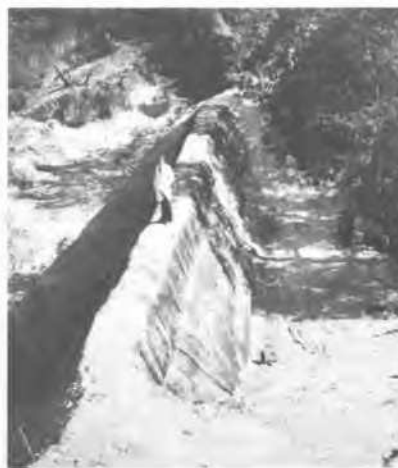
FIGURE 6b Completed geofabric-reinforced dam

Figure 6a shows the design of a fabric-reinforced gravity section embankment. This latter embankment has actually been built and is illustrated by the photograph in Figure 6b. The dam illustrated in Figure 6b

spans a valley between two tailings deposits down which a natural stream flows. The stream has been by-passed through a culvert which runs down the valley and under the gravity section dam, while the gravity section dam itself acts as a filter dam for precipitation running off the slopes of the tailings dams on either side of the valley.
