Consolidation of the Historical Cities of San Leo and Orvieto

L. DIAMANTI
C. SOCCODATO

SYNOPSIS The report, after a brief geological description of the areas, describes the basic mechanics of the rocky failures of two localities of peculiar historical and artistic interest: the Rocca of St. Leo in Romagna and the town of Orvieto in Umbria, as well as the methods applied to prevent rockfalls and for the stabilization of the cliffs.

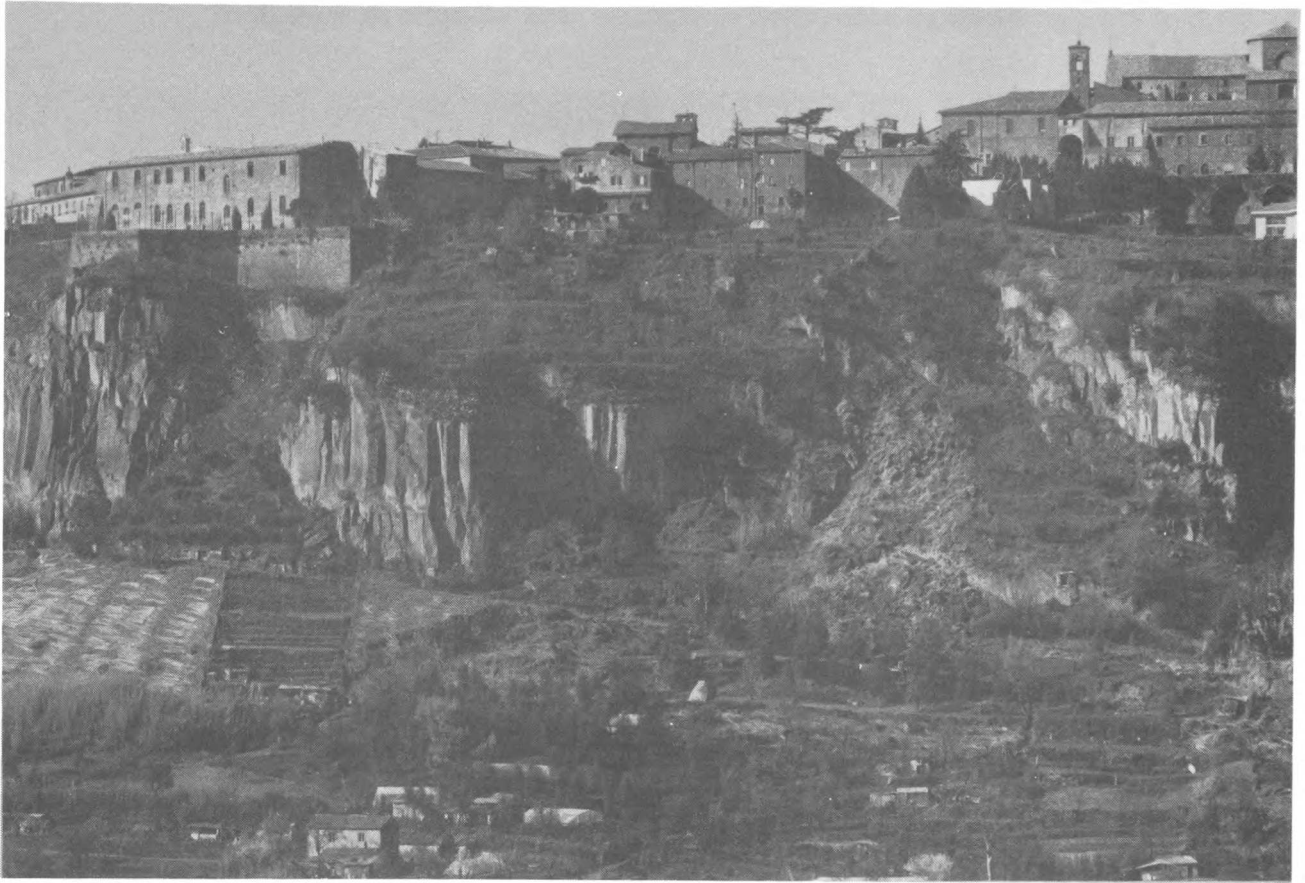
fig. 5 - South side Failures and Proposed works.

The installations of the retaining and draining structures, are similar to that already executed or in execution in St. Leo and they are described in the enclosed figures for the different sites.

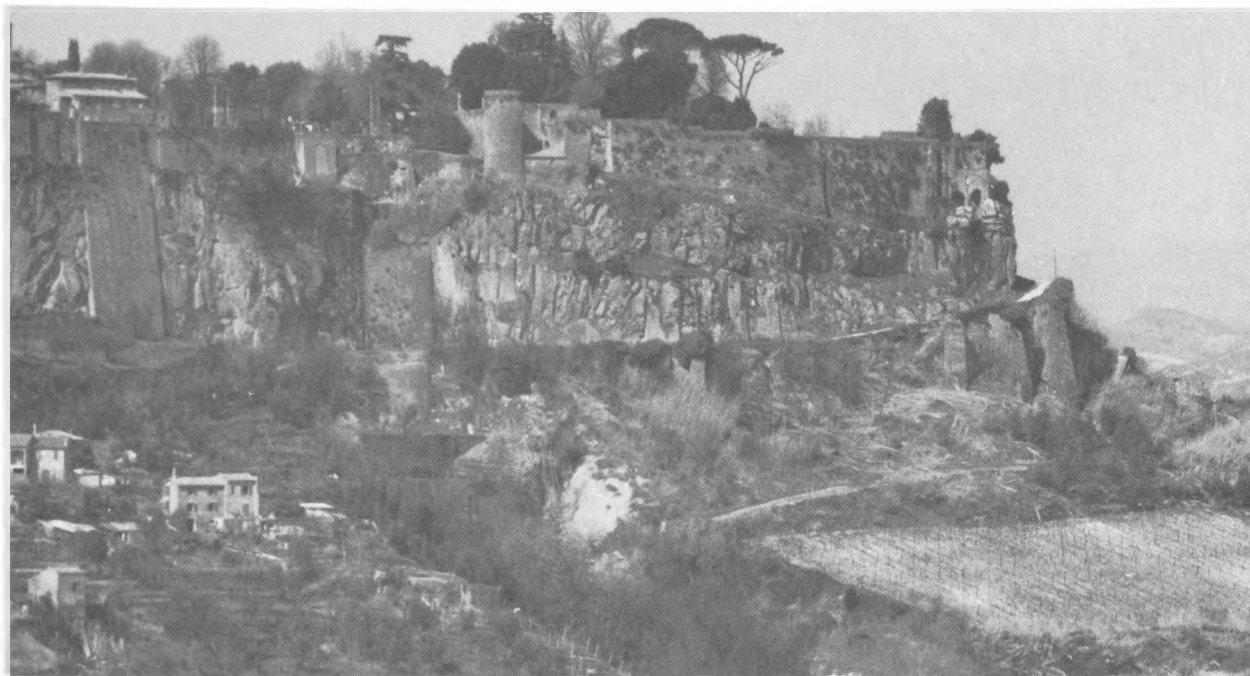
Fig. 6 - The Rocca of Albornoz. General view and proposed works
