# Behaviour of Wooden Pilings in Long Time Service

## Comportement des Fondations en Bois en Service pour Longtemps

R-D. PEEK  
H. WILLEITNER

Dres, Institute for Wood Biology and Wood Preservation of the Federal Research Centre for Forestry and Forest Products, Hamburg-Reinbek, Germany

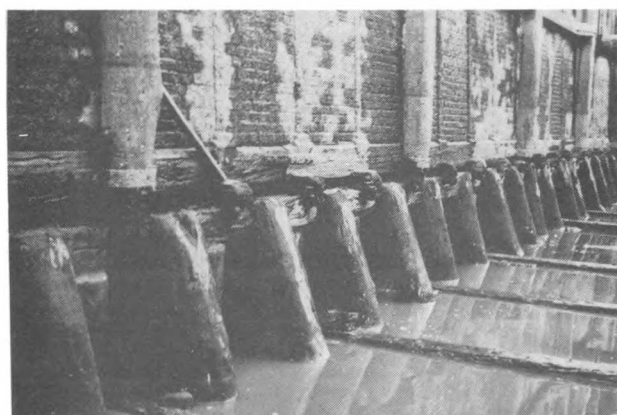
Fig. 6: Foundation of a sluise

Timber in salt water can be heavily attacked by different marine organisms including special marine fungi. Most important are several genera of ship worms (Teredo, Bankia, Martesia) or Crustaceae like Limnoria. Shipworms are hardly visible on the pile surface due to very small entrance holes but they may badly deteriorate the interior. Marine borers need a minimum salinity, as e.g. 7 o/oo for Teredo (Bavendamm, Schmidt, 1960). In the foundation of the sluise (see Fig. 6) which connects the sea with a side-arm of a river, the two piles nearest to the sea-side flood gate showed a marked attack of Teredo navalis while the subsequent piles were impaired to a much lesser degree. In the centre of the sluise only sporadic attack occurred.
