End of Construction Failure of a Slope in a Stiff Boulder Clay

T.F. WIDDIS
H.G. CLAPHAM

SYNOPSIS There are very few recorded case histories of end of construction failures of slopes in firm to hard boulder clays. Such a failure took place during the excavation of a temporary 60° cutting in a firm to hard boulder clay at Glenhove Reservoir. An immediate investigation of the slip revealed the presence of an inclined thin layer of silty clay some 1 m. from the base of the excavation. The interfaces between the silty clay and the boulder clay formed smooth pre-existing failure surfaces along which a wedge-type failure took place when the lateral support was removed by construction requirements. The equilibrium of the slope has been analysed in terms of total, effective and residual stresses mobilised by several modes of failure. The results of these analyses indicate that the strength of the silty clay rather than the boulder clay controls stability. In particular the assumption of the most likely failure mechanism would indicate that residual strength controls stability.

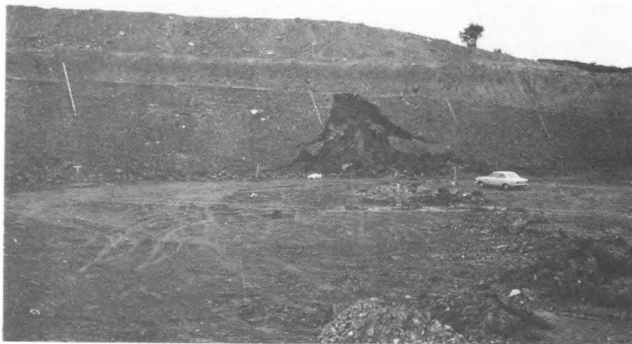
Prior to the commencement of construction the slopes of the temporary excavation were designed using the $\phi = 0$ method of analysis and the undrained shear strength of the boulder clay. A side slope of 60° to the horizontal (Approx. 2:3) was recommended. It was also recommended that surface water running down the natural slope should be prevented from entering the slope by cutting an interceptor drain at and parallel to the top of the excavation. In addition excavated material was to be placed at least 7.5 m. from the edge of the top of the excavation. A section through the as dug excavation is given in Fig. 2. Excavation commenced on 17.4.69 and was carried out in two stages, the first reducing site level to 126.5 m. and the second to 121.0 m. The excavation of the south slope was completed in the period from 23.6.69 to 6.7.69. On the 7.7.69 cracks were observed in the face of the excavation and a small failure occurred overnight between 8.7.69 and 9.7.69. A photograph of the failure taken on 10.7.69 is shown in Fig. 1.

Fig. 1. INITIAL FAILURE

Three sections S1, S2, S3 as shown in Fig. 1 were analysed for angles of slope of the silty clay layer of 3, 4 and 5 degrees. Two failure models were analysed. In the first a vertical tension crack extending from the surface to the layer of silty clay was assumed containing water varying in depth from 0 to the full depth of the crack. The factors of safety of the slope in terms of total, effective and residual stresses using the shear strength parameters of the silty clay as given in Table 1 and the methods of analysis as given in Fig. 7. were determined. Section S3 was found to give the lowest factors of safety for the analyses in terms of total and effective stresses. As the factors of safety are not too sensitive to the small variations of one degree only those for section S3 and a slope of 4° are given in Table 11 and Fig. 8. Section S1 was found to give the lowest factors of safety in terms of residual strength and these are given in Table 11 and Fig. 8. The second failure model consisted of a simple earth pressure model with zero pore water pressures. The factors of safety were obtained as before for various values of the coefficient of active earth pressure varying from 0.05 to 1.5, and the results are given in Table 11 and Fig. 9.

The results of the analysis of both failure models in terms of total and effective stresses indicate that section S3 is the most critical, whereas the analysis in terms of residual stresses indicate that section S1 is the most critical. The actual initial failure on site as can be seen in Fig. 1 took the form depicted by section S1 and not that of S3. This means that the analyses in terms of residual stresses conforms to the real mode of failure whereas those in terms of total and effective strengths do not.

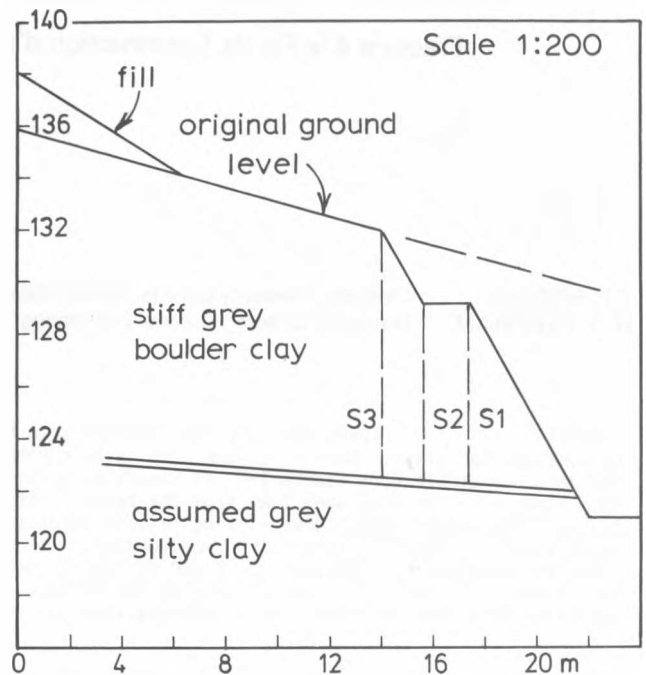
A section through the slope immediately prior to failure is given in Fig. 2. In this figure a layer of silty clay dipping from south to north at 4° is assumed. In subsequent weeks a continuous regressive type failure took place, accompanied with the formation of large tension cracks at the top of the slope. A physical examination of the failure revealed a thin layer of silty clay some 1 m. above the base of the excavation. This layer had a maximum thickness of 260 mm. and had smooth surfaces where it made contact with the boulder clay. These pre-existing failure surfaces sloped downwards from south to north at an angle varying from $2\frac{1}{2}^\circ$ to 5° . Failure took the form of a triangular wedge of boulder clay sliding along the smooth surface of the silty clay when the lateral support was removed by construction operations. In places the thin layer of silty clay had been squeezed out by the unstable overlying boulder clay moving over the stable boulder clay in the base of the excavation. Detailed photographs of the failure surface are given in Fig. 3 and 4. A close up photograph of the silty clay and its surface is shown in Fig. 5.

Fig. 2 SECTION THROUGH FAILURE

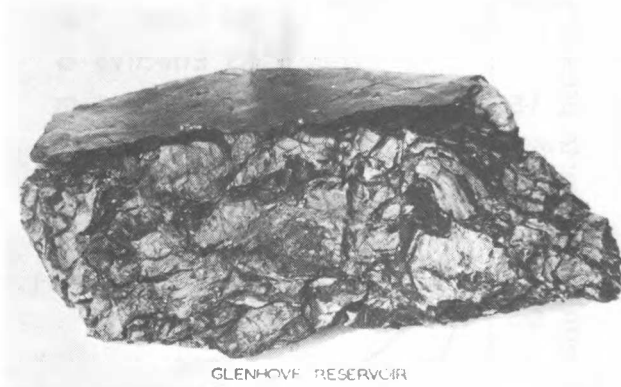
Fig. 5. SILTY CLAY FAILURE SURFACE

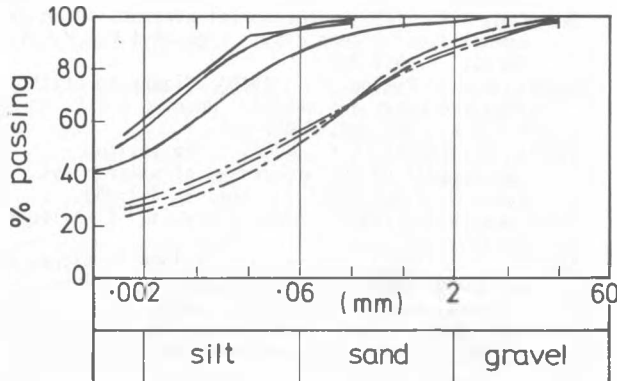
On the day after the failure undisturbed block samples of the boulder clay and the silty clay were taken along with samples containing the actual shear surface. Classification tests were carried out on disturbed samples. Triaxial and shear box tests were carried out on hand trimmed samples to determine the shear strength parameters in terms of total, effective and residual stresses. Shear box tests were carried out on the actual shear surface to determine the residual shear strength of the silty clay. The results of these tests are given in Table 1. Particle size distribution curves were determined for some of the 38 mm diameter triaxial specimens and the results are shown in Fig. 6.

Fig. 6. GRADING CURVES SILTY CLAY (—) AND BOULDER CLAY (- -)

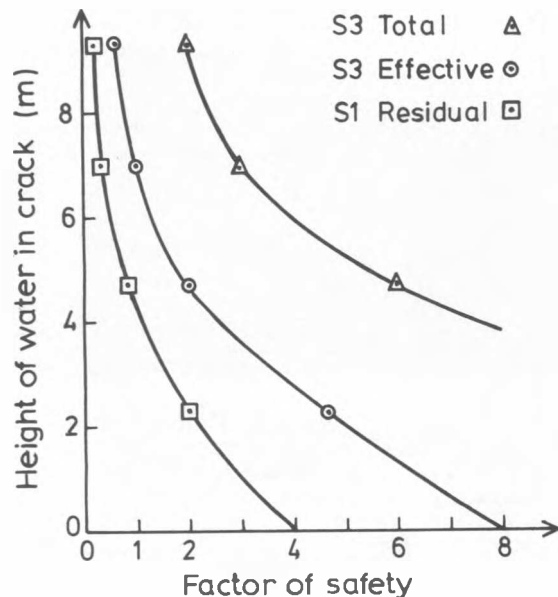
Fig. 8 FACTOR OF SAFETY VERSUS HEIGHT OF WATER IN TENSION CRACK.

In addition the factors of safety in terms of total and effective strengths with the exception of those corresponding to unrealistic depths of water in the tension crack and high coefficients of earth pressure, are greater than unity. The factors of safety in terms of residual strengths are mostly less than unity. A coefficient of active earth pressure of 0.15 (or 4.2 m. of water in a tension crack) give factors of safety of unity in terms of residual strengths.

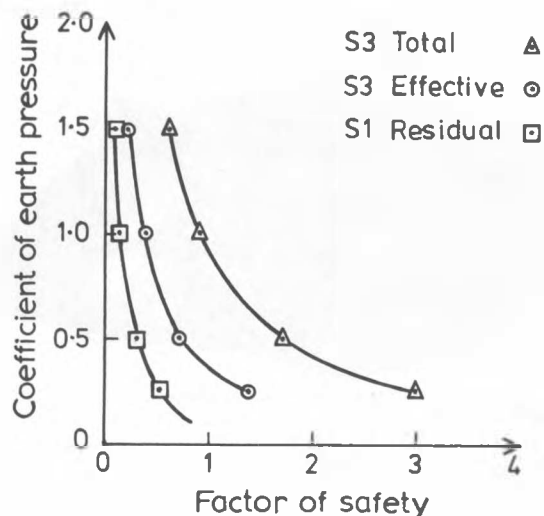
Fig. 9. FACTOR OF SAFETY VERSUS COEFFICIENT OF EARTH PRESSURE.
