Stability of a Heterogeneous Sandy Coastal Cliff

G. WISEMAN

SYNOPSIS

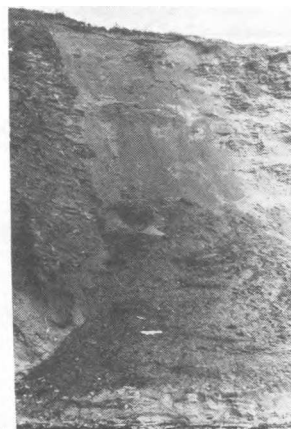
Fig.1 A Typical Slide

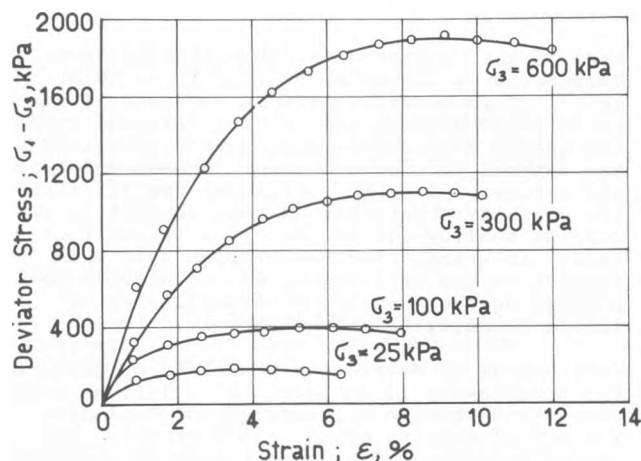
Fig.4 Triaxial Stress-Strain Curves - Unit 2

sists mostly of particles of about 0.3 mm diameter. The internal structure of the unit is of the type seen in Fig. 3 which shows an X-ray photograph of a sample of the same soil type located at a different site along the coast. The dry density of blocks of material was found to be generally between 1550-1700 Kg/m³, with some occasional values outside this range. Carbonate content is of the order of 20% in the - 40# fraction and 40% - 60% in the +40# fraction. Specimens for laboratory strength testing were obtained by taking block samples from the cliff, partially saturating them in the laboratory, freezing, and then coring cylindrical, frozen specimens. These specimens were placed in the triaxial cell, subjected to all round pressure and then allowed to thaw; they were then saturated and sheared under fully drained conditions. Frydman et al (1979) demonstrated that this procedure of specimen preparation had no significant detrimental effect on the friction angle, ϕ' , of sand. Fig. 4 shows stress-strain curves and Fig. 5 shows corresponding Mohr failure stress circles and strength envelope resulting from one series of tests; the strength parameters obtained in the investigation were $c' \sim \text{kPa}$, $\phi' \sim 37^\circ$.

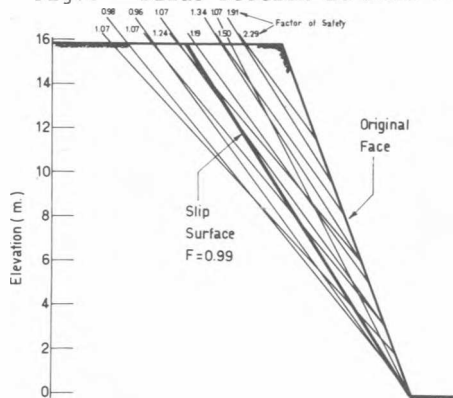
the slope face above its base, yielded factors of safety below 1. The fact that slip actually occurred on the most shallow surface having a factor of safety below 1 and not on deeper surfaces which yielded lower factors of safety suggested that the cohesion increases with distance into the cliff profile away from the face, possibly as a result of decreased wetting and erosive effects.

Fig. 9 Slip Surfaces Analysed at Beit Yanai

The detailed topography of the slip region was established using photo-theodolite measurements, while the slope of the cliff preceding the slide was known to correspond more or less to that of the stable material at its sides. Fig. 8 shows a section through the middle of the slip region both prior to, and after the slide. Stability analyses by the simplified Bishop method were carried out for the actual slip surface, using different strength parameters and it was found that for strength parameters $c' = 20$ kPa, $\phi' = 30^\circ$, a factor of safety of 0.99 was obtained. Using these strength parameters, a large number of possible slip surfaces were checked, and the resulting factors of safety are shown in Fig. 9. It was found that of all the possible surfaces passing through the base of the slope, the actual slip surface was the shallowest one which provided a factor of safety of less than 1. No surfaces analyzed which cut
