Saving Cities and Old Buildings

Sauvetage des Cités et des Bâtiments Anciens

Chairman	J. Kerisel (France)
Co-Chairman	A. Croce (Italy)
General Reporter	U. Smolczyk (FRG)
Co-Reporter	R. Butterfield (UK)
Technical Secretaries	S-E. Rehnman and H. Bohm (Sweden)
Panelists	M. Gonzáles Flores (Mexico), J. Huder (Switzerland), A. Loizos (Greece)

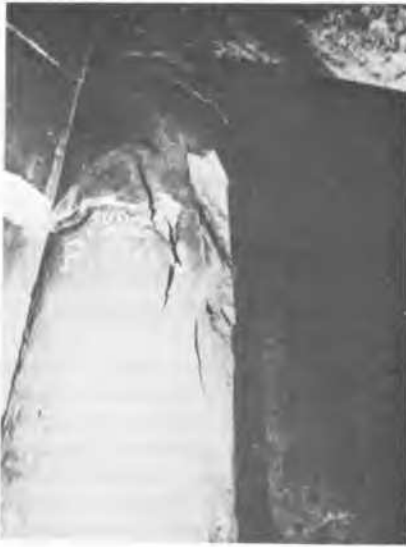
Fig. 5

Therefore it was necessary to transfer the loads transmitted by the domes and the vaults directly to the foundations. In this way it was possible to substantially reduce the stress-field in the columns, whose material had seriously weakened (Fig. 5).

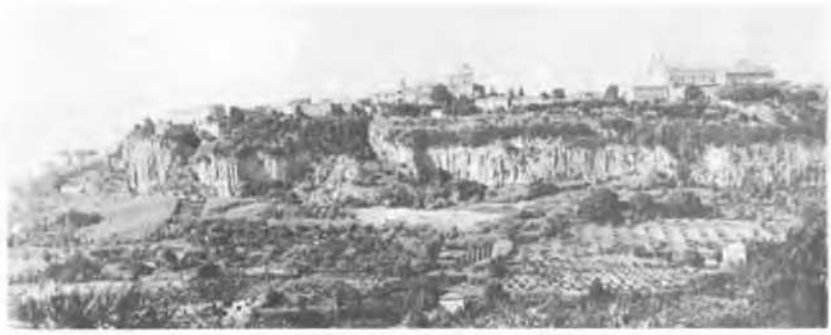
Fig. 3 - Panoramic view of the southern side of Orvieto Hill. The following can be noted in the picture: jointed lithoid tuffs passing to pozzolana in the cliff that shows its typical bee-hive structure; a portion of the cliff affected by a landslide in the more pozzolanitic material; the "step-like" configuration at the edge of the tuffaceous slab

Figure 3 shows a global view of the town where the gentle slopes of the basal clay formation and the almost vertical cliffs in the overlying tuffaceous slab can clearly be seen. The top of the hill is entirely covered with buildings. The hill on which the town rises is completely isolated from the surrounding reliefs. The top is elliptical in shape, its longer axis lying in the EEN-WWS direction (1600 m) and its shorter axis being about 800 m long.

like" configuration of the border zones, consists in the lowering of the marginal clods of the tuffaceous cliff with respect to the back rock mass. This phenomenon is visible not only directly (Figs. 3, 7) but also through the stratigraphic reconstruction (Fig. 8). Another type of instability occurring in the tuffaceous cliff which is obviously related to the movements and deformations in the clay formation is the "disarrangement" of the tuff mass (Fig. 9), caused by a number of irregular fractures which tend to propagate from bottom to top. With time, slices of tuff reaching right up to the top of the cliff or involving only part of it, detach and then fall. In the latter case overhanging portions of tuff are left (Fig. 10).

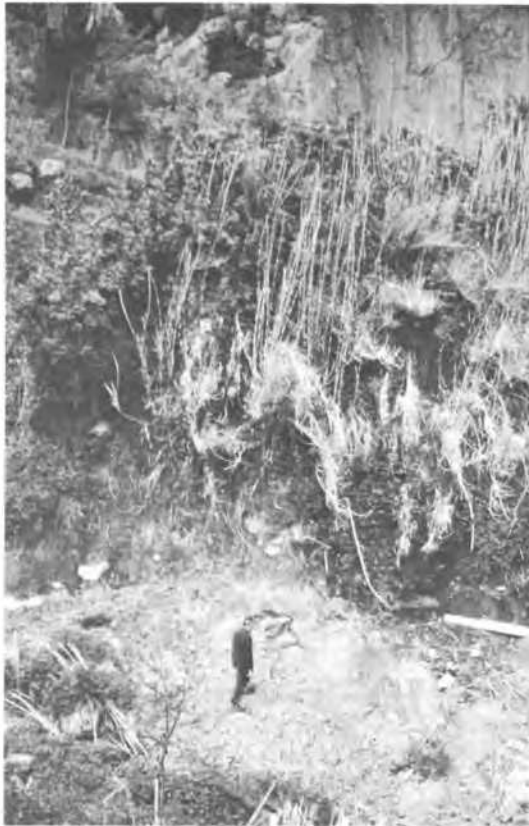
Fig. 5 - Scarp of the "Cannicella" landslide

An ongoing study is looking into the details of one such slide ("Cannicella") that occurred very recently (Manfredini et al., 1981) and the results obtained so far are rather meaningful. Fig. 5 shows the scarp of such a landslide; in

the back of the figure the base of the cliff is shown to be very close to the scarp. In Fig. 6 the results of the back analysis of the landslide are compared with the strength parameters determined by laboratory tests; the mobilized strength is very close to that of the softened materials.

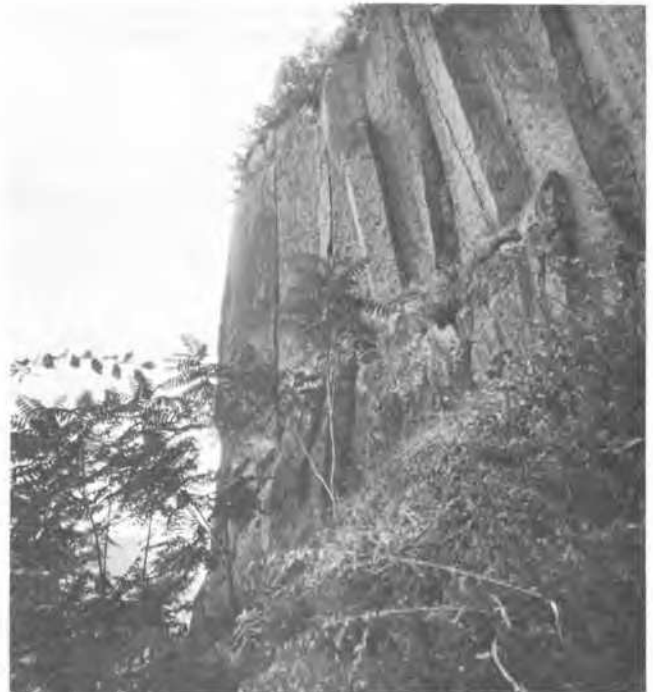
Fig. 7 - "Column" fracturing of a spur and "step-like" configuration of border areas

At Orvieto for example, there is a close relationship between the orientation of the joints in the lapideous tuff and that of the cliff faces; the main sets of fractures are all subvertical; one of them is parallel to the faces, one is perpendicular and the other two form angles of about 45° (conjugated) with the faces. The latter two sets of joints are found mainly where the border of the cliff forms projecting edges or spurs; where the latter are frequent the rock appears to have a column-like structure (Fig. 7).

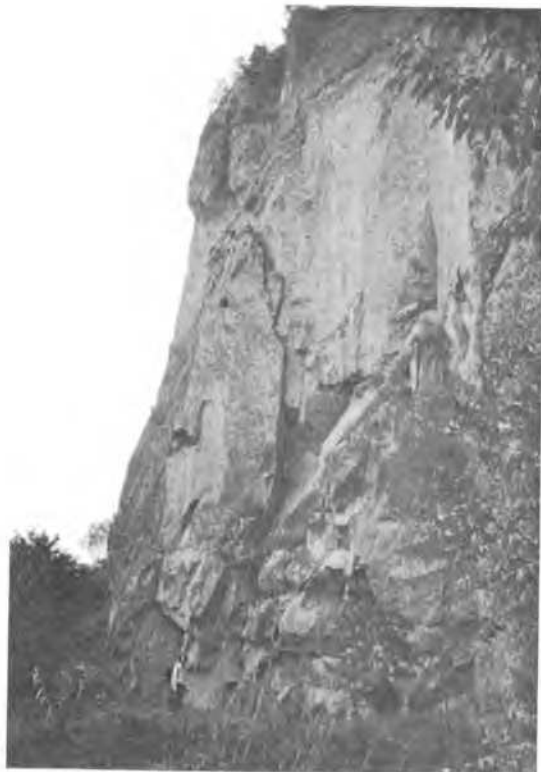
Fig. 9 - "Disarrangement" of the tuffaceous mass

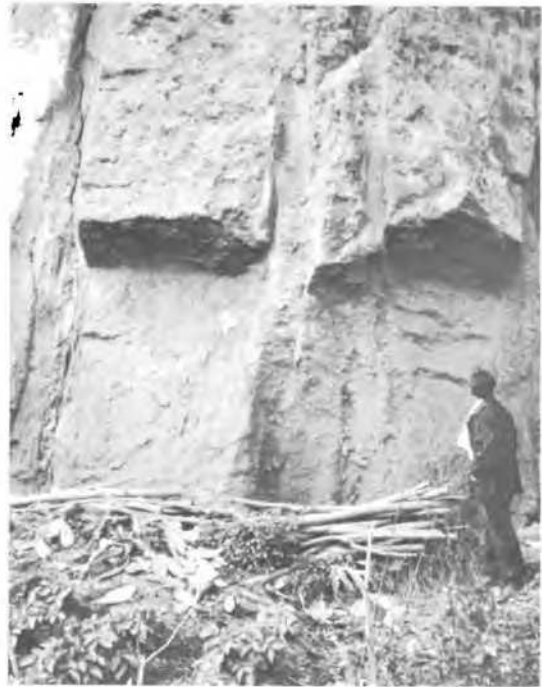
Fig. 10 - Portions of overhanging rock

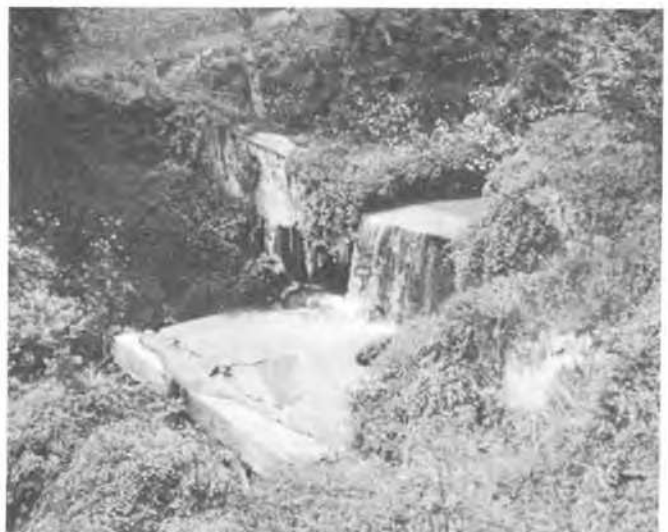
Fig. 11 - Broken and displaced check-dam; water infiltrating into the clay formation

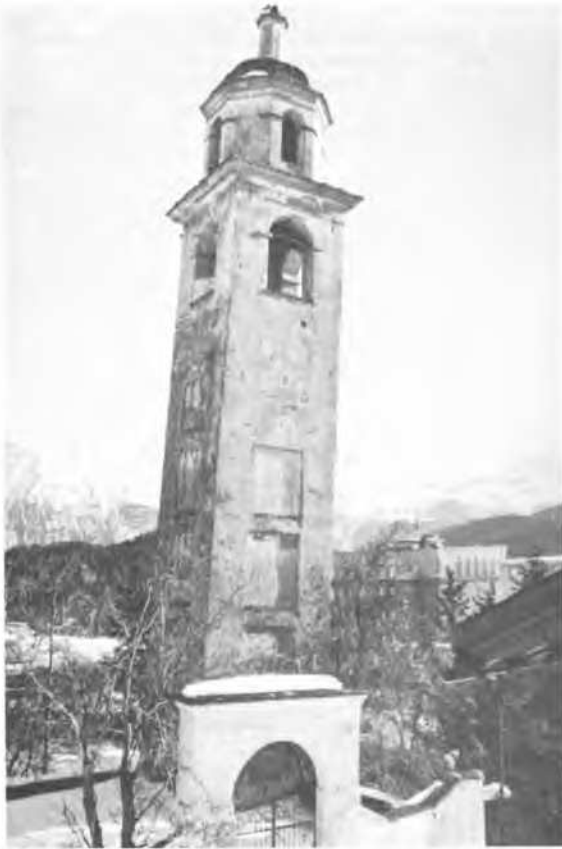
Fig. 1 Le clocher penché de St. Moritz

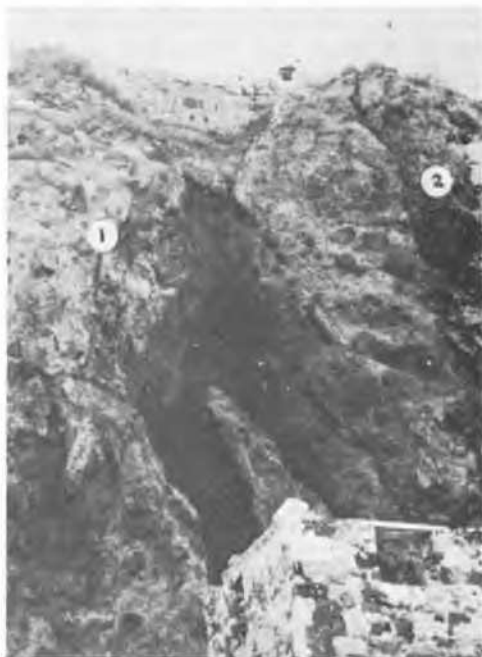
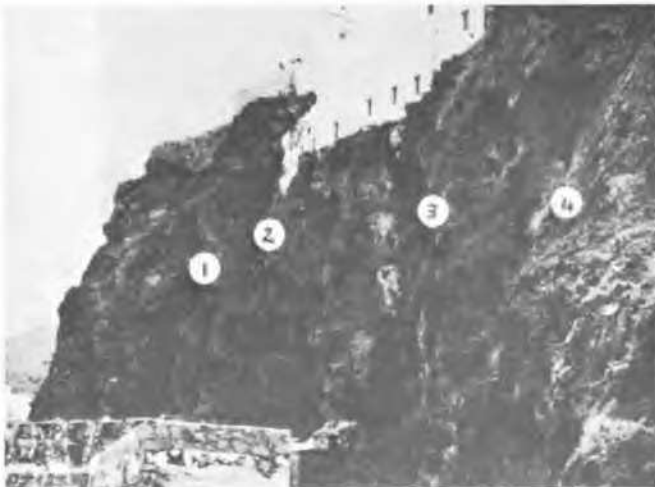
- a. There is a natural triangular concave under the wall of the stairs of the monastery. This extends over a large part of the total height of the slope, having a base of approx. 10m. and a depth of 4 to 5m (see Photos 1, 2 and 4 point (1)).
- b. Under the steeple of the monastery, there is a surface system of small faults, surrounding a wedge-like zone. This zone extends almost over the whole height of the slope and has a width of 4-5m. under the monastery yard (see Photos 1, 2 and 4 point (2)).

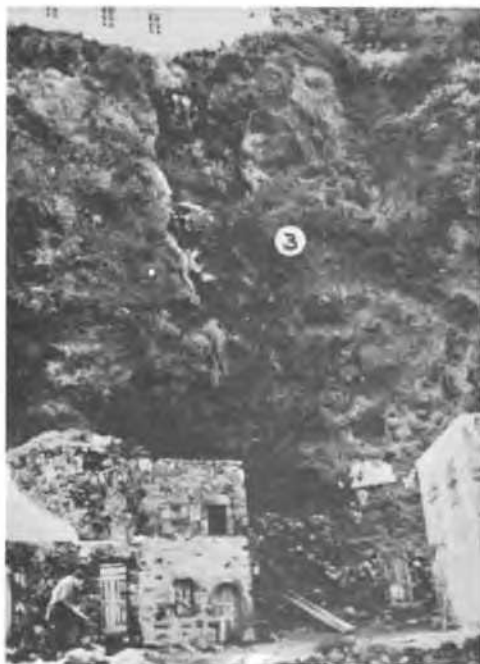
Phot. 3

- c. At a distance of approximately 10m from the zone of point 2, there is another zone of small faults which extends from the basis of the wall of the monastery up to the ceiling of the artificial concave, the width of this zone being up to 5 to 6m. The erosion is intense at the surface of the zone and it could be attributed to a certain degree to the

waterpipe of the monastery which discharges freely at the upper basis of the zone (see Photos 3 and 4 point (3)).

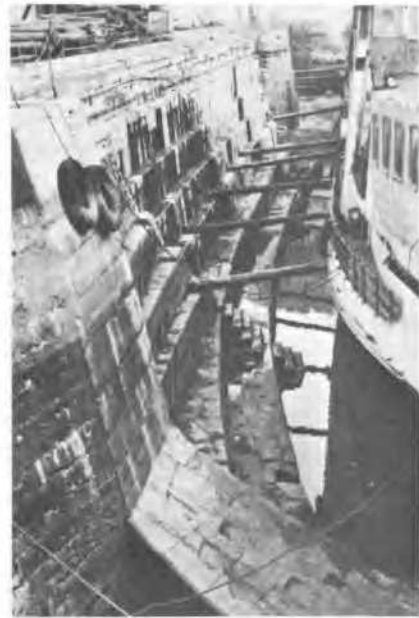
FIG. 2 - Present view of the once repaired corner.

Then a large mass of mortar and rubble was placed on top of them. Large flat stones were placed on the mortar and rubble mass, in a grid formation. By doing so, builders presumably expected to achieve various things. They had had (a) a high strength backfill, (b) a fairly rigid pile cap against lateral movements, (c) an impermeable plug behind the deformed section. Of course, one of the merits of this design was that the vertical loads and possible moments were transferred to the rock foundation through the piles. This arrangement proved to be successful and no further repairs or reinforcements were required (Fig. 2).
