Erosion Tests on Loess Silt, Banks Peninsula, N.Z.

G.L. EVANS Consulting Engineer, Christchurch, New Zealand

SYNOPSIS The natural erosion processes in loess include, (1) subsurface seepage with tunnel formation and ultimate collapse into gullies, (2) surface soil creep on steeper slopes which generate slips and shallow slides. The incidence and severity of erosion varies from place to place in soils which appear to be similar, but have significantly different characteristics and behaviour. Subsurface tunnel formation is strongly influenced by the dispersive and slaking tendencies of the soil. For engineering work in urban development on loess hill slopes it is important to know the potential and possible behaviour of the upper two or three metres of the soil. The erosion properties of "undisturbed" samples have been investigated by a simple test which can be used to identify areas, that may be unstable and create future slope problems. The test measures the combined effect of dispersion and slaking and indicates the extent to which the soil becomes unstable with saturation.

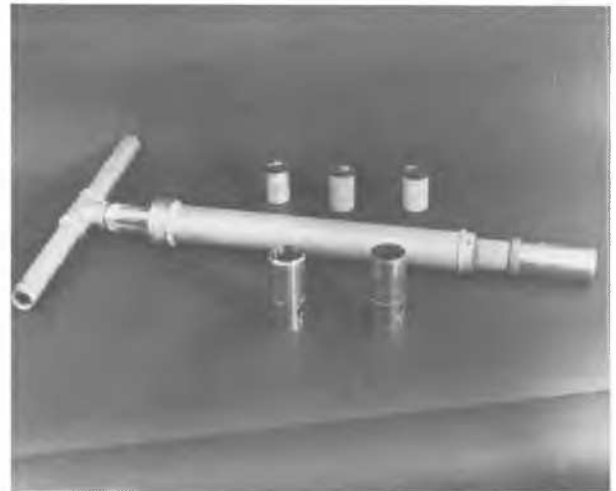
Fig. 4 Field Sampling equipment

Apparatus: The field equipment as shown in Fig. 4 comprises the small sampling tubes (36mm in dia and 83mm long) which are attached to an impact driver for insertion into the ground. Small airtight containers are used to collect small samples of each material for moisture content tests.

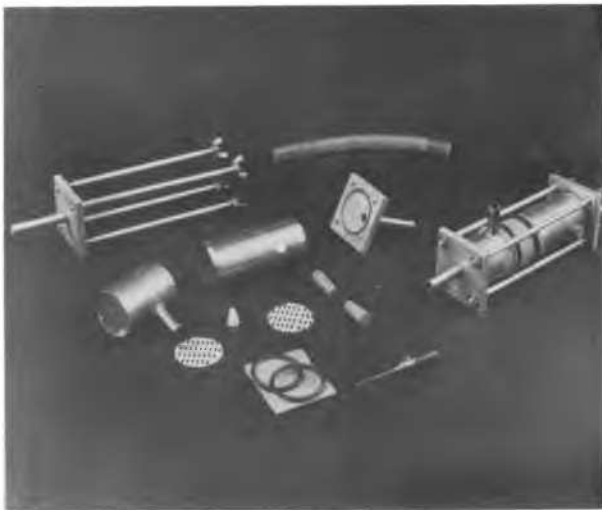
Fig. 5 Components of erosion test cell.

The components of the cell are shown in Fig. 5 which also illustrates a made up cell. This operates basically in the way described by Sherard.

A small head tank is connected to the cell and also a stand pipe to control the head on the sample. Provision is made for the connection of four cells for simultaneous testing.

In the laboratory the samples of soil in the tubes are trimmed at the ends, measured and weighed to obtain densities and then inserted in the permeability cell after the hole is drilled down the centre. The ends of the sample are protected with plastic mesh and supported with fine pea gravel.
