Slide in Overconsolidated Clay below Embankment

N.JANBU The Norwegian Institute of Technology,
 O.KJEKSTAD Norwegian Road Research Laboratory (Now NGI),
 K.SENNESET The Norwegian Institute of Technology, Norway

SYNOPSIS This paper deals with a slide which took place during construction of a road embankment placed on a slope of overconsolidated clay. Extensive field and laboratory investigations of the soil conditions in and around the slide area gave reliable data for a detailed study of this interesting case record. The overall findings lead to the following conclusion:

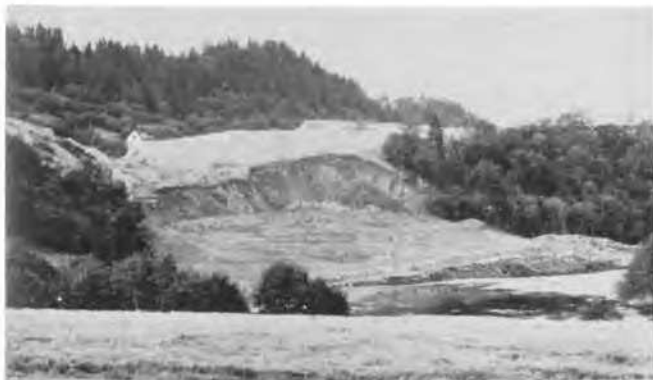
Fig.1 Photo of slide

On August 15., 1972 a slide of some 160.000 m³ took place beneath a road embankment placed on a slope of overconsolidated clay, about 4 km south of downtown Trondheim.

The sandwich fill embankment was part of a rerouting operation for the main highway E6 out of Trondheim, south to Oslo. See photo in Fig. 1.

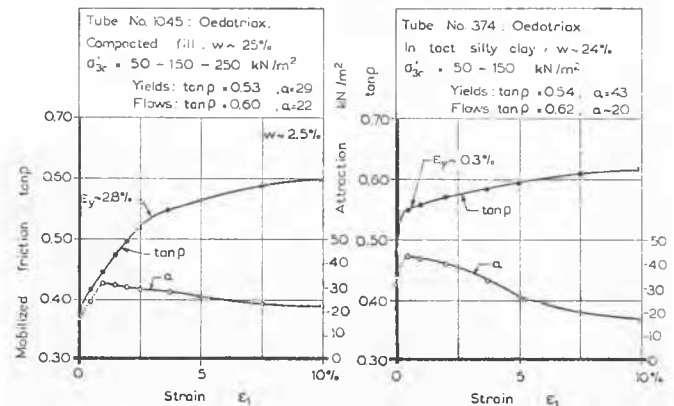
Fig. 7 Mobilization curves for compacted fill and intact clay

Fig. 7 shows two typical mobilization curves for two series of oedotriaxial tests, one series for the compacted clay fill, and one for the intact clay. The mobilization curves show how attraction (a) and friction ($\tan\phi$) are being mobilized with increased strain ϵ_1 , where

in which σ_c' = effective normal stress and τ_c = shear stress, both on the critical plane where F = minimum. As "failure" is approached $\tau_c \rightarrow \tau_f$ when $\tan\phi \rightarrow \tan\phi_f$. Both curves indicate a "yield" point for the same $\tan\phi$, the difference being that the intact soil reaches yield at a much smaller strain (1%) than the compacted fill (~3%) (young soil). Moreover, attraction is somewhat larger for the intact clay. The "ultimate failure", corresponding to approximately constant parameters (a and $\tan\phi$) are reached for large strains (~10%) and the parameters are then nearly equal for the fill and the intact clay. Note, however, that for the intact clay attraction is being broken down as strain increases (from 43 to 17 kN/m^2 for $\epsilon_1 = 1\%-10\%$). The authors believe this is due to a gradual breakdown of the old geological bonds within the clay structure. This belief is supported by the entirely different behaviour of the fill, with fairly constant a over large ϵ_1 -variations.

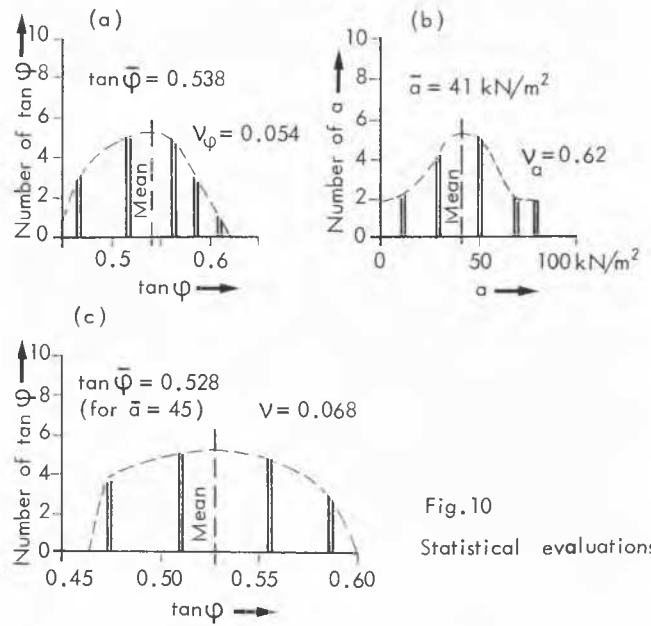
Fig.10
Statistical evaluations

A statistical analysis of single test a, ϕ -determinations lead to $\tan \bar{\phi} = 0.538$ and $\bar{a} = 41$ with coefficients of variation $v_\phi = 0.054$ and $v_a = 0.62$, respectively, see Fig. 10 ab. A lumped test determination with assumed $\bar{a} = 45$ yields $\tan \bar{\phi} = 0.528$ with $v_\phi = 0.068$, see Fig. 10c.

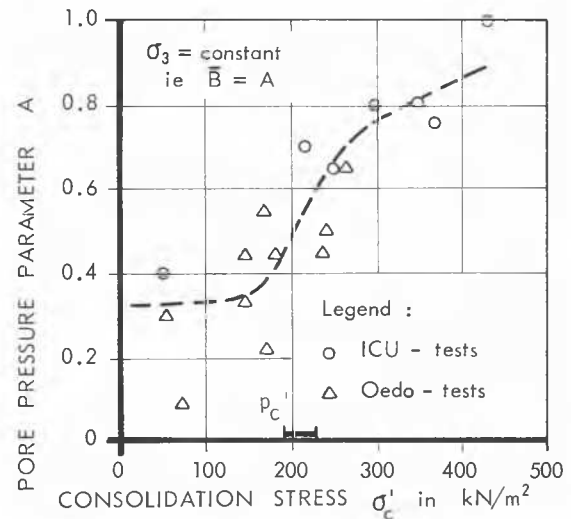
Fig.11 Measured A versus σ'_c for intact clay

The slopes of the stress paths in the working stress range define Skempton's pore pressure coefficient A. For tests with $\sigma_3 = \text{constant}$ $A = B = \Delta u / \Delta \sigma_1$. Fig. 11 shows that A is approximately equal to the elastic value (1/3) for $\sigma'_c < p'_c$ but increases rapidly towards 1.0 for $\sigma'_c \gg p'_c$.

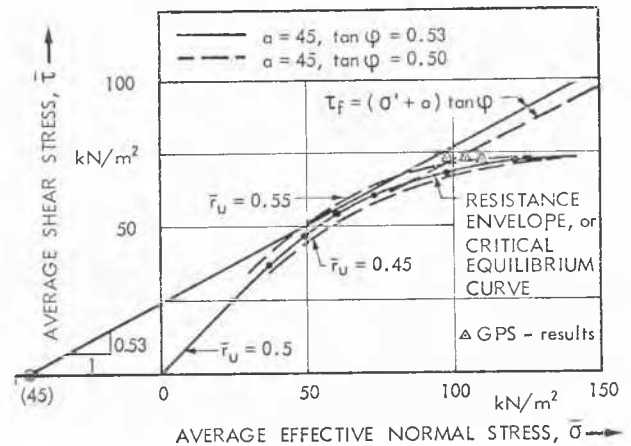
Fig. 12 Critical equilibrium (resistance envelope) analysis of the Kroppan Slide

In Fig. 12 three such curves (for $\bar{r}_u = 0.55, 0.50$ and 0.45) are shown, the middle one fully drawn, the two others are dashed. The shear strength lines for average $\bar{a} = 45 \text{ kN/m}^2$ and $\tan \phi = 0.53$ and $\tan \phi = 0.50$ are also drawn to compare with the critical equilibrium curves. It is seen that $\bar{\tau} \approx \tau_f$ (i.e. $F \approx 1$) for a fairly large $\bar{\sigma}'$ -variation when $\bar{r}_u = 0.45 - 0.55$. This means that $F \approx 1$ for surfaces of different depths within say ± 2 meters. For comparison GPS are
