# The In Situ Shear Behaviour of Fissured Soils

A.A.B.WILLIAMS    Sr. Chief Research Officer, Nat. Building Research Inst., CSIR, Pretoria,  
J.E.JENNINGS      Kanthack Prof. of Civil Eng., Univ. of the Witwatersrand, Johannesburg, South Africa

**SYNOPSIS** In many transported clay soils there is a pattern of jointing consisting of vertical cracks due to shrinkage and inclined fissures due to shrinkage and swelling. The 'line survey' technique for measuring all the important joint parameters is described, and typical values are given. A full-scale test to failure of a vertical bank showed that the pre-existing pattern of fissures initiates distress and a particular failure mechanism. Overall stability of the mass is probably governed by the residual strength along the joints.

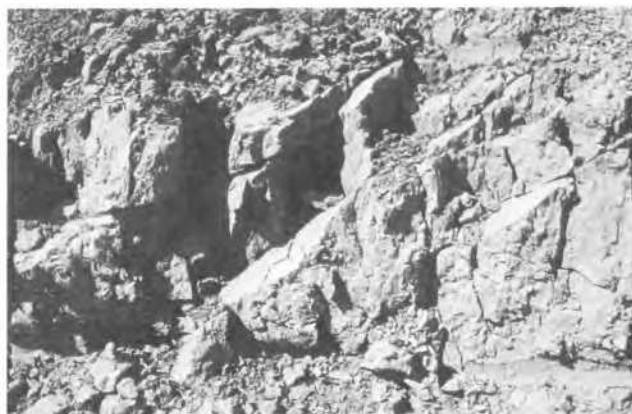
Fig. 1 Abundance of inclined slickensides

The pattern of cracking in certain residual soils, such as weathered shales, has been explained by the inherited jointing along bedding planes or by cross-jointing plus subsequent shrinkage cracking. In many transported soils little information exists on the definite modes of origin or occurrence of such joints and the abundant inclined slickensides such as those shown in Figure 1.

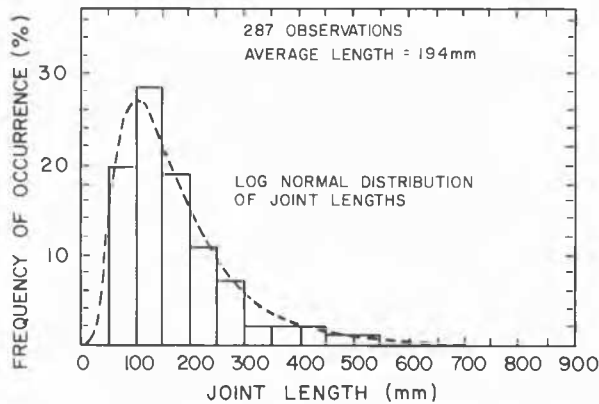
encountering a single major joint, which could govern stability, should not be forgotten. It was found that a fairly good fit to the experimental values was obtained with a logarithmic normal distribution, in other words, the logarithms of the lengths were normally distributed. In Figure 5 the frequency distribution curve computed on this basis has been superimposed on the histogram for the Vereeniging mottled yellow brown clay horizon. It will be seen that the log normal distribution gives a fairly good fit in this typical case. A similar distribution has been found to fit fracture data by Bridges (1975) who used the word 'continuity' to describe extent or size of fracture.

Fig. 5 Log normal frequency distribution of joint lengths

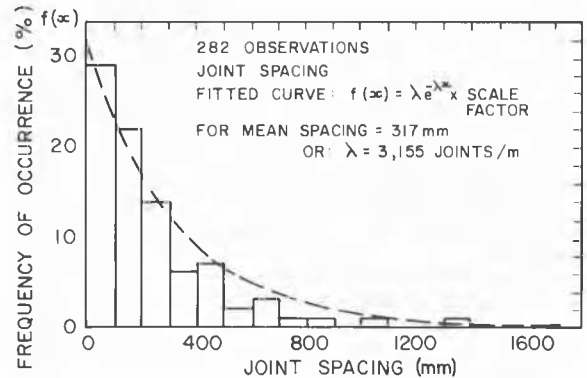
While a fair amount of information appears to have been published on joint lengths and dip, little is available on the spacing of joints, except mean values that are quoted from consideration of the total length of survey and total number of joints intersected. Following the work of Hudson and Priest (1975) a negative exponential distribution was considered for the Vereeniging data. One of the histograms given by these data for spacings is represented in Figure 6, on which the theoretical distribution based on the mean joint spacing is also superimposed, and it will be noted that the fit is fairly good.

Fig. 6 Negative exponential frequency distribution of joint spacings

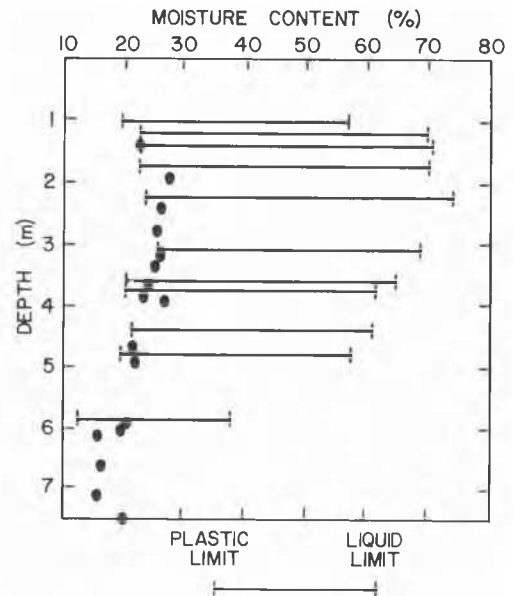
The general profile at this site is described in Figure 2 and the in situ moisture profile is given in Figure 7. The Plastic Limit and Liquid Limit down the profile are also given and it will be noted that the moisture content was very close to the Plastic Limit. The bulk density of the clay was about 1915 kg/m<sup>3</sup> and the degree of saturation was in the region of 90 per cent down the major portion of the profile.

Fig. 7 Moisture content profile at Vereeniging Civic Centre

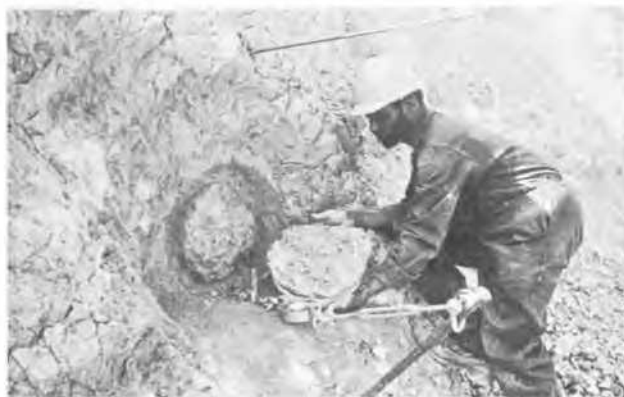
were cemented to carefully trimmed clay surfaces exposed in the bank, using a quickset epoxy paste, and a direct pull was applied. Failure always occurred suddenly and fracture surfaces through some intact material could be discerned as well as separation along inclined fissures - see Figure 9. The highest strength recorded on 45 mm diameter plates was 18 kPa while a typical value on 200 mm diameter plates was 8 kPa.

Fig. 9 Failure surface after tension test in situ

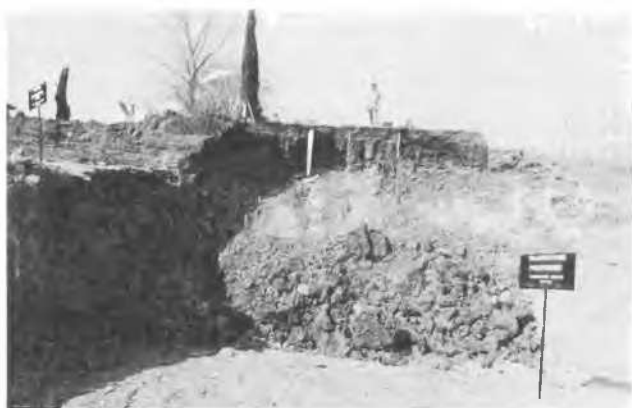
- (v) The final shape of the bank which then remained stable for many days indicated a vertical section, which terminated in an inclined surface, on which sliding had probably occurred, and then the lower portion of the excavation was covered by a heap of loose debris. (See Figure 14).

Fig. 14 East bank after failure showing slope debris
