REDUCTION OF NEGATIVE SKIN FRICTION ON STEEL PILES TO ROCK

L. BJERRUM, I.J. JOHANNESSEN, O. EIDE

Norwegian Geotechnical Institute, Oslo, Norway

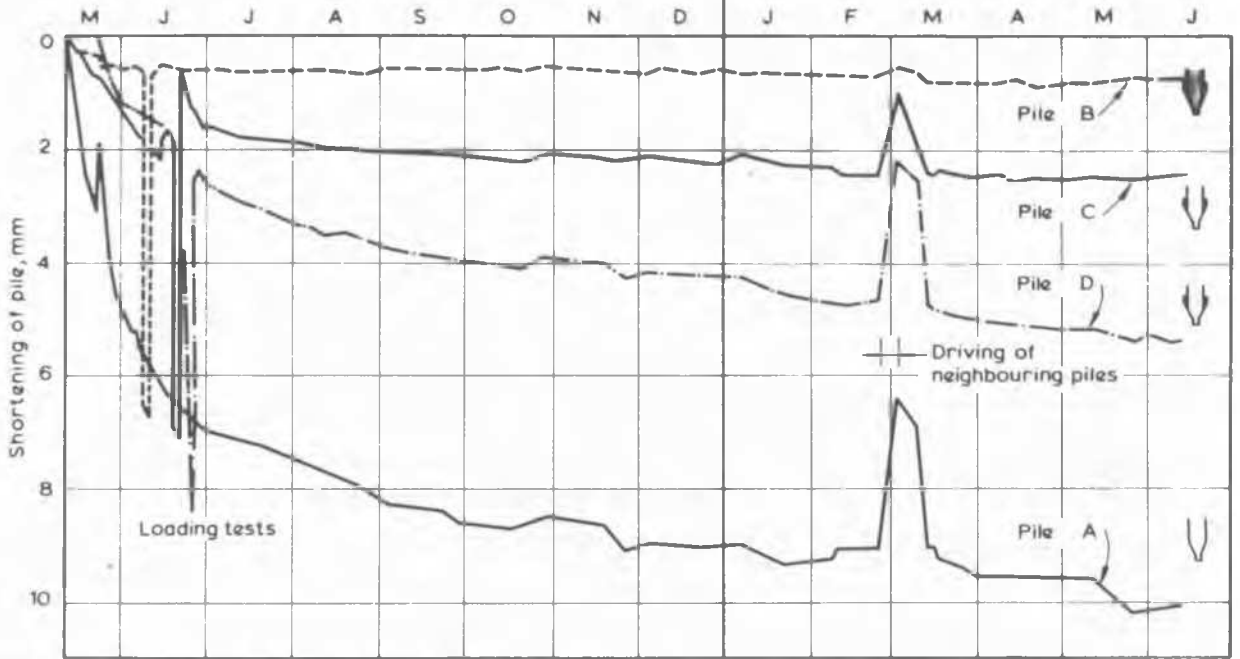
Fig. 4 Total shortening of piles against time.

As mentioned above, all piles were instrumented such that the compression of the pile could be followed. Fig. 4 shows how the total compression of the piles developed with time permitting a direct evaluation of the average value of the negative friction on the piles. From the diagram it is readily observed that measurable deformations of pile A occur im-

mediately and that they are large compared with the deformation of the other piles and first and foremost piles B and C. When in June 1966 the first observations became available the deformations of piles B and C appeared so surprisingly small that it was feared that the point of the piles were not in contact with rock. It was consequently decided to test load the three piles with 50 tons. These loading tests confirmed that the points of all three piles were in contact with rock and that the measurements therefore were reliable. As observed from the curves on Fig. 4 the negative skin friction on all piles decreased temporarily in March 1967. The explanation of this reduction is that in this period piles for the foundation of the factory were driven at a distance of only 10-12 m. Excess pore pressures resulting from the pile driving caused a temporary reduction in effective stresses in the clay surrounding the piles and thus a decrease in friction between pile and clay.

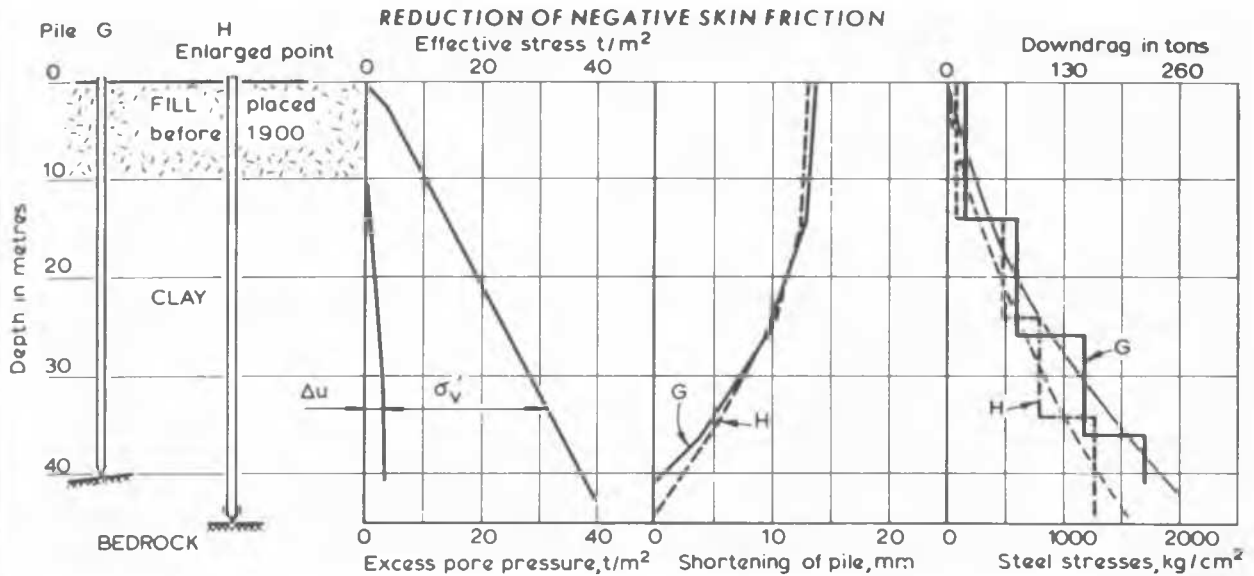
Fig. 7 Sörenga - Test piles and soil description. Test results from piles on the previously reclaimed area.

Below the other end of the building the fill showed a thickness of 13 m. The fill had already been placed at the end of the last century and it consisted mainly of sawdust and sandy organic mud. As the fill was more than 70 years old the consolidation of the below clay had been completed and the rate of settlements was very small. As shown on Fig. 7, the depth to rock was 40 m and the thickness of the soft marine clay was thus only 27 m.

The test installation at this location had only the purpose to find out how large the negative friction would be at that part of the site where the settlements were completed. Therefore, only two piles were induced, a reference pile, pile G, and an identical pile with an enlarged point, pile H. After two years of observation the drag load on the two piles had increased to 250 and 210 tons in piles G and H respectively, which correspond about to the values observed on those areas where the rate of settlement still is large.
