# SOME SOILS ASPECTS OF THE PLOVER COVE MARINE DAM QUELQUES ASPECTS DES MATERIAUX DU BARRAGE EN MER DE PLOVER COVE

C.M. GUILFORD, M.A., M.I.C.E., A.M.I.W.E., M. ASCE.  
 Associate, Scott Wilson Kirkpatrick & Partners, Hong Kong.

H.C. CHAN, B.Sc., M.I.C.E.  
 Senior Assistant Resident Engineer, Plover Cove Water Scheme.

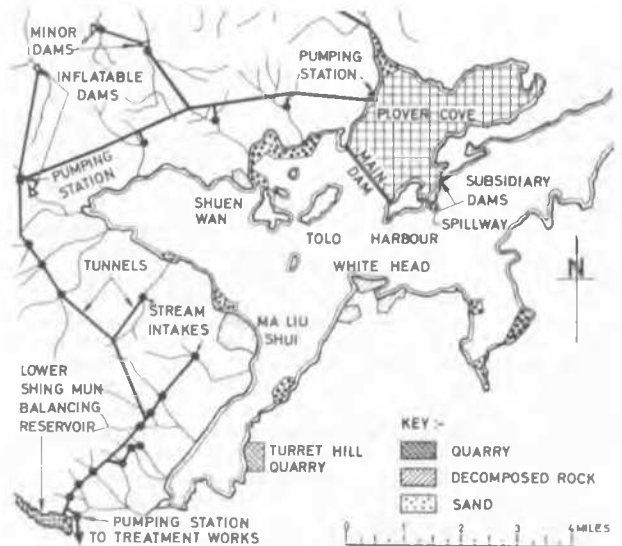
Fig 1 Layout of Plover Cove Water Scheme & Sources of Filling Materials

In view of the compressible nature of the foundation, it soon became clear that a flexible type dam would have to be built using naturally occurring materials. The choice of constructional materials was largely influenced by those which were available within reasonable distance of the dam site - see fig 1.
