# SLICKENSIDES IN RESIDUAL SOILS AND THEIR ENGINEERING SIGNIFICANCE

B.J. St. JOHN,  
Law Engineering Testing Company, Atlanta, Georgia U.S.A.

G.F. SOWERS, Regents Prof.  
Georgia Institute of Technology

**SYNOPSIS** Thin black seams, often slickensided, are found scattered throughout residual soils derived from igneous and metamorphic rocks. These seams are composed of complex iron-manganese organic compounds that filled old joint cracks in the original rock. The slickensided surfaces exhibit less than half the shear strength of the host soil; the unslickensided seams somewhat more. The black seams and particularly those that are slickensided, constitute planes of weakness along which landslides occur, although the host mass may be generally stable. They also focus soil expansion upon excavation parallel to their orientation.

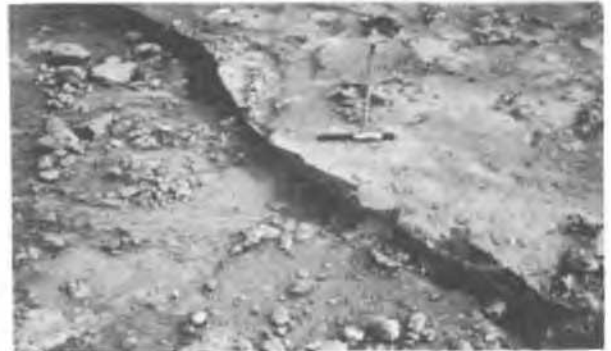
has been stable for 6 years despite a large crack about halfway up the slope. Fig. 8 and 9, which appeared immediately after excavation was complete. The soil above the crack is displaced outward 3 in. or 7.5 cm. The crack is an old slickenside; the soil above it expanded when the stress was released upon excavation.

Fig. 9 Photograph of expansion crack of Fig. 8

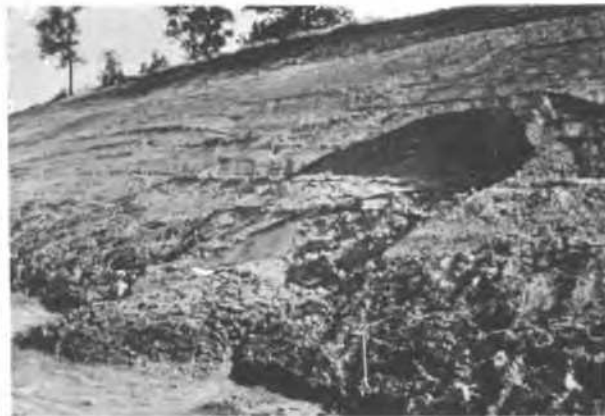
A railroad cut 50 to 75 ft or 15 m to 22 m deep in the same project as the powerhouse in the previous example developed a very localized slide during construction. As can be seen in Fig. 10, the top of the slide commenced well below the top of the slope, focusing on a pair of intersecting slickensides similar to Fig. 5. A porewater pressure unbalance in the cracks probably precipitated the movement, because the excavation had advanced faster than the installation of drainage. The cut slope .7 (H) to 1 (V) was designed on the basis of consolidated undrained (CU or R) shear with  $c = 0.3$  Kg per sq cm and  $\phi = 22$  deg. Standard penetration resistances, N, were 12 to 15 blows per foot in the deepest part of the cut and 9 to 12 at the ends.

The residual soils throughout the cut contained numerous slickensided seams concentrated in some areas and almost entirely absent elsewhere. Although the borings, spaced 200 ft or 60 m apart, disclosed the presence of the black slickensides neither their distribution nor orientation could have been predicted in advance. In spite of the large number of slickensides, only one pair were oriented favorably for sliding and the remainder of the 2500 ft or 800 m long cut was stable.

Fig. 10 Local slide in a railroad cut 75 ft or 22 m deep in weathered diorite in North Carolina which commenced on two intersecting slickensides similar to Fig. 5

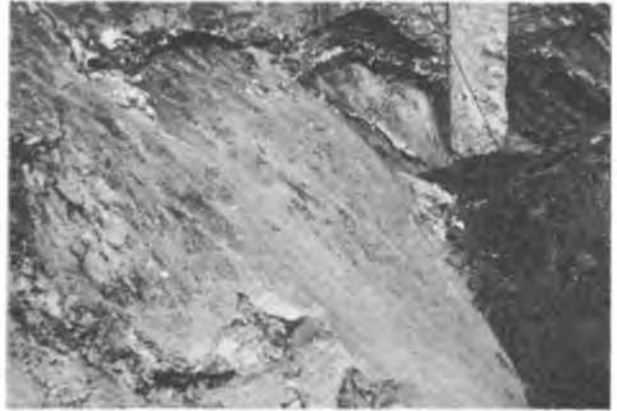
A 60 ft or 18 m deep excavation in a micaceous silty sand derived from the decomposition of granite gneiss in Georgia employed 10 in. or 25 cm steel H-piles 10 ft or 3 m apart around the perimeter as soldier piles. Wood lagging was installed between them sporadically as excavation progressed. At the same time steel wales and rakers were placed to support the soldier piles. At several points chunks of residual soil weighing up to 4 tons slid between the soldier piles, moving an old slickensided surfaces, Fig. 11. No failures occurred where the lagging had been installed, although the lagging had little flexural strength.

Fig. 11 Slickensided surface that caused a localized sliding of soil between soldier piles 10 ft or 3 m apart in an excavation 60 ft or 18 m deep. Width of photograph approximately 10 ft or 3 m
