# FAILURES AT KIMOLA FLOATING CANAL IN SOUTHERN FINLAND

E. KANKARE, I. Sc., (Eng)

**SYNOPSIS** The paper deals with the failures of the slopes of the Kimola floating canal excavated in soft slightly overconsolidated glacial clay. Most attention is paid to the great failure of November 3rd 1965, because the soil properties and pore pressures in the centre of the failed area were known before the slide. Calculations based on Bishops method give a safety factor close to unity at the time of the failure whereas the conventional  $\phi = 0$  method has proved to be unreliable.

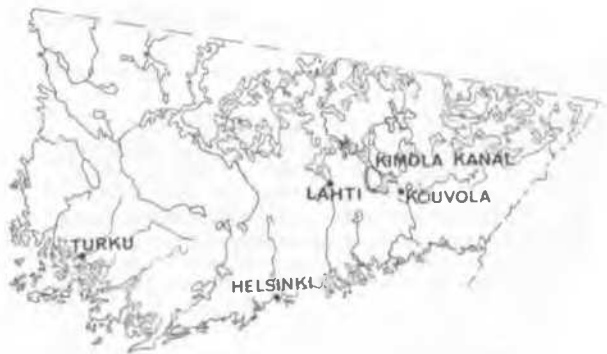
Fig.1 The Site of Kimola Canal

Kimola floating canal is located at the southern border of the Mid-Finnish lake district about 120 km northeast from Helsinki as shown in figure 1. It connects the lakes of Konnivesi and Pyhäjärvi and its only purpose is to give effect to the floating of timber in the southern part of the Päijänne lake system.

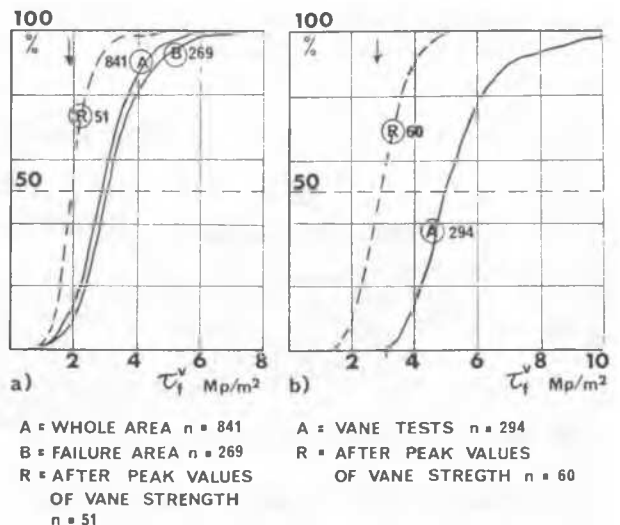
Fig. 7 Cumulative Frequency Curves of Shear Strength

The undrained shear strength (vane strength  $\tau_f^v$ ) is furthermore illustrated by figure 7, a and b, which shows cumulative frequency curves of vane strength and after-peak values of it. The arrows in the figure indicate shear stresses in the critical slip circles calculated by  $\phi = 0$  method.

- a) Upper Part of Lower Canal  
b) Upper Canal

The after-peak values thus obtained are presented in form of cumulative frequency curves in figure 7 and from station 25 m left from the center line in shear stress... vane rotation coordinate system (the torsion angle of the extension rods is eliminated) in figure 8. From the last mentioned it appears clear how the shear stress after the maximum point first decreases rapidly. When the rotation angle, however, has grown to 70 ... 80 degrees it approaches a rather constant value, which has been defined as the after-peak value,  $\tau_{f, vr}$ , of the shear strength. Its average relative magnitudes compared with the peak values ( $r = \tau_{f, vr} / \tau_f \times 100\%$ ), angles corresponding to the peak values, number of tests in each borehole, n, and standard deviations of the determinations are shown in table 3. In calculation of  $\alpha$  both the torsion of the extension rods and the initial disturbance in the beginning of many curves (fig.8) are eliminated.

It should be noted that the median of the after-peak values in the failure area (fig.7) is  $1.9t/m^2$ , which is quite the same as the calculated shear stress in the critical slip circle in the same area calculated by  $\phi = 0$  method.
