**INVESTIGATION OF LANDSLIDES ON A NATURAL
SLOPE AND RECOMMENDED MEASURES**
ETUDES DE LA STABILITE D'UN TALUS NATUREL ET LES MESURES RECOMMANDEES

SYNOPSIS This paper presents an investigation carried out on an old slide area and the recommended measures to stop the soil movements.

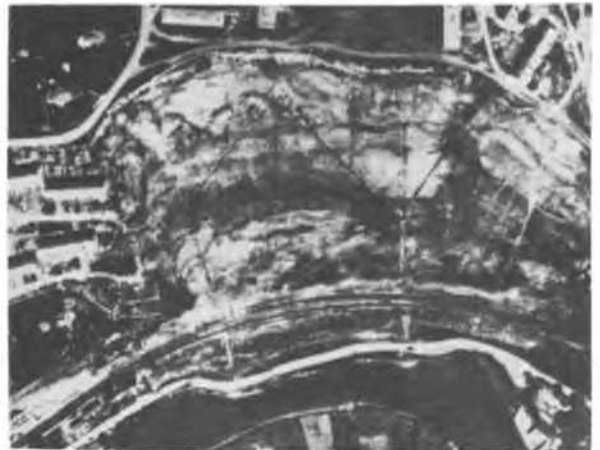
Fig.1 Airphoto showing the slide area in 1967

After a comparatively long period of rest, in 1963, a series of slides began to displace the railway track several meters and destroyed the asphalt road as shown in Figs. 1 and 2.

A comparison of the airphoto shown in Fig.1 with a previous air photo taken some ten years ago showed that the movement of the river bank is of the order of 20 meters.

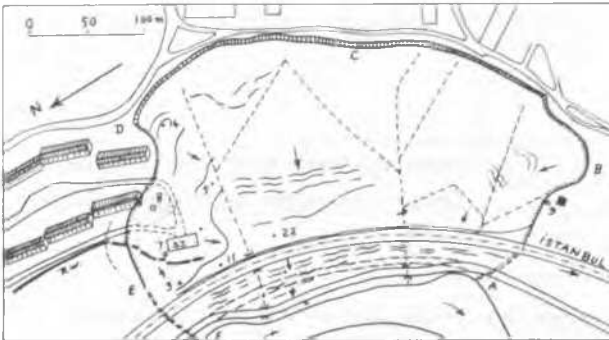
Fig. 2 Plan of the slide area showing the displaced road, septic tank (S.T.), Retaining wall (R.W.), and the tension cracks and wrinkles on the roots and bulged tongues of the slides. Railway track has always been shifted back to its original position following a slide.

Similarly, a comparison of the original position of the road with that shown in Figs. 1, 2 and 3 gives approximately the same amount of soil movement at the skirts of the slide area.

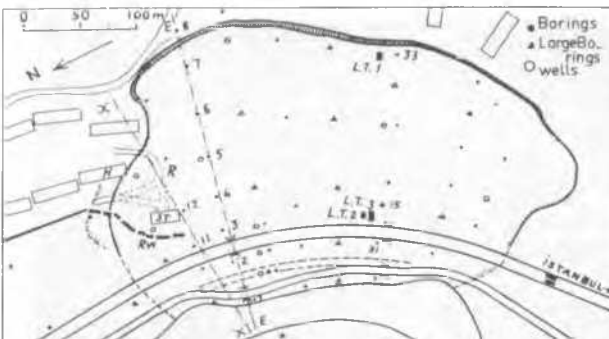
Fig. 3 Plan showing the places of borings and test pits which were converted into observation borings and wells. (L.T.) denotes the locations of the lateral load tests on piles.

The localities of these observation borings and wells are marked on the Fig.3.

As the soil in deeper strata is very stiff/hard fissured marls and marly clays bored cast in place piles are recommended. Lateral load tests have been carried out on three pile caps as shown in Fig.11. Piles are cast with the concrete method and with dimensions and reinforcement as shown in the figures. The places of the test piles are marked on the Fig.3 as (L.T.1 - L.T.3).

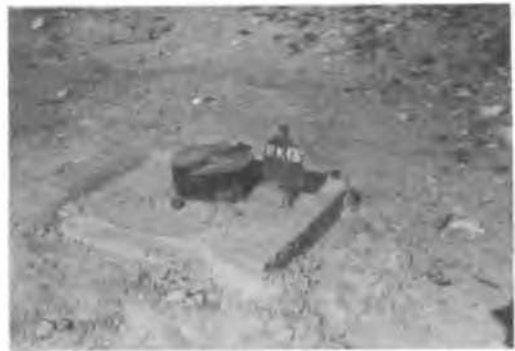
Fig. 4 Head of one of the large diameter observation borings.

Fig. 4 shows the head of one of the large diameter observation borings.

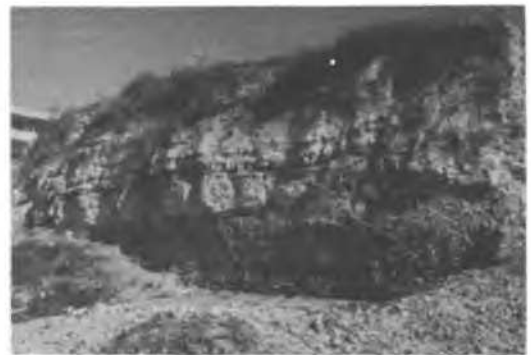
Fig. 5 Precipice formed at the head of the slide area near the boring No.33.

Fig. 6 A close up photograph of the Fig.5.

Fig.5 and 6 show undulated clay and calcareous materials underlain the layered and jointed coarse limestone in the vicinity of the boring No.33, Fig.3.

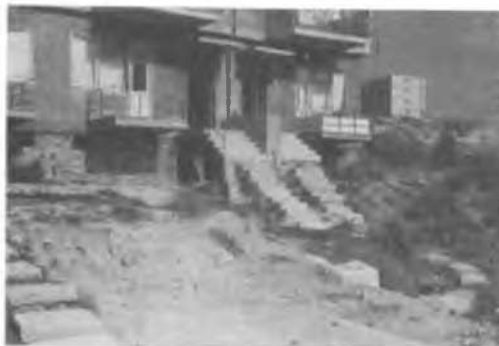
Fig.8 Depression of the ground in front of the house (H) at the edge of the sliding mass along the X-X axis.

Section E-E prepared in 1963 shows the estimated slide surfaces. Section X-X is of a comparatively recent slide. This slide destroyed and moved the road and the low retaining wall and the septic tank shown on Figs.1, 2, 3, 8, 9.

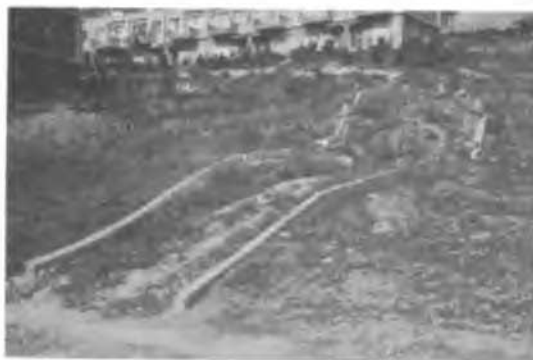
Fig.9 Destroyed road (R) on the sliding mass. See Figs. 1 and 3.

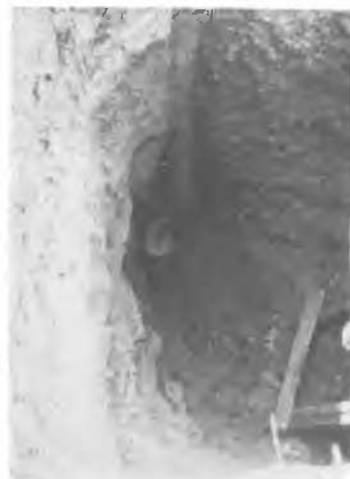
According to the observations made in June 1966 soil movements are still continuing as the Fig. 10 shows. This photograph belongs to the sketch of the sheared away observation borings No.11.

Fig.10 Photograph of the displaced plastic tube and destroyed concrete filling of the observation boring No.11.
