# Adjustable Box Foundation as a Measure against Excessive Settlement and Tilting

H. PEYNIROĞLU, ORD. PROF. DR. ING., *Technical University of Istanbul, Turkey*

## SUMMARY

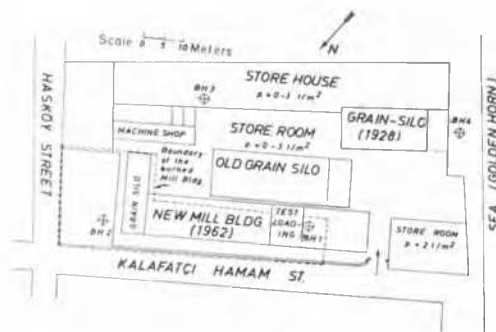
FIG. 1. Plan of the site.

A FIVE-STORY MILL BUILDING, with two silos at the ends, was to be constructed at the site of an 80-year-old mill building which was destroyed by fire in July, 1960. The author was called to investigate the problem and to recommend an economic and safe foundation. The plan of the site is given in Fig. 1 which shows the existing buildings, store rooms, and areas, and the location of the four boreholes. The geological section of the subsoil and the dimensions of the two buildings subject to investigation are shown in Fig. 2.

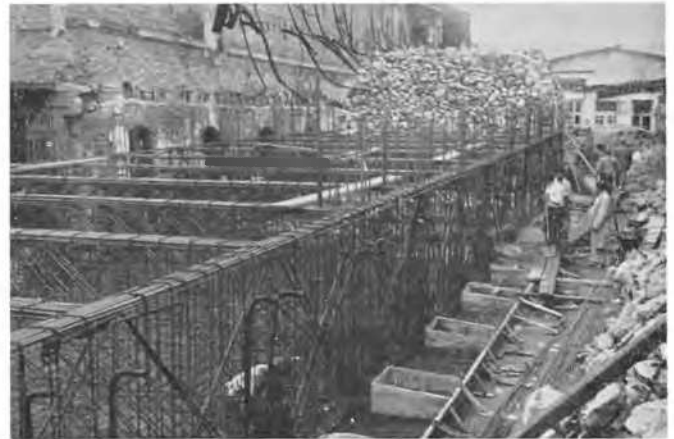
FIG. 12. Reinforcement of the box and injection tubes.

carry the building when it rests on 12 hydraulic jacks. Fig. 12 shows the reinforcement of the box and the tubes for mortar injection. It was planned that, if necessary, mortar will be injected between the raised sole of the box and the surface of the concrete mat. To resist the reactions the mat was reinforced under the jack niches. The surface of the concrete mat was covered with a waterproofing material followed by a 4-cm thick mortar layer to protect the membrane. The mat was given a reverse inclination as shown in Fig. 10.
