Analysis of a High Crib Wall Failure

G. P. TSCHEBOTARIOFF, DR.ING., DR.H.C., *Associate of King & Gavaris, Consulting Engineers, New York, N.Y., U.S.A.*

SUMMARY

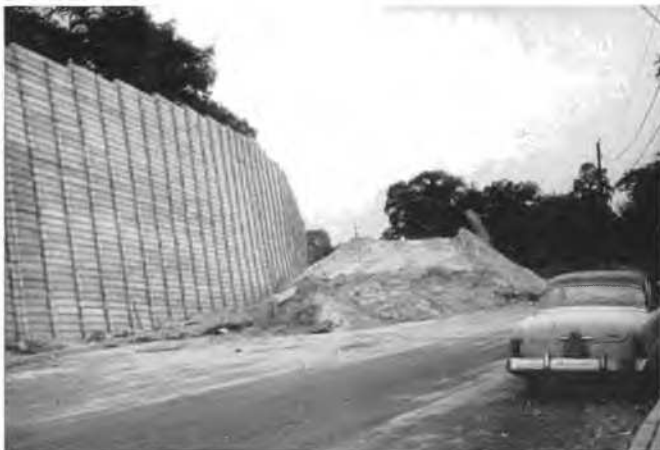
FIG. 1. General view of 34-ft high concave crib wall.

EARTH RETAINING CRIB WALLS built of precast reinforced concrete units are comparatively simple to analyse when their height does not require a width exceeding that of one cell (Tschebotarioff, 1951). Such crib walls easily adjust themselves to longitudinal differential settlements parallel to their face (Tschebotarioff, 1962). In recent years, attempts have been made to increase the height of crib walls to an extent requiring the use of two interlocking rows of cells in the lower portion of the wall in order to increase the width of its base. Such walls can be very sensitive to transverse settlements, however. This is illustrated by the following case of a concave 24-ft to 34-ft high wall (Figs. 1 and 2).

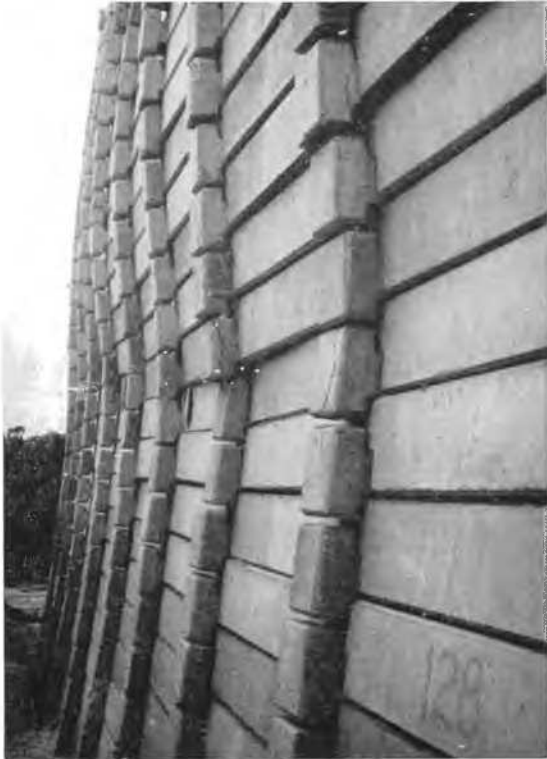
FIG. 3. Outward bulge of upper part of crib wall.

The upper part of the wall had noticeably bulged outwards (Fig. 3). As a result of this outward movement and of the concave curvature in plan of the wall, the expansion joints between double vertical rows of headers had widened (Fig. 4). This widening occurred only in the upper part of the wall, thereby giving another indication that the outward sliding had taken place only where the wall was one cell in width.

It should be noted that a convex (Fig. 5a) crib wall of approximately the same height in the vicinity did not show any signs of distress. The severe cracking of the reinforced concrete headers and stretchers of the concave concrete wall (Fig. 3) had to be attributed, therefore, to tensile stresses induced in the headers (Figs. 5b and 5d) as a result of the outward sliding (Fig. 5c) of the upper one-cell wide portion of the wall. This sliding was, therefore, the primary cause of the trouble. The original designers of the wall had detailed it (Fig. 2) and had analysed its stability in a conventional

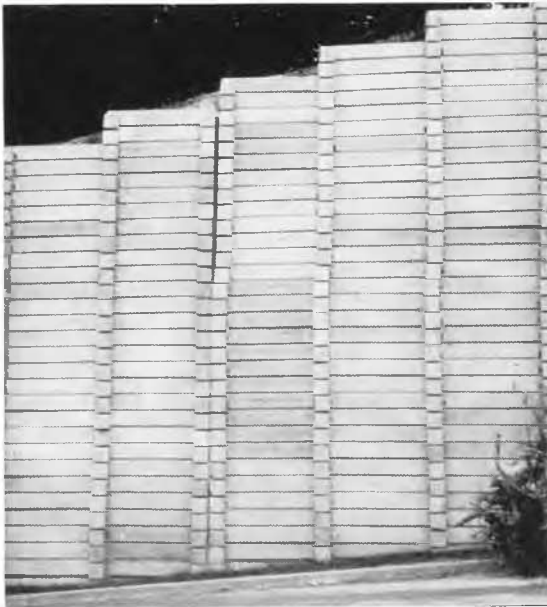
FIG. 4. Opening of upper part of expansion joint.

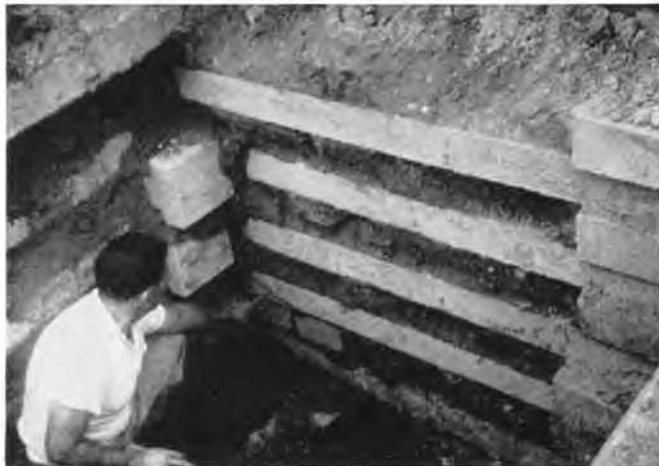
FIG. 8. Photo of crack illustrated by Fig. 9 (taken from opposite direction).

To check this point, three cells were fully excavated and the anticipated cracks were actually found in the headers (see Fig. 8). The measured deflection of the headers indicated that the central longitudinal crib wall must have settled at least two inches more than the outer face of the crib.
