Forecasting the Time of Occurrence of a Slope Failure

M. SAITO, *Head, Soil Mechanics Laboratory, Railway Technical Research Institute, Japanese National Railways, Japan*

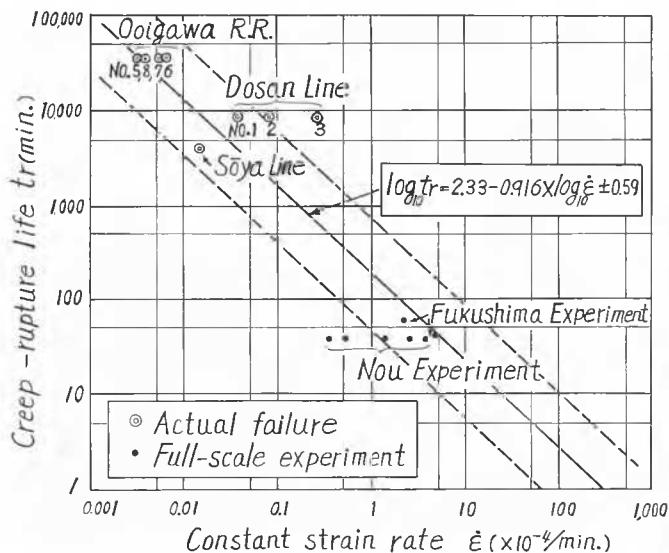
FIG. 5. Comparison of results of field measurement with the relationship between strain rate and creep rupture life.

and opposite to the wall in relation to the railroad track, was used as a basis. The values of calculated strain rate are shown in the figure. Creep rupture life was taken as the length of time from November 20 to December 14. The constant strain rate and the corresponding creep rupture life are plotted to a log-log scale on Fig. 5. The results show fairly good coincidence with the relation obtained in the laboratory tests.

Referring to Fig. 4, the time of slide occurrence was estimated as that corresponding to the intersection of the extensions of the two straight parts of the displacement curve. In this case the measured value has good coincidence with the aforementioned relationship, as seen in Fig. 5.

In this connection, the results of full-scale experiments are shown again in Fig. 5, and it is well understood that long-term records can be obtained only through observation of actual slides.

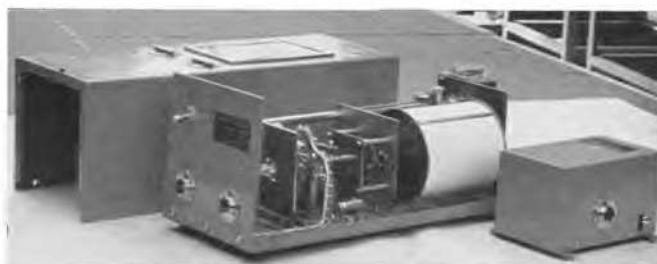
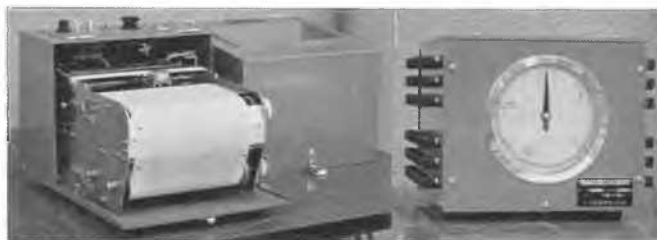
FIG. 6. Strain meters. A, Direct recorder; B, single remote recorder; C, multiple remote recorder.

It is necessary to measure the relative displacement continuously in order to use it for the purpose of forecasting. Several kinds of strain meters have been developed and are shown in Fig. 6, where A shows a direct recorder, used at a site which is easily accessible, B a single remote recorder, used at a site where access is difficult, and C a multiple remote recorder, for making concentrated observations.

The principle of these devices is that relative displacement is converted to revolution of a recording drum or a pointer or indicator through super-invar wire stretched between two stakes, and a recording pen or a dot-marker moves on recording paper by clockwork or by motor drive. Recorders of these types are now widely used in our country for various purposes.
