Frost Cracks in Roads

by F. RENGMARK, Head and R. GANDHAHL, First Geologist, Geological Department, National Road Research Institute, Stockholm, Sweden

Summary

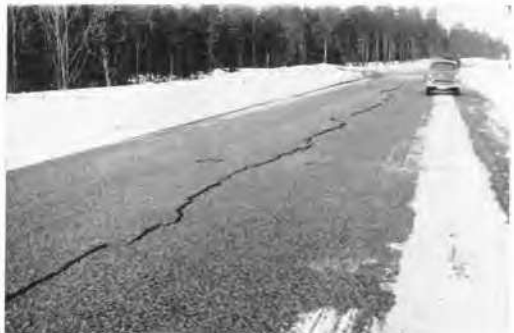
Fig. 1 Frost crack in a road near Ernsås, Sweden.
Fissure sur la route d'Ernsås, Suède.

Swedish roads, particularly those in the northern parts of the country, have in recent years been subject to longitudinal frost cracks (Fig. 1) on a large scale. In these areas, the frost usually penetrates the ground to a depth of some 2 metres. The cracks, which have generally appeared in newly built roads with bituminous surfacing, are usually formed fairly early during the frost period, i.e. in January or even as early as the latter part of December. Thus they are formed during that part of the year when the roads are frozen and consequently have great bearing capacity.

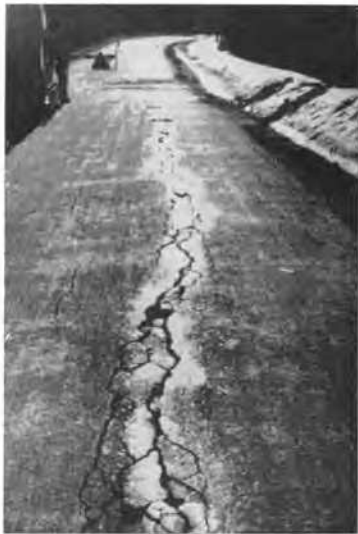
Fig. 2 Frost crack in a road, Germany (after A. Dücker).
Fissure sur une route allemande (d'après A. Dücker).

The types of cracks described here seem to appear also in Germany. In *Strasse und Autobahn* (No. 3, 1956), A. Dücker writes on page 79 : "Zwar handelte es sich hierbei nicht um Frostaufbrüche, sondern um längsgerichtete Frostrisse. diese während der Frostzeit entstandenen Schäden" (Fig. 2).
