Slope Consolidation of the Banks of the Monguelfo Reservoir, Italy

by D. FINZI, Dr. Ing ; C. NICCOLAI, Dr. Ing. Soc. Montecatini, Milano, Italy

Summary

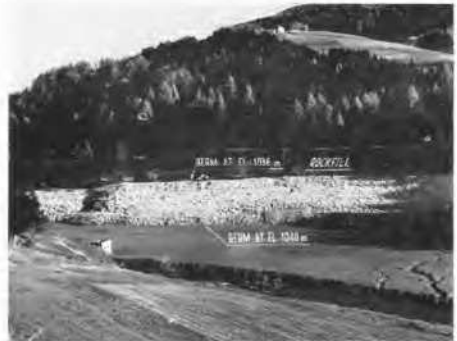
Fig. 4 View of a consolidated stretch of slope.
Vue d'une zone à talus consolidés.

6. In conclusion, after having examined several types of slope protection, also within the selected alternative, a twin-zoned protective shell having the following features was adopted (Figs. 3 and 4) :
