Large Scale Preconstruction Tests of Embankment Materials for an Earth-Rockfill Dam

by George F. SOWERS, Professor of Civil Engineering, Georgia Institute of Technology, Atlanta, Georgia and Consulting Engineer, Law Engineering Testing Co., Atlanta, Georgia, U.S.A.

and
Clayton E. GORE, Engineering Geologist, Alabama Power Co., Birmingham, Alabama, U.S.A.

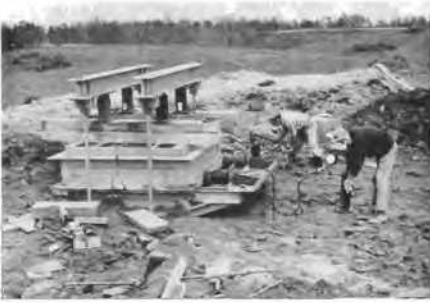
Fig. 5 Direct shear box test in progress.
Exécution d'un essai dans la boîte de cisaillement direct.
