A Landslide Due to Long Term Creep

by L. ŠUKLJE, Dr. Techn., Professor, and S. VIDMAR, Civ. Eng., Assistant, University of Ljubljana, Yugoslavia

Summary

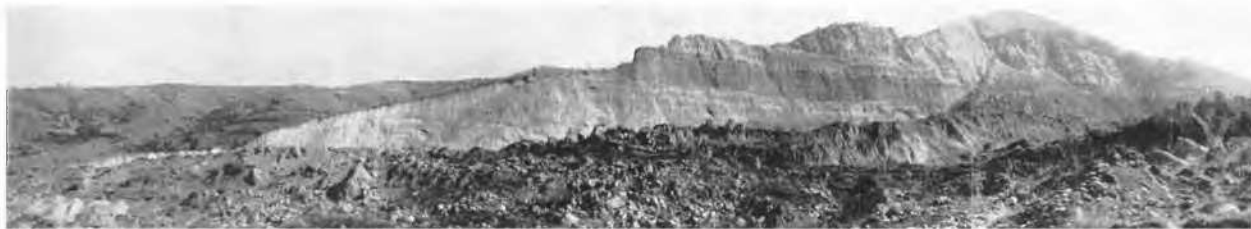
Fig. 1 Landslide panorama. (The rubble slope on the toe of the break-off wall proceeds from blowing up the cap of the hill after failure.)
 Vue panoramique du glissement. (Les débris au pied de la crête rompue proviennent du sautage du sommet après le glissement.)

the valley under the landslide which left behind 130 metre high wall of the broken mountain.

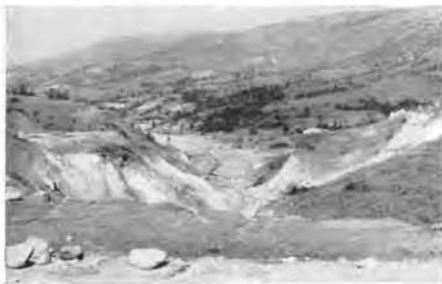
Fig. 3 The erosion bed created by the overflow of floodwater in 1957.

The Vatasha river is of torrential type. It swells in spring and in autumn. The maximum flow under flood conditions is estimated to be as high as 150 cub. m. per sec., but commonly it does not exceed 30 cub. m per sec. Under summer drought conditions the river bed is dry and this was the case at the time when the landslide occurred; the drought was preceded by extremely sultry weather. In 1957, before satisfactory spillways had been constructed, the floodwater overflowed the dam crest and some 600-000 cub. m of material has been eroded and swept away. The erosion bed is shown in Fig. 3.
