The Swelling Soils of the Quiroz Canal System

by M. MONTERO P., Chief of the Structures and Soil Mechanics Department, Bureau of Irrigation Ministry of Public Works, Peru

The Quiroz Irrigation Project, in northern Peru, South America, has a total length of 184 km of main canals and 554 km of branch canals.

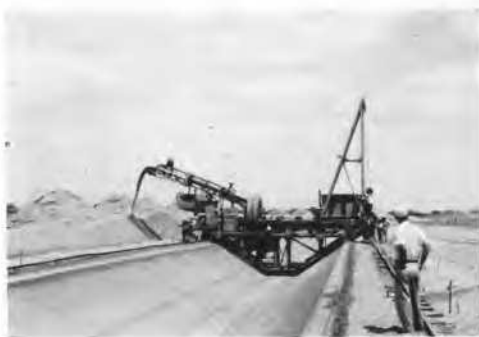
Fig. 2 Trimming Machine.
Machine à profiler.

During field investigations and early construction operations it was noted that the terrain through which the main canals called "Tablazo" and "Tambogrande", and the Tablazo branch canals 15.8 and 31.7 (see Fig. No. 1), had soils which displayed possible troublesome swelling characteristics. During the design stage it was deemed necessary to line a considerable length of the main and branch canals to reduce seepage losses through pervious strata; the lining for the main canals and wide branch canals is 4 in thick and was placed by means of lining machines (Figs No. 2 and 3).

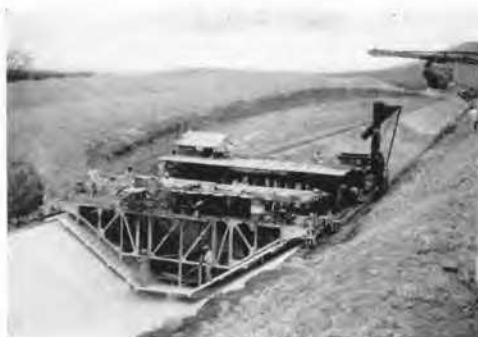
Fig. 3 Lining Machine.
Machine pour la mise en place du revêtement.

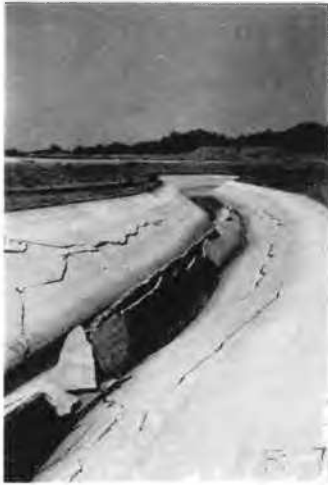
As the 1958 rainy season came to an end, it was noted that the lining in some sectors of the Tablazo Canal had been cracked, and in two more months there were 950 metres of canal disrupted, of which 875 metres were due to heavy swelling of the soils; the rest was due to hydrostatic pressure (see Fig. 7). The damage was impressive in some sectors, but of minor consequence considering the magnitude of the

The author tried to find the reason why the lining was cracked in these reaches, and he came to the conclusion that treatment was short and the head of water sometimes inadequate.

Fig. 7 Disrupted lining. Tablazo Canal.
Revêtement fissuré. Canal du Tablazo.

In the damaged zones it was decided to postpone repairs for as long as it would be practicable to do so, allowing the water to flow through those sections and to soak them thoroughly, checking this treatment by tests (Table 3).

After the water had been flowing for some months, the sections were repaired by reinforcing the concrete lining with No. 4 steel bars spaced at 12 inch. centres both ways. This procedure was adopted in order to prevent further cracking of the lining, but in the author's opinion this work was superfluous (Figs 8 and 9).

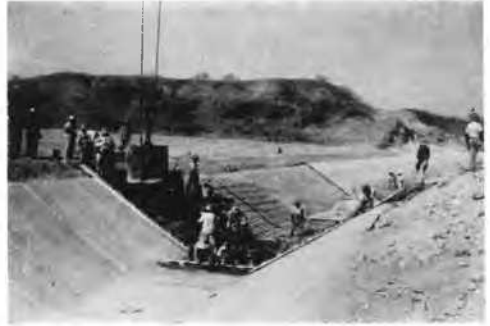
Fig. 9 Lining with reinforcement.
Pose d'un revêtement avec armatures.

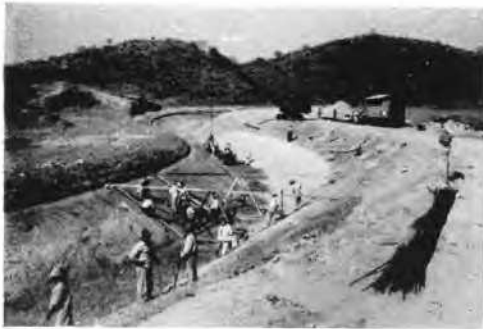
Fig. 8 Trimming to line swollen section.
Mise au profil d'une section gonflée.
