Substantial Consolidation and Swelling of Clay Cause Two Interesting Cases of Serious Damage to Hospital Buildings in Egypt

by M. S. YOUSSEF, Assistant Professor, A. A. SABRY, Research Assistant Professor, and M. M. TEWFIK, Research Assistant Professor, Faculty of Engineering, Cairo University, Egypt

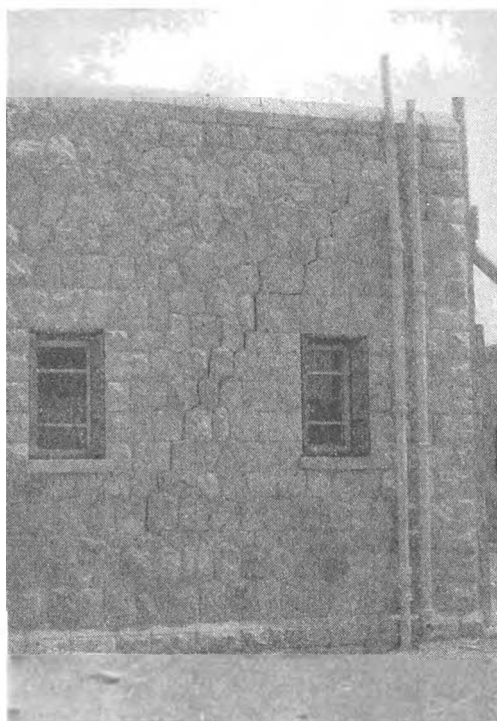
The swelling of the soil, upon which the foundation of the three-storey building was established, resulted in the raising of some parts of the building while the rest remained in place. These differential movements seriously damaged the building and it is hard to say that one wall was left intact. Some of the cracks were about 2 cm wide. In parts, where the toilets and wash rooms were located, the reinforced concrete ceiling crept horizontally on the walls for a distance of about 3 cm. In these places the glass windows were crushed. The floor of the wash room on the ground floor was raised for a height of about 50 cm above its levelled horizontal surface. The pavement around the building took a wavy shape due to the swelling of some parts of the soil close to the places where water percolated. Figs. 8, 9 and 10 are photographs taken of the buildings.

Fig. 8 Wall of toilet rooms in the one-floor building showing serious cracking
Fissures dans le mur du bâtiment sans étage

From site investigations, it was found that swelling of the soil was due to percolation of the sewage water from the septic tanks into the soil under the foundation. As the hydrated soil was confined in the horizontal direction, swelling took place in the vertical direction which was least resistant. This resulted in lifting the building upwards. The downward pressure from the weight of the building is only a fraction of the swelling pressure. To stop the clay from swelling, or to reconsolidate it after swelling back to its initial void ratio, tremendous pressures will be required of the order of 100 kg/cm² and more, as can be seen from the e -log P curves in Fig. 5.
