Residual Soil and Rock Slides in Santos (Brazil)

by M. VARGAS, Professor of Soil Mechanics and Foundation Engineering, Escola Politécnica da Universidade de São Paulo, Brazil

E. PICHLER, Head, Engineering Geology Department, Instituto de Pesquisas Tecnológicas de São Paulo, Brazil

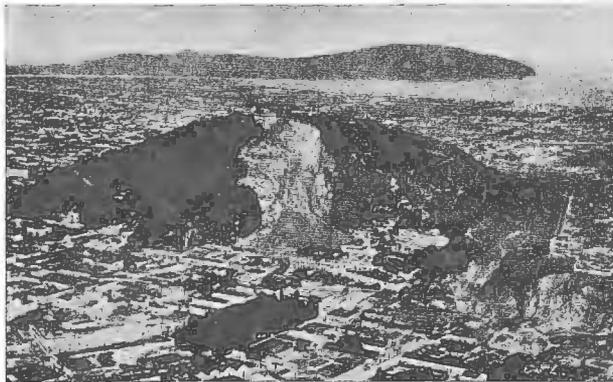
On 10 March 1928 a great slide occurred at the northern side of a hill that surrounds the city of Santos. A mass of several thousand cubic metres of residual soil moved down the hill and destroyed a number of houses and part of a hospital. Fig. 1 shows a view of the slide.

Fig. 1 Old slide at Monte Serrate (1928)
Ancient glissement au Monte Serrate (1928)

Type A. Slides of the thick residual soil mantle at the top of the hills. At the left side of Fig. 5, sound rock is shown covered by a strata of residual soil of some thickness. Slides occurring at places like this are very dangerous because they involve great volumes of earth. A typical example of this kind of slide was the 1928 slide at Monte Serrate (Fig. 1).

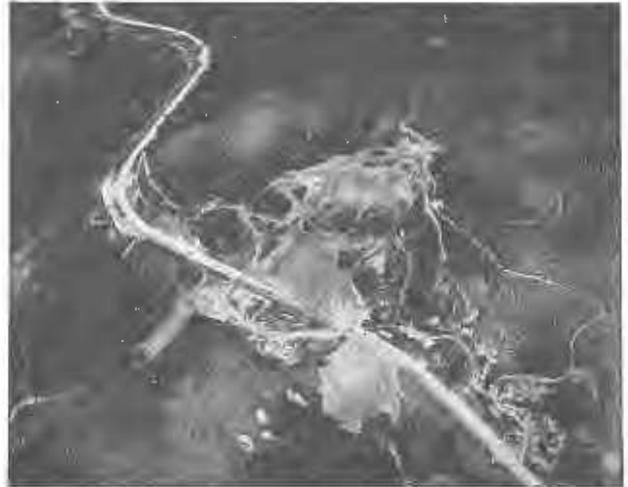
rest just behind a big electric power-house at the foot of the coastal range, locally called Serra do Cubatão, some 10 km west of Santos, started to move. Well-designed drainage works prevented the movement. About one year later another similar movement, also at an old slide area about a kilometre from the first one, took place as the result of an excavation for a cut in the construction of a new express-way road linking Santos with São Paulo. Fig. 2 shows an aerial view of the slide area. Here again drainage works successfully stopped the movement.

Fig. 2 Slide at the foot of Serra do Cubatão (1948)
Glissement au pied de la Serra do Cubatão (1948)

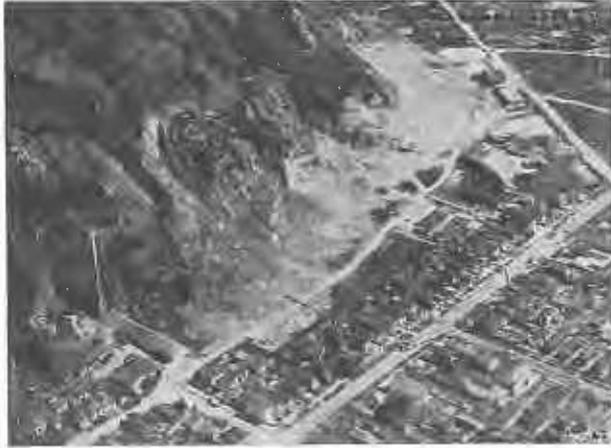
Fig. 3 Marapé scarp before slide
La pente du Marapé avant le glissement

The last example to be analysed is the Marapé rock-slide already shown in Figs. 3 and 4. In the first photograph a system of jointing can be easily observed at the place where the slide occurred. This system consists mainly of exfoliation joints which tend to separate large slabs of rock from the main body. Also dislocation joints are shown throughout the fall

houses were destroyed. Fig. 3 presents a picture of the site before the slide and Fig. 4 after the occurrence.

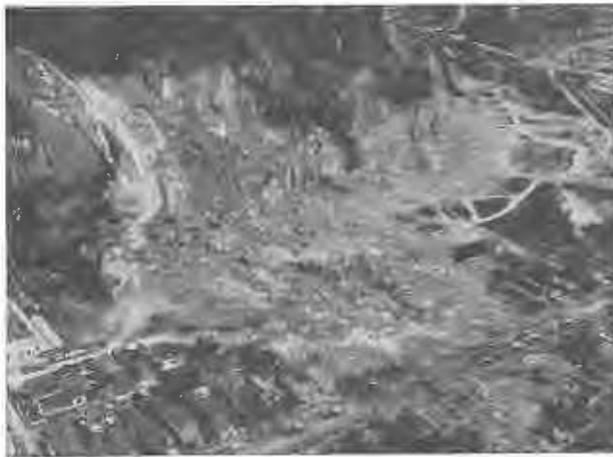
Fig. 4 Marapé slide (1 March 1956)
Le glissement du Marapé (1^{er} mars 1956)

area having the same direction and dip. These latter joints had broken the rock slabs into large blocks which hung on the slope. Circulation of rain water through the fissures had accelerated the decomposition of the less resistant minerals, so that after a certain time conditions had become more and more favourable to sliding. Also vibration from blasting at a nearby quarry had contributed to a certain extent in aggravating these conditions so that at the time of the slide the heavy rainstorm could disrupt the already weakened material.

On 1 March, after a heavy rainstorm, some slides occurred at the slopes of a hill called Morro Sta. Terezinha, at the Marapé quarter of the city of Santos. The most important one was a rock slide in the vicinity of an operating quarry. Twenty-one people were killed, 42 hurt and more than 50

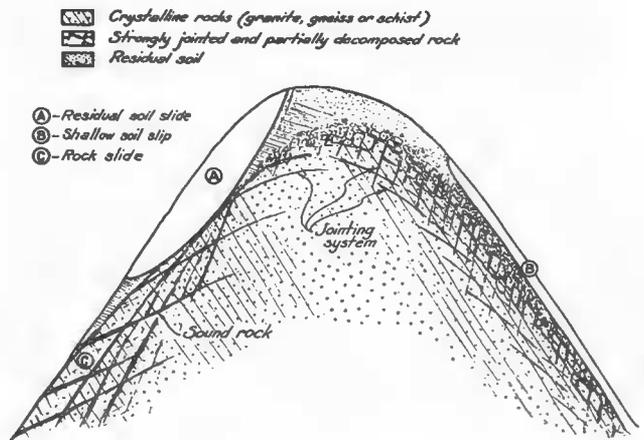
Fig. 5 shows a general and schematic outlay of the prevailing geological conditions in the Santos slides, all belonging to the above-mentioned class (3). According to their situations they can be divided into three major types:

Fig. 5 Diagram of geological slide conditions in Santos
Schéma des conditions géologiques des glissements à Santos

Type B. Shallow residual soil slides. At the right side of Fig. 5 rock is shown covered by a shallow mantle of residual soil. Below the mantle the rock is broken along its natural jointing system producing a layer of blocks of various dimensions reaching depths of tens of metres. Slides in cases like this are mainly slips of the residual mantle along the fissured blocks, producing long shallow strips on the slopes. Fig. 6 shows a view of the Caneleira scarp, which is of the above-mentioned formation, before the slide. Fig. 7 is a photograph taken of the same site after the landslide occurred.

Type C. Rock slides. Where the rock surface is laid bare, as in the lower left-hand side of Fig. 5, a jointing system is observed, which tends to separate large blocks of rock from the main body. After heavy rainstorms these blocks may slip along the sound rock surface as occurred at the Marapé slide (Figs. 2 and 3).

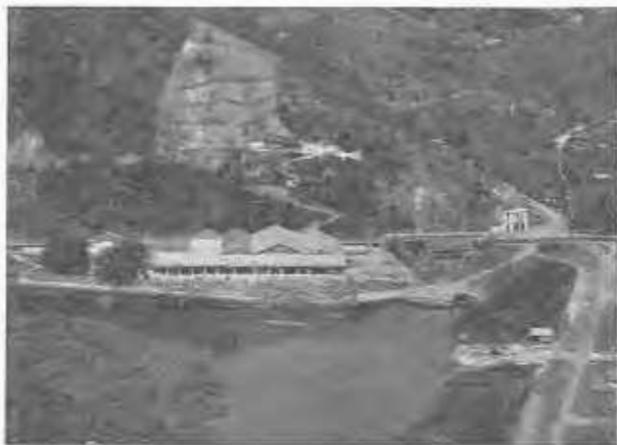
Fig. 6 Caneira scarp before slide
La pente de la Caneira avant le glissement

The second typical example is given by the Caneleira slide shown in Figs. 6 and 7. It was produced by the slip of a shallow residual soil mantle along fissured blocks of partially decomposed rock. Fig. 10 shows a cross-section of the slide area.

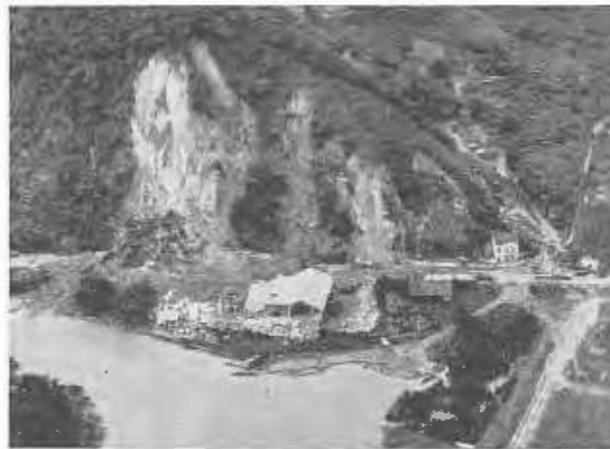
Fig. 7 Caneira slide (24 March 1956)
Le glissement de la Caneira (24^{ème} mars 1956)

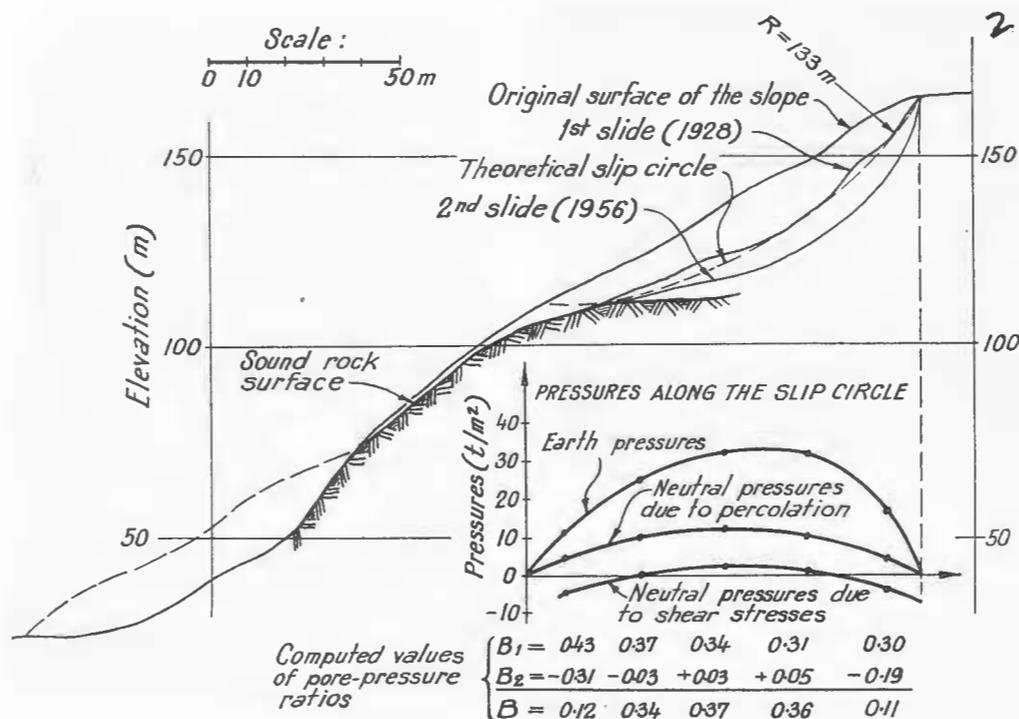
Fig. 8 Monte Serrate slides—cross-sections
Glissement du Monte Serrate—sections transversales

Fig. 8 shows a cross-section of the slide area. One can observe that the 1928 slide slipped along a circular surface with a radius of 133 m. The stability analysis of the slope was made according to the classical slices method, in which the static equilibrium of the mass of soil is considered satisfied, at the moment of rupture, by the following equation:

Now, the pore pressure u can be considered as the sum of two components: $u_1 = B_1(W/b)$, due to the percolation of water through the soil mass, and $u_2 = B_2(W/b)$, due to the deformation of the soil pores during rupture. The first one can be easily computed by a flow-net analysis. Fig. 8 shows the results of such an analysis on a graph which indicates percolation pore pressures along the slip circle. The second component can be obtained from the results of slow shear tests in

comparison with those of triaxial undrained tests on the same material. The same graph, in Fig. 8, shows neutral pressures due to shear stresses, along the sliding circle, obtained in this way. From the values of u_2 thus obtained, the values of B_2 , in Fig. 8, were computed, which added to B_1 gave the theoretically computed values of B at five points along the slip circle. These values are shown in the lower part of Fig. 8. It can be seen that these values are in close accord with the average B value obtained by the slice method computation.

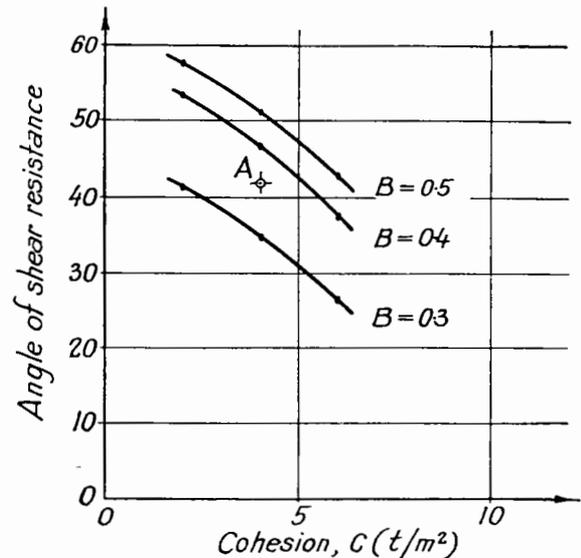
The result of such an analysis is shown on a graph in Fig. 9 where the required values of cohesion and angle of shearing resistance are expressed in curves for three values of B . As the available shear characteristics of the soil correspond to point A in the graph, one can conclude that, at the moment of rupture, a pore pressure had developed at the sliding surface. As can be observed on the graph, the corresponding value of B is 0.35.

Fig. 9 Required values of c and ϕ for stability at verge of rupture in the Monte Serrate slope
 Valeurs de c et ϕ pour la stabilité au moment de la rupture du talus du Monte Serrate

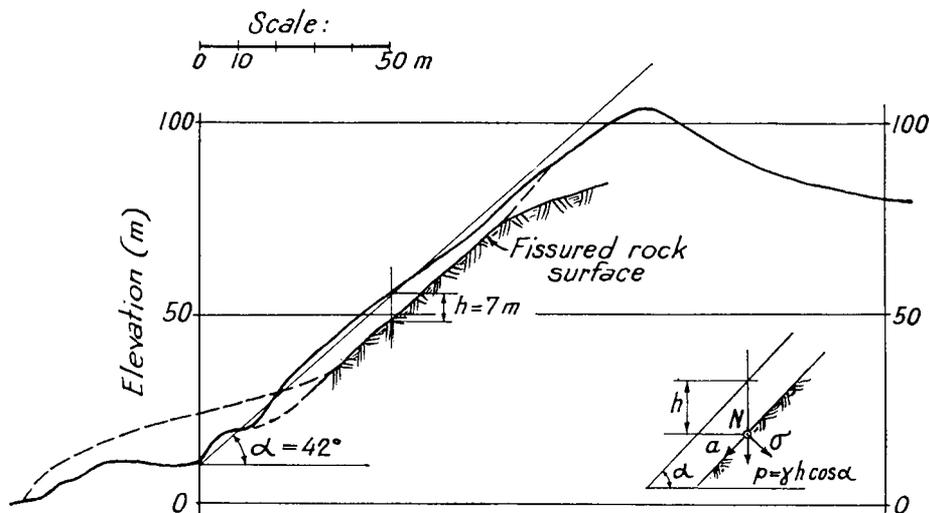
This slide can be easily analysed if it is assimilated to a slip of a layer of constant thickness, h , along a rigid surface, as indicated in the right corner of Fig. 10.

Fig. 10 Caneleira slide—cross-section
Le glissement de la Caneleira—section transversale

Substituting the numerical values in equation 7 the value of B will be found to be 0.3, which is just what should be expected, assuming that the flow-net equipotentials are straight lines normal to the rock surface.
