The Behaviour Under the Influence of Soil Creep Pressure of the Concrete Bridge Built at Klosters by the Rhaetian Railway Company, Switzerland

by R. HAEFELI, Professor, CH. SCHAEERER, Dipl. Engineer, and G. AMBERG, Dipl. Engineer, Laboratory of Hydraulic Research and Soil Mechanics at the Swiss Federal Institute of Technology, Zurich, Switzerland

Summary

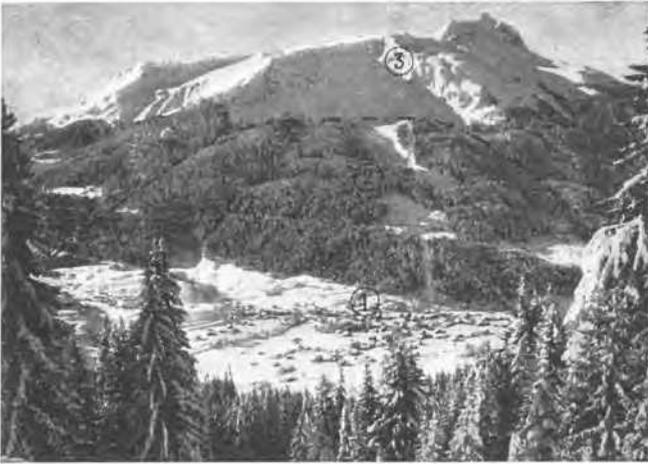
A railway bridge in reinforced concrete was built over the river Landquart at Klosters in 1930 in accordance with a project of the late Engineer *R. Maillart* of Geneva. It consisted of a centre arch with stiffening girder of a span of 30 m and arch height of 7.90 m. The axis line of the railroad makes a horizontal curve with a radius of 125 m (Figs. 1 and 2). The approach spans on both sides are built as stiff frames and the foundations of all parts of the structure had to be built on talus. The left slope of the river bank consists of a loamy landslide mass that is rich in dolomite boulders and which is subject to creep (see also *Terzaghi*, 1951). The right bank of the river is formed of detritus material which has been deposited by the river Landquart (for general configuration of the terrain see Fig. 8).

Fig. 8 General View: (1) Bridge; (2) Slide Area; (3) Airal Railway Gotschna; (4) Railway
 Vue générale: (1) pont; (2) zone de glissement; (3) télécabine de Gotschna; (4) chemin de fer
