W.A. LEWIS

Department of Scientific and Industrial Research
Road Research Laboratory

In recent years numerous investigations of road foundation failures have been undertaken by the Road Research Laboratory. The primary object is to reveal the causes of failure, and thus to obtain information leading to improved methods, of design, but they are, of course, of immediate assistance to the road engineer responsible for the maintenance of the roads.

A. AN INVESTIGATION OF THE CAUSES OF CRACKING AND DISINTEGRATION OF PORTIONS OF A CONCRETE ROAD

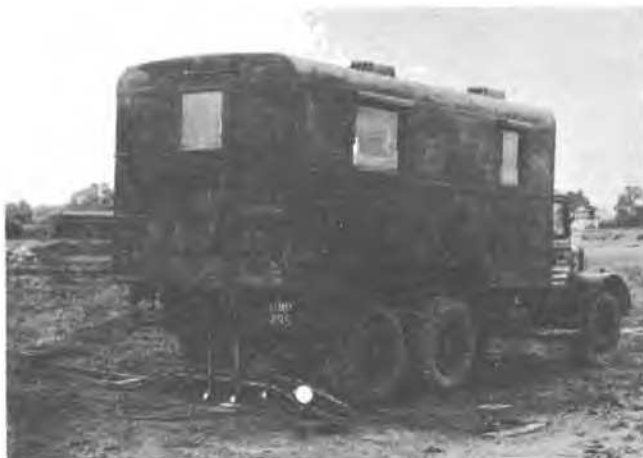
FIG.2

At each site several load-deflection measurements are made on the surface of the subgrade and also on the sub-base if one be included in the construction. The apparatus used is shown in Figs. 2 and 3. An 18 in. (46 cm) diameter plate is often employed, as this size

Equipment used in the Investigations to Measure the Bearing Value of the Soil.

is found more convenient to use and is thought to reproduce more closely the state of stress produced by the normal road vehicle than the 30 in. (76 cm) diameter plate sometimes specified. The load-deflection measurements enable values of the modulus of subgrade reaction ("K" lb/sq.in./in.) to be found.

The field work is carried out by an officer aided by two or three assistants. A mobile laboratory is stationed at the site during the investigation, and if desired, all the soil tests can be carried out in the field. The mobile laboratory used in the investigations is shown in Figs 2 and 4.

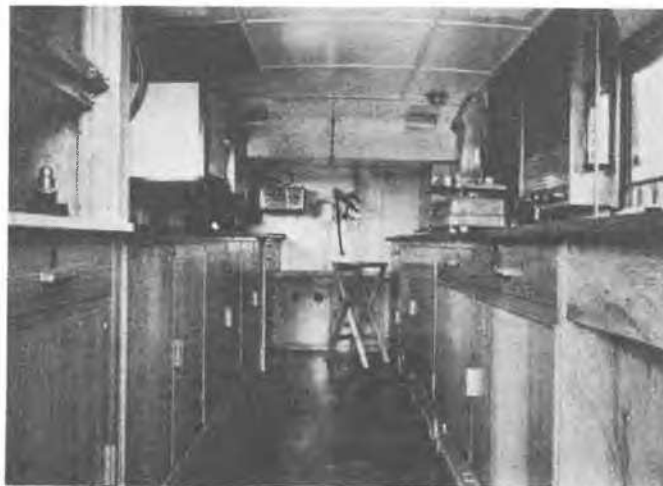
FIG.4

Interior of Mobile Laboratory.

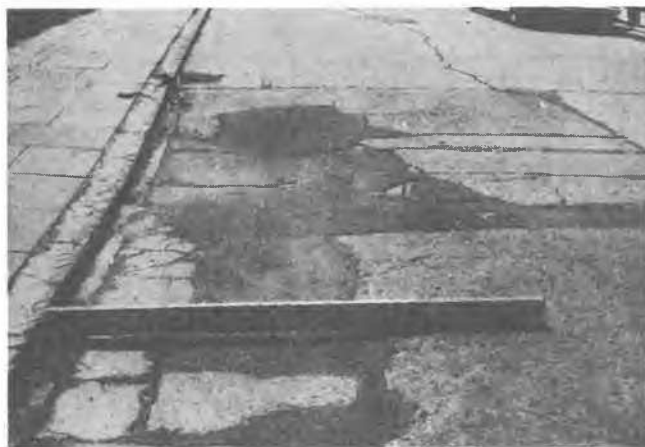
FIG.5

The road at the site of the investigation was constructed in 1924 and consisted of a 24 ft. (7.3 m) wide singly-reinforced concrete carriageway with no central longitudinal expansion joint. Apart from the formation of a longitudinal crack along the crown of the carriageway, the road carried normal traffic satisfactorily until 1944 when unusually heavy traffic caused the rapid deterioration of many of the slabs (see Figs 5 and 6).

Area of Cracking and Settlement of a Concrete Road.

The conclusions arrived at from the investigation were (a) that the defective areas on the road developed as a result of insufficient thickness of concrete and sub-base to carry the very heavy traffic, and (b) that a total thickness of base and surfacing of 16 in. would have been adequate to prevent the occurrence of any serious defects. The continuous crack along the crown of the road would have been avoided by the use of a central longitudinal joint.

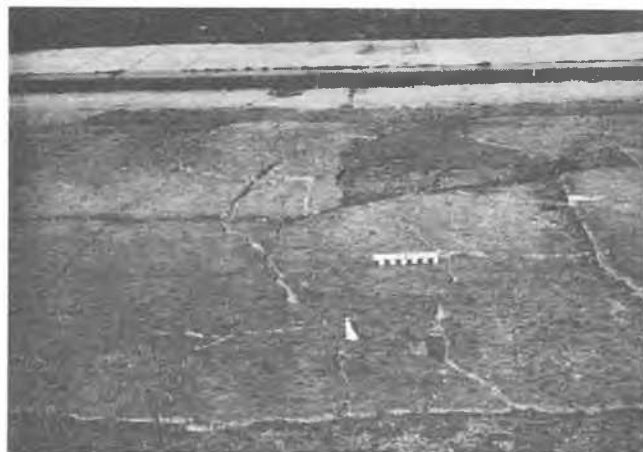
FIG.6

Severe Cracking and Disintegration of Slabs of Concrete Road.

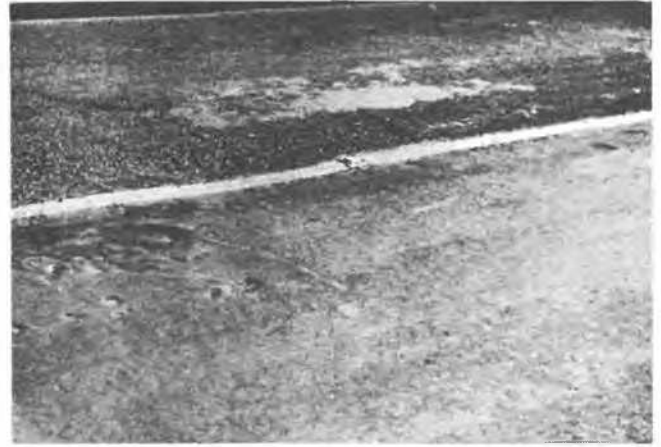
FIG.11

A 24 ft. wide bituminous surfaced road had shown severe settlement accompanied in some places by disintegration especially along the crown and northern side of the road (see Figs 10 and 11). This section of road had been a source of trouble for a considerable period of time and approximately £8000 had been spent on maintenance over a period of 8 years prior to the investigation.

Close-up View of Area of Settlement and Disintegration along the Crown of the Road.

The main factors contributing to the failure were, therefore, an insufficient thickness of construction along the crown of the road and an inefficient intercepting drainage system.

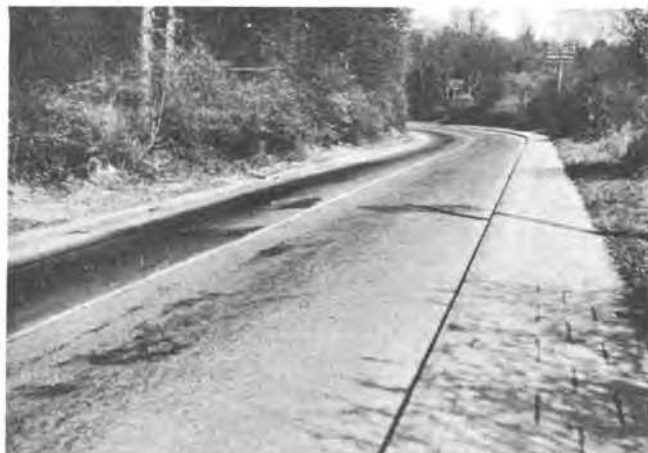
FIG.10

General View of Bituminous Surfaced Road which had Developed Areas of Settlement and Disintegration.

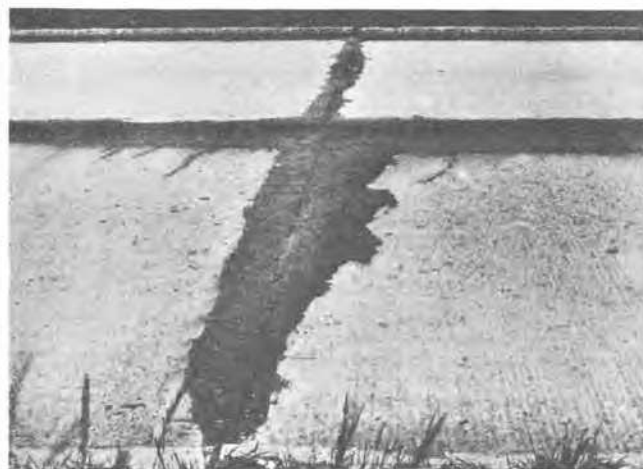
FIG. 15

Differential Movements between Slabs of a Concrete Road.

The subject of the investigation consisted of a 20 ft. (6.1 m) wide concrete carriageway with a central tongued longitudinal joint laid on an existing tarmac road. Differential movements had occurred along the longitudinal joint at intervals over a length of about 900 ft. (275 m) of the road, the slabs being up to 2 in. (5 cm) lower on one side than on the other. (see Figs. 15 and 16).
