## VIII e 4

### FROST-DAMAGE TO ROADS IN DENMARK

AXEL RIIS, Chief Engineer  
Danish State Road Laboratory

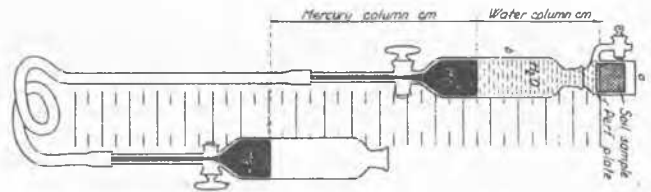
FIG. 2

Capillarity is measured by Beskow's capillarimeter (fig. 2) the design of which, however, does not permit the measurement of greater capillarity than 10 m. Greater capillarities

Dr. Beskow's Capillarimeter.

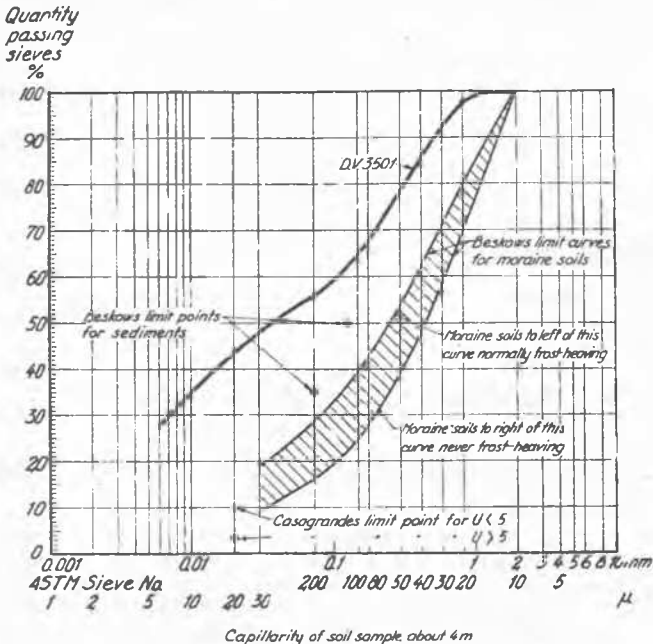
FIG.1

His rule for the former is that they are with certainty not frost-hazardous when not more than 50% of the fines (i.e. < 2 mm) is under 125  $\mu$  (A.S.T.M. sieve No.120) and not more than 35% is < 75  $\mu$  (A.S.T.M. sieve No.200). On the accompanying diagram (Fig.1) these two points are marked with two small concentric circles. Soils for which curves lie to the right of these points should, therefore, represent frost-safe sediments, and those lying to the left frost-hazardous.

For heterogeneous soils two limit curves are given (drawn in thin firm lines on the diagram) between which will lie the more doubtful cases, while here again curves to the right of the doubtful area represent safety and those to the left hazard, unless the curve lies so much to the left and so high that it depicts a fine-grained soil that is so impervious to water that it is practically safe.

Grain-size diagram of a soil sample D.V. 3501.

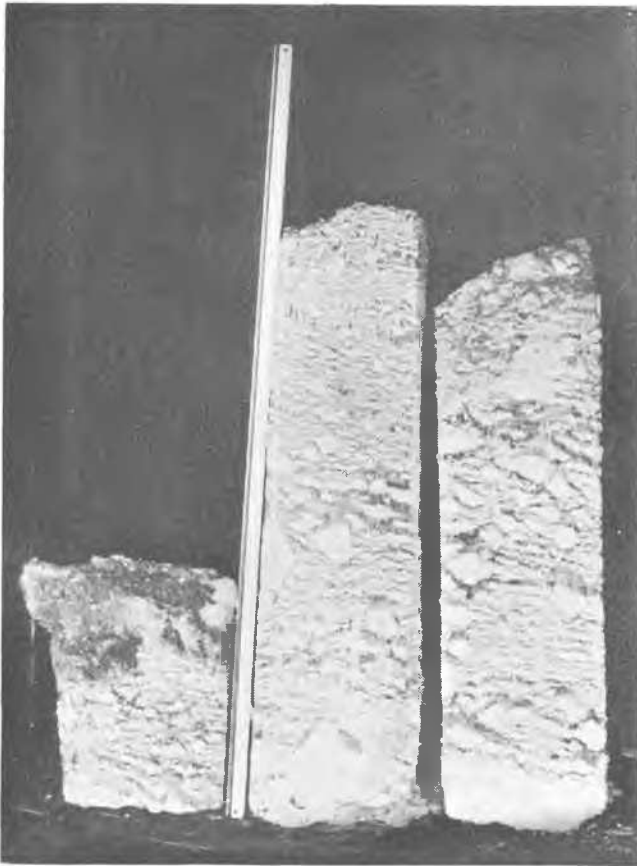
FIG.3

As an instance of the information to be gathered by observation alone of the undisturbed frozen samples, a photograph is given in Fig. 3 of 3 chalk samples as received at the

Photograph of chalk sample No. 2447-2449, taken from frost heave. Ice layers are seen as dark streaks between layers of chalk. The boundary between sand and chalk is seen in the upper part of the sample at the left (No. 2447) and the frost limit in the lower part of the sample at the right (No. 2449). Cf. Fig. 4

Laboratory, and in Fig. 4 a sketch of the positions under the road from which these samples were taken. The frost heave at the site concerned varied between 20 and 27 cm and extended in length for about 35 m. The frost had penetrated through the 22 cm metalling, the 9 cm sand layer and 49 cm deep into the underlying chalk, in all to 80 cm under the road surface. In Fig. 3 the ice layers are seen as dark streaks in the fragmented chalk. At the lower part of the sample on the right the frost limit is observable.

The water content in the frozen chalk (average of 5 determinations at various depths) was found to be about 92% of the dry weight of the samples, while in the lower unfrozen chalk the water content was about 25%.

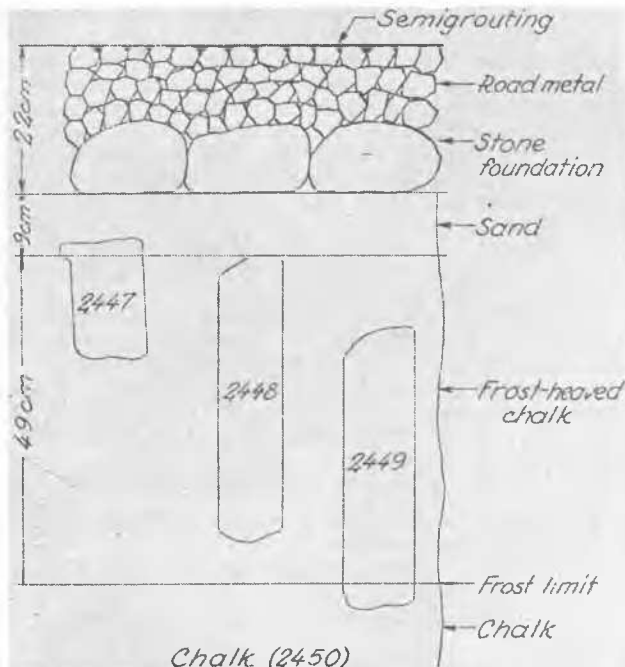
FIG.4

Sketch of position of samples Nos. 2447-2450.

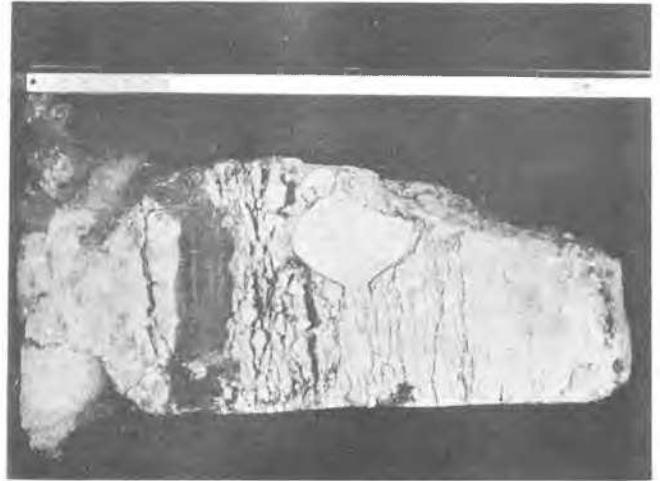
FIG.5

Photograph of chalk sample No. 2454 taken from frost heave. Ice forms dark horizontal streaks, the lowest of which (3 cm thick) is situated some 2 cm above the frost limit. In the centre of the picture a piece of closer texture chalk is seen which is not disintegrated by frost.

Fig. 5 shows another chalk sample, taken in undisturbed condition from a road bed that had not yet been metallated but was covered by a thick layer of snow, the frost penetration was consequently only 40 cm. The picture shows an ice layer some 30 mm thick, whose lower ed-

ge was only a cm or two above the frost limit.

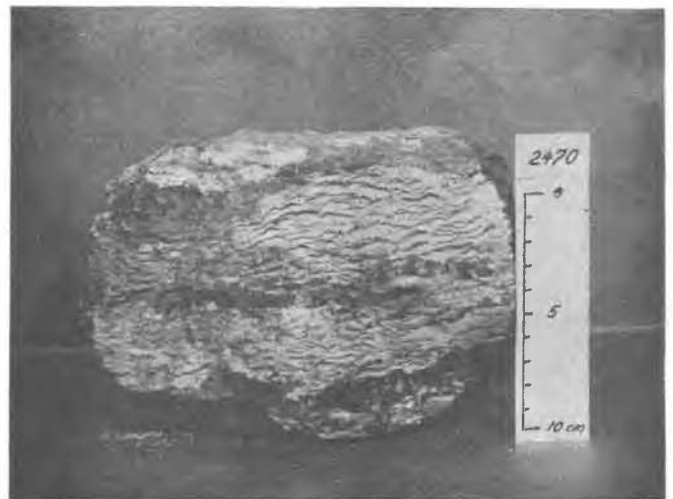
FIG.6

Photograph of clay soil sample No. 2470 from frost heave. Heavy icelenses in centre and below

Regarding water content in the samples received, it can be mentioned that in two clay soils taken respectively from a frostlifted area and a non-lifted area immediately adjacent thereto, the quantity was found to be 47% and 13% of the dry weights. Both samples were frost-hazardous and similar. Worthy of note is that although both sampling points were about 5 m from a 3 m deep excavation, the sub-surface water conditions were not equalised at the two points (which lay in a  $\frac{1}{2}$  m deep cutting). In another case for similar adjacent clay samples the water content was found to be 115% and 15%, the former being the greatest amount found in a sample of frozen soil. Fig. 6 shows the sample concerned; thick ice layers are seen in the centre and below.

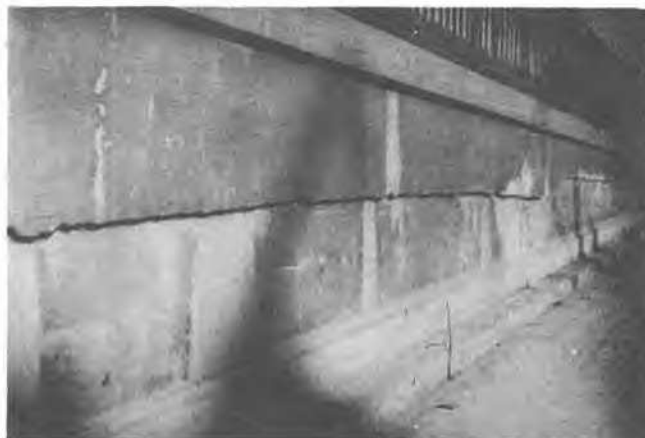
FIG. 7

As an instance of the manner in which ice lenses, formed in a slanting plane by the conditions of exposure, can bring about a horizontal movement, a picture of an underpass viaduct is shown in Fig. 7. The carriageway is sunk up to 2 m below the foot- and cycle paths. Both retaining walls were cracked in an approximately horizontal plane, probably at a concreting joint. Displacement of the one wall was  $2\frac{1}{2}$  cm and of the other  $4\frac{1}{2}$  cm.
