### THE PRESENT SCOPE AND POSSIBLE FUTURE DEVELOPMENT OF SOIL MECHANICS IN BRITISH RAILWAY CIVIL ENGINEERING CONSTRUCTION AND MAINTENANCE.

A.H. TOMS, B.Sc., A.M.I.C.E., Southern Rly. Company

### PRECIS

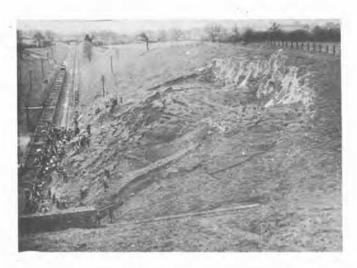
FIG. 2

Photo Fig. 2. shows a big slip which took place in 1939 in Weald clay cutting at Sevenoaks, Kent, and Fig. 3. indicates the slip surface as found during excavation for the drainage trenches, which were benched in concrete and backfilled with tightly packed brick rubble. The results of tests on the clay from the slip zone and other points are shown, together with a calculation based on the nearest arc, from which it will be seen that the measured shear strengths (taken as half the unconfined compressive strengths) were in many cases less than the calculated shear stress along the arc.

The slope was re-shaped with a "berm" to reduce the weight on the back of the slip.

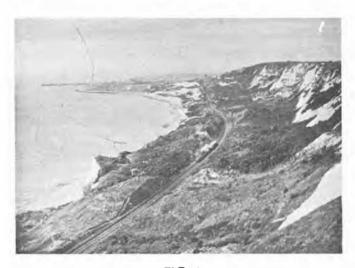
FIG. 4

The extremely large coastal landslides in the Gault clay in the "Warren", east of folkestone, Kent, are of major concern to the Southern Railway, since for over two miles it passes over ground which at various times in the past has slipped bodily, or in part, towards the sea; See Photo Fig. 4.

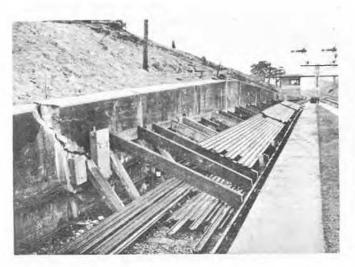
**FIG.13**

Photos Figs. 13 and 14 and Fig. 15 show a slip in the cutting in mottled clay of Wool-wich and Reading beds at Arundel, Sussex. After a period of stability, the wall commenced to move forward slowly. In the winter of 1946-7 the movement developed rapidly and a slip of the cutting became evident with heaving and pushing out of line of the adjacent track. Reference points were immediately established and 150-tons of rails were deposited on the track to resist the heave and to act as a mass against which to strut the wall; and this stopped movement.

The movements recorded indicate a deep slip, but in the boreholes, no recognisable slip surfaces were found, all measured strengths being well above the calculated limits for stability.

Large quantities of surface water were, however, found in the upper loamy strata and, prior to diversion, this was probably causing hydrostatic pressures.

The wall will be cut down to 3-ft above rail level after sheet piles have been driven along the back, and the bank will be re-shaped to take weight off the back of the slip.

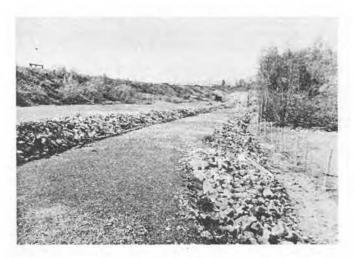
FIG. 20

Photo Fig. 20 and Fig. 21 show a very long and important embankment at Witley in Surrey, which was dealt with in this manner after soil tests had given an indication of the best distribution of the extra toe load. In this analysis, the theoretically worst slip circle was determined by trial for an assumed hard basement 4-ft. below original ground level, and the shear stress on this surface calculated. Various profiles of tipped material were then investigated similarly on the basis of this shear strength for the clay and a profile adopted at each of several sections of the bank, giving a factor of safety of 1.25. As the filling progressed, a most marked and immediate dim-inution in the amount of packing of the track above was brought about. As an additional precaution, one drainage "leg" was constructed in each of the main bulges in the bank.
