Experimental study on reinforcement of existing bridge pile foundations using sheet pile wall

Tanatan Tikanta, Chakree Bamrungwong

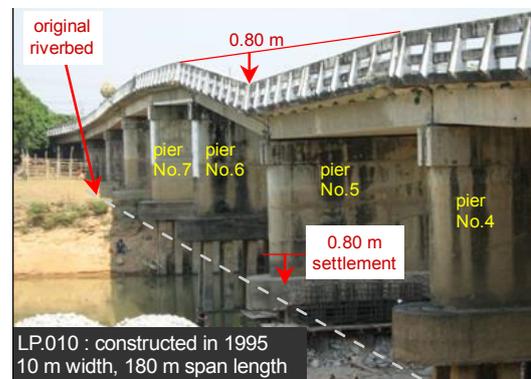
Figure 2. Differential settlement of the bridge LP.010 in Lamphun, Thailand.

Figure 2 shows the first case of bridge foundation damage

in 2006. One of pile foundations of the bridge LP.010 in Lamphun settled during a high flood season. The investigation and arrangement for the solution were performed for 2 years. The settled bridge LP.010 was repaired in 2008 by using new additional piles, extension of the footing, jacking up the bridge girders and extending the height of the settled bridge pier by 0.80 m to keep flat level of the bridge slabs.

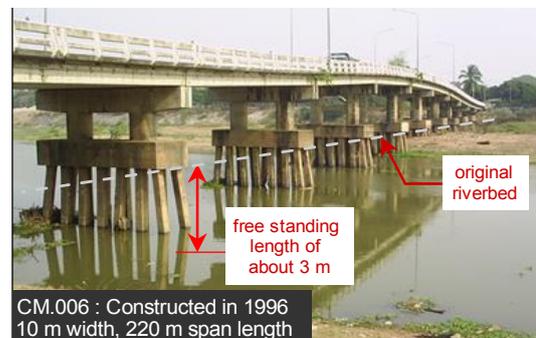
Figure 3. An example case of undamaged bridge which has potential risk of damaging.

The main cause of the bridge foundation damages mentioned above was the lowering of riverbed soil, in other words, the reduction of pile embedment length. Though the damaged bridges were repaired, most of undamaged bridge pile foundations along the river still have potential risks of damaging due to the riverbed soil excavation as shown in Figure 3. It should be noted here that excavation of the riverbed is prohibited by regulation at present.

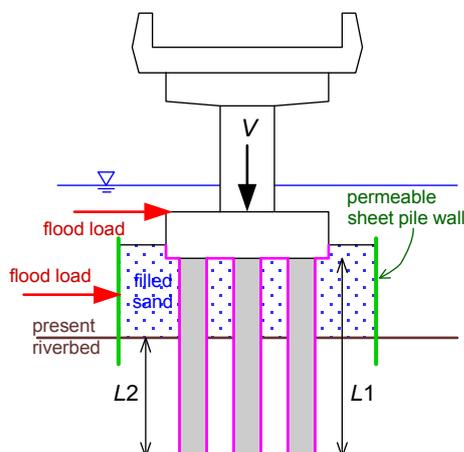
Figure 4. A concept of Sheet Pile Wall (SPW) reinforcement method.

Figure 4 illustrates the concept of SPW reinforcement method. The construction procedure of SPW reinforcement consists of 2 simple steps without new additional piles or any modifications of existing structures. Firstly, a permeable sheet pile wall is constructed surrounding the existing problematic bridge pile foundation. Finally, the empty space inside the SPW is filled with sand or other porous materials such as crushed concrete.

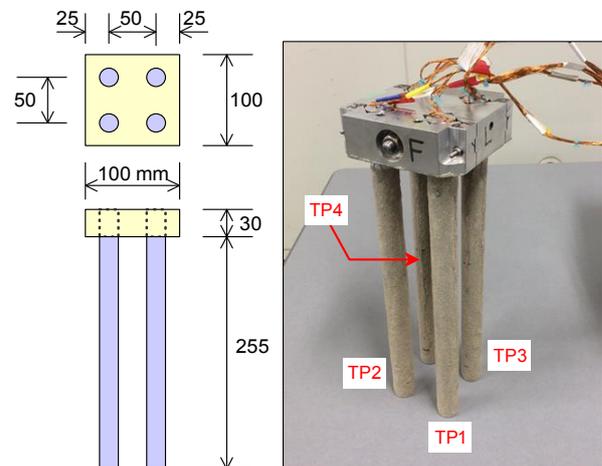
Figure 5. Configurations of the 4-pile pile foundation.

Figure 5 shows the configurations and dimensions of the 4-pile pile foundation model. Geometrical and mechanical properties of the model pile and the pile cap are listed in Tables 1 and 2.

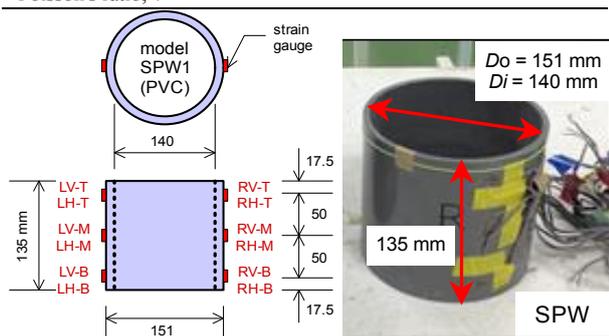
Figure 6. Configurations of the model SPW.

A PVC (polyvinyl chloride) pipe having 140 mm inner diameter with 135 mm length as shown in Figure 6 and Table 3 was used as model SPW in the reinforcement stage of load tests. Strain gauges were instrumented on the outer surface of SPW to measure vertical (axial) and horizontal (hoop) strains during the load tests.

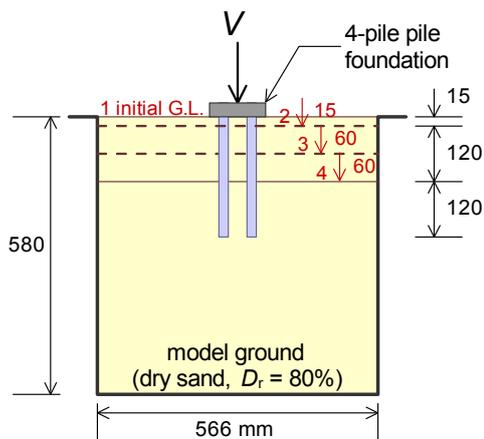
Figure 7. Test conditions of VLTs at the initial stage and in the embedment reduction stage.

VLTs on the 4-pile pile foundation were carried out at the initial condition and in each stage of the pile embedment length reduction and the SPW reinforcement, as shown in Figure 7 (reduction stage) and Figure 8 (reinforcement stage). In the reinforcement stage, SPW1 was located very close to the model foundation, as shown in Figure 9. It is desirable to minimise the size of the SPW so that the SPW structure does not interfere river stream as much as possible when the SPW reinforcement is applied to an actual bridge foundation.

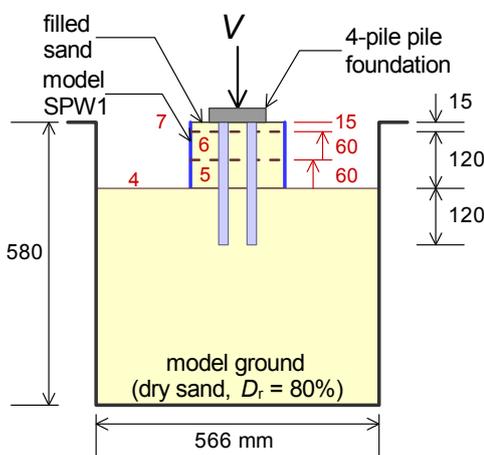
Figure 8. Test conditions of VLTs in the reinforcement stage.

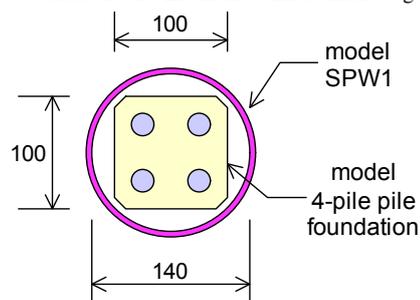
Figure 9. Top view dimensions of SPW reinforcement in VLTs on 4-pile pile foundation.

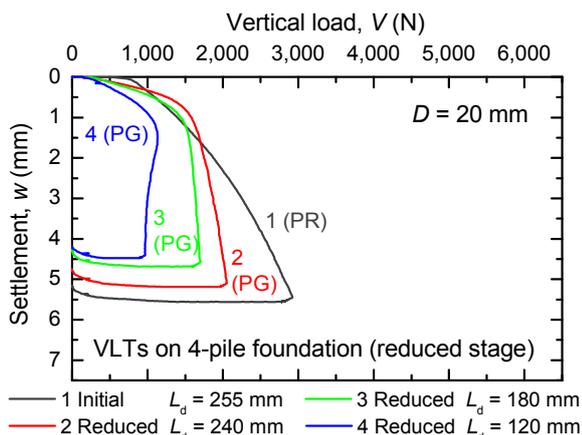
Figure 10. Load-settlement curves of the foundation at the initial stage and in the stage of pile embedment reduction.

Figure 10 shows load-settlement curves at the initial stage No.1 and in the embedment reduction steps No. 2 to No. 4. Note here that settlement was zeroed at the start of loading in each step for comparison. It is seen that vertical resistances and initial stiffness of the pile foundation decreased with the reduction of pile embedment length from No. 2 to No. 4. It is also seen that the load-settlement curves in the reduction steps No. 2 and No. 3 exhibit a plunging behaviour and the response in step No. 4 exhibits a softening behaviour, while the response at the initial stage No. 1 shows a progressive failure behaviour.

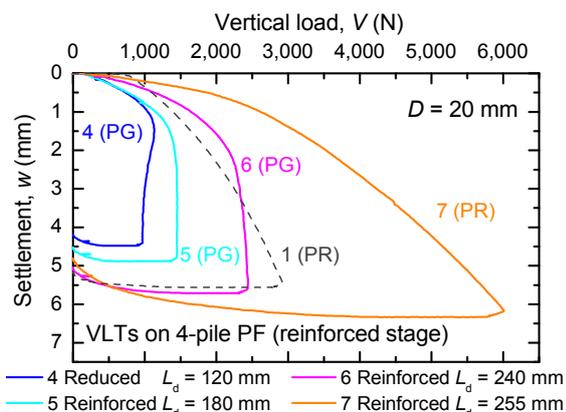
Figure 11. Load-settlement curves in the reinforcement stage.

Figure 11 shows load-settlement curves in the reinforcement steps No.5 to No.7, comparing with the results at the final embedment reduction step No.4 and the initial stage No. 1. It is seen that the vertical resistance and stiffness of the 4-pile pile foundation increased from step No. 4 to step No. 7 with increasing pile embedment length using the SPW reinforcement. In particular, the vertical resistance at the final reinforcement step No. 7 was much greater than that of the initial stage No. 1.

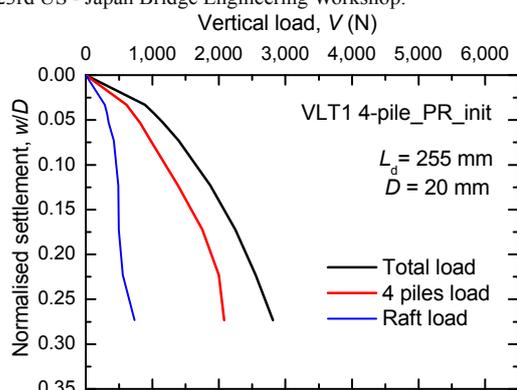
Figure 12. Loads carried by the piles and the raft at the initial stage.

Figures 12 and 13 show the loads carried by the 4 piles and the raft at the initial stage (step No. 1) and at step No. 7 (the final reinforcement), respectively. It is seen from the

comparison of both figures that the vertical resistances of both the raft and the 4 piles increased by approximately double, comparing step No. 7 with step No. 1, showing a considerable effect of the SPW reinforcement.

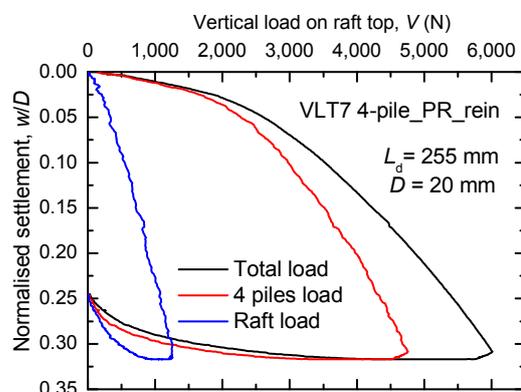
Figure 13. Loads carried by the piles and the raft at the final reinforcement No. 7.

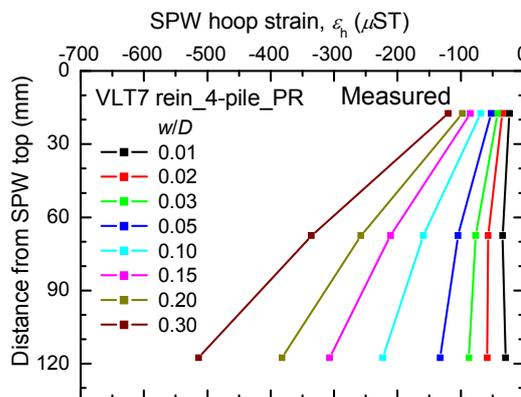
Figure 14. SPW hoop strain distributions in the final reinforcement stage of VLTs on 4-pile pile foundation.

Figure 14 show changes of distributions of hoop strains of the SPW with increasing normalised settlement of the foundation, w/D , where w is the settlement and D is the pile diameter, respectively, during load test at the final reinforcement step No. 7. Note that compression strain is taken as positive and tension strain is taken as negative. It is seen that the maximum values of hoop strain were generated around the SPW base. Absolute magnitudes of the hoop strains were larger than those of the axial strains at each w/D . This means that the soil inside the SPW is subjected to large horizontal stresses by the existence of SPW. Hence, it is reasonable that the foundation, especially the raft component, at step No. 7 has the larger resistance than that of the initial stage. Although the direct estimation of the horizontal stresses of the soil inside the SPW from the measured hoop strains of the SPW is difficult, the results of Figures 14 indicate that larger vertical and horizontal stresses are generated in the soil inside the SPW at step No. 7.

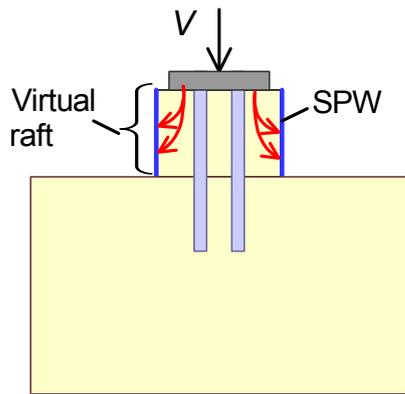
Figure 15. Conceptual expression of stress transfer from the raft to the soil inside the SPW.

Figure 15 shows a conceptual expression of stress transfer from the raft base to the soil inside the SPW. A part of the vertical load on the foundation is supported by the raft. The vertical load supported by the raft base is transferred to the soil inside the SPW. The horizontal stresses as well as vertical stress in the soil are increased by the increase in the raft base stresses due to the existence of the SPW. Hence, it seems to be reasonable that the raft resistance after the construction of the SPW becomes larger than that at the initial condition. It is inferred from the experimental results that efficiency of the SPW reinforcement is governed by size (distance) relative to the existing foundation, and stiffness of the SPW as well as stiffness of the soil inside the SPW.
