# Water shielding mechanism of a double-layered compacted earth structure and its application to conservation of tumulus mounds

Mai Sawada, Mamoru Mimura

Graduate School of Engineering, Kyoto University, Japan, sawada.mai.6c@kyoto-u.ac.jp

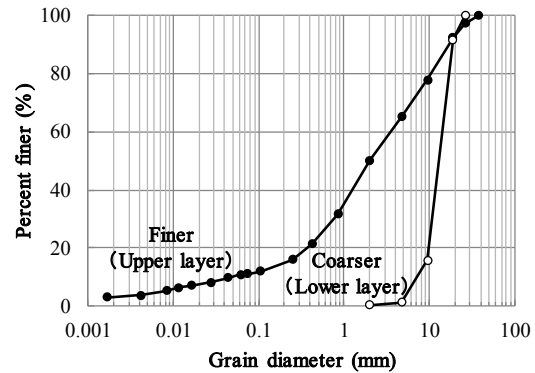
Figure 3. The grain size distribution of the soils.

A capillary barrier was observed by the model chamber test shown in Fig. 2. A 30cm thick finer grained layer was placed on an underlying 20cm thick coarser grained layer in the chamber of 110cm in length and 12cm in width. The grain size distribution curves of the soils are shown in Fig. 3. At the end of each layer, there was an outlet from which a part of the infiltrating water drained. The drainage from each of the outlets was measured by a weighing balance. Degree of saturation was also measured by moisture sensors at 6 points in each layer. A rainfall simulator which produces water drops of constant intensity was set above the chamber. The constant precipitation was applied continuously for 45 hours. More details on the model chamber test are found in Sawada et al. (2016).

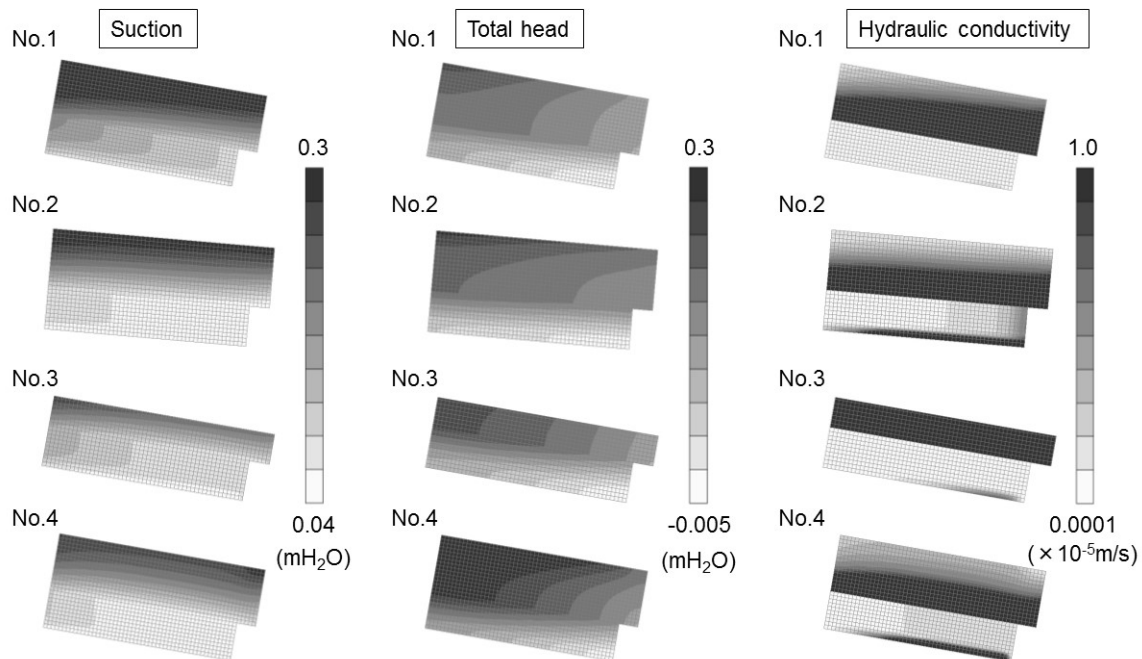
Figure 4. The distribution of suction, total head and hydraulic conductivity in a steady state.

Fig. 4 shows the distribution of the suction, total head and hydraulic conductivity in the soil layers in a steady state. The suction of the finer grained layer is higher than that of the coarser grained layer in all the tests. The condition for formation of a capillary barrier described in 2.1-1) is hence satisfied, but No.2 and No.4 observe significant amount of drainage from the coarser grained layer. On the other hand, the total head of the finer grained layer is higher than that of the coarser grained layer and 2) is not satisfied in all the tests, but No.1 shows almost perfect water shielding. These inconsistencies indicate that suction and total head are not direct causes of water shielding by a capillary barrier although they are related to water flow in the soil layers.

Compared to 1) and 2), 3) is a more feasible explanation for the results. The coarser grained layer has lower hydraulic conductivity hence a part of the infiltrating water is diverted at the soil interface and drained from the upper outlet although all the infiltrating water is drained from the lower outlet in No.2 because the inclination is less than the threshold for drainage (Sawada et al., 2016). The amount of upper drainage corresponds to the degree of difference in hydraulic conductivity of the two layers. In No.1, the capillary barrier with high diversion capacity is formed on the coarser grained layer of which hydraulic conductivity is about 10000 times lower than that of the finer grained layer. This suggests that water shielding by a capillary barrier is caused by the mechanism shown in 3) and it is effective when the hydraulic conductivity of the two soils are contrasting.

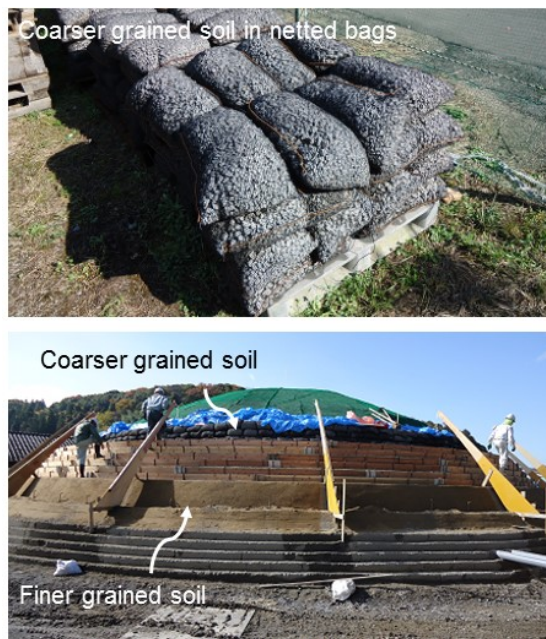
Figure 8. The construction of the double-layered earth mound (September, 2014).

Fig. 7 shows the Garandoya Tumulus restored by constructing a double-layered earth mound. The earth mound has been applied to cover around the concrete building that stores the burial chamber. The coarser grained soil was packed in netted bags and placed on the building. Then, the finer grained soil layer was compacted on the coarser grained layer using a lightweight compaction machine. The soils used for the restoration were the same with those used in the model chamber tests. They were obtained close to the tumulus where volcanic ash deposits are
