Performance of instrumented sections along a highway in the Canadian arctic

Earl Marvin De Guzman, Marolo Alfaro

ABSTRACT: Highway embankments in the Canadian arctic are often built in permafrost terrain and on thaw-sensitive foundations. Higher embankment fill heights are sometimes required to comply with vertical road geometry requirements. Such design cause side-slope sloughing and embankment cracking due to rising of the permafrost table in the fill and lowering of the permafrost table below the toe of the embankment. A reinforced test section was built along a newly-constructed highway with layers of wicking geotextiles on its side slopes to provide reinforcement and drainage path for the water during the thawing season. An unreinforced section was also constructed beside the reinforced section. Both sections were instrumented to monitor temperatures and deformations. The geotextile reinforcement has been additionally instrumented with strain gauges to measure tensile forces. Field observations indicate that placement of the wicking geotextiles reduced lateral displacements in the reinforced embankment. This paper presents the analysis and synthesis of the two-year performan

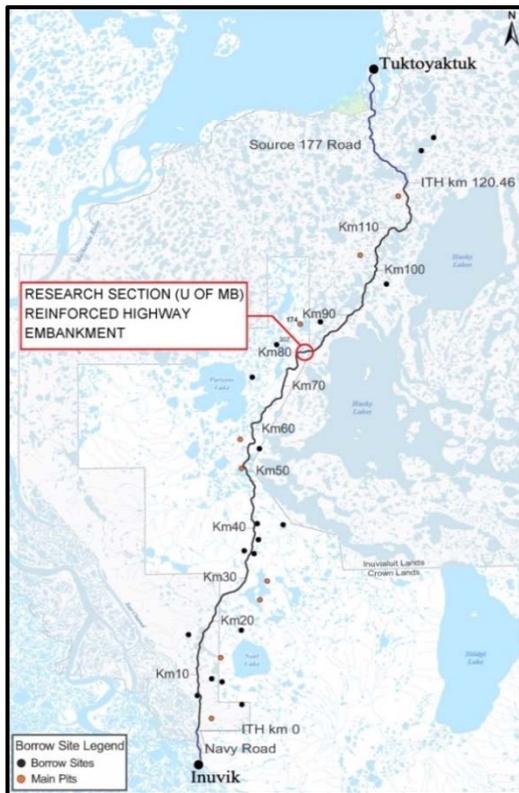
Figure 1. Alignment of the Inuvik-Tuktoyaktuk Highway and the University of Manitoba's research section.

Detailed road alignment, environmental data gathering, and engineering design were conducted in the 1960's and 70's and has been continuously revised to address the concerns of local communities and other stakeholders during an extensive environmental review process, leading to the development of the route alignment alternatives in 2009. The highway has been identified as a priority development by the Government of Canada and Government of the Northwest Territories (GNWT). The ITH, which extends the Dempster Highway past the community of Inuvik to the Arctic Coast, will be an all-weather transportation link and will complete Canada's road network from the Pacific, to Atlantic, and to Arctic coasts. Figure 1 shows the designed alignment of the highway.

Knowledge gaps exist on the behaviour of high fills compacted under Arctic winter construction conditions. Therefore, research is needed to (1) investigate the operating mechanisms causing instabilities and deformations of the embankment; and (2) develop efficient mitigation strategies. A partnership was developed between the University of Manitoba, Université Laval, and the Department of Transportation of the Government of Northwest Territories to construct two 20 m-long test sections side-by-side along the ITH to address these research needs. The test site location along the ITH, which was completed in April 2015, is shown in Figure 1. The two-year performance of the highway is presented in this paper.

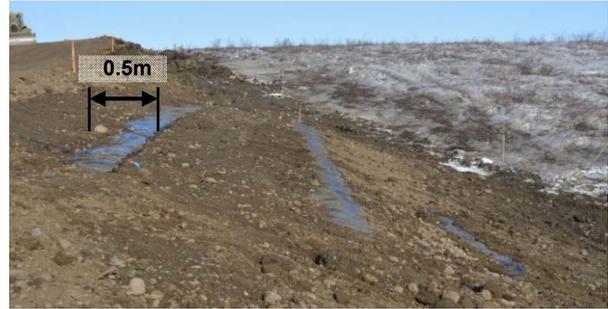
Figure 2. Geotextiles exposed on the side slopes of the embankment

The woven geotextiles installed at the side slopes of Section B have drainage capabilities in addition to their reinforcement function. It is assumed they provide drainage paths for the water during spring and summer seasons when the embankment undergoes thawing. The ultimate tensile strength in both machine and cross directions is 78.8 kN/m. This type of geotextile has been successfully used in the Dalton Highway Beaver Slide Area in Alaska to act as a capillary barrier and

prevent the occurrence of frost boils (Zhang et al. 2014). A similar successful application was used in the Pioneer Scenic Byway in Montana to prevent the occurrence of frost heaves along the highway (Sikkema and Carpita 2016). For these studies the wicking fabric only utilized its drainage function. The geotextile has an overhang of 0.5 m (Figure 2) to allow water to flow out of the embankment and dissipate the potential build-up of pore water pressure during thawing. The length of the geotextile installed was conceptualized to intercept the failure surface when the embankment thaws and if sloughing occurs. The geotextiles were spaced at every 0.9 m of elevation, starting at Elevation 22.45 m on the west side of the embankment. Both embankment sections are 5.3 m high.

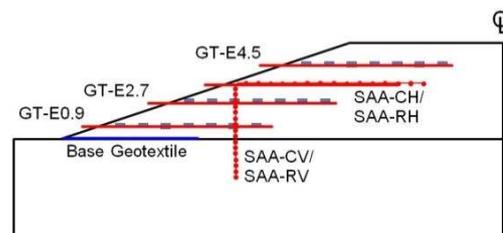
Figure 3. Schematic representation of the locations of the SAAs and geotextiles.

Figure 3 shows the locations of the geotextile layers for Section B and the SAAs for both test sections. The vertical SAAs are recording lateral movements closest to the ground surface. The lateral displacements recorded in the reinforced section (Figure 4b) are less than that of the control section (Figure 4a). Maximum lateral deformation of the Section A at a point near the slope surface is approximately 40 mm greater than that of Section B for the first year of thawing on September 02, 2015. On the same date the following year, additional lateral deformations were observed equal to 55 mm for both test sections. Interestingly, the depth of zero-movement (2 m below the slope surface) coincides with the first layer of geotextile at Elevation 22.45. This indicates that the soil is still frozen as will be discussed later in temperature results.

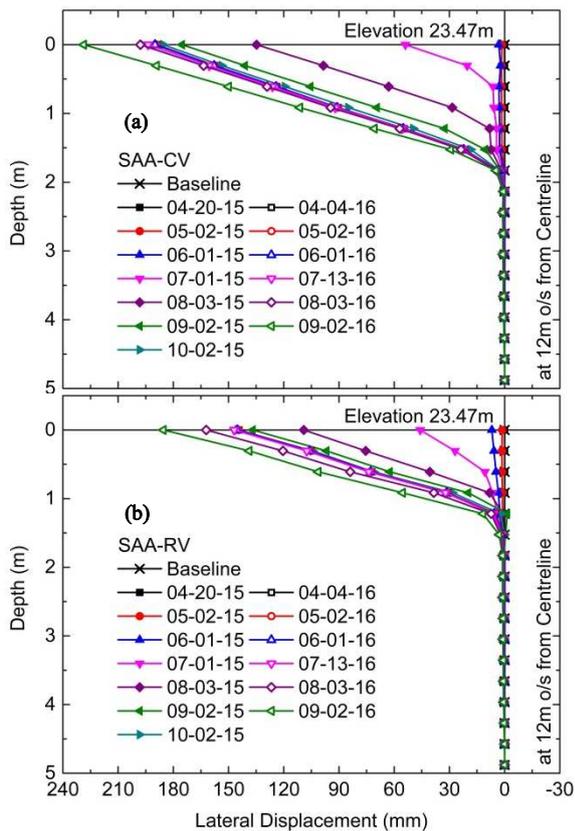
Figure 4. Lateral deformations at 12m o/s from centerline in (a) control and (b) reinforced sections

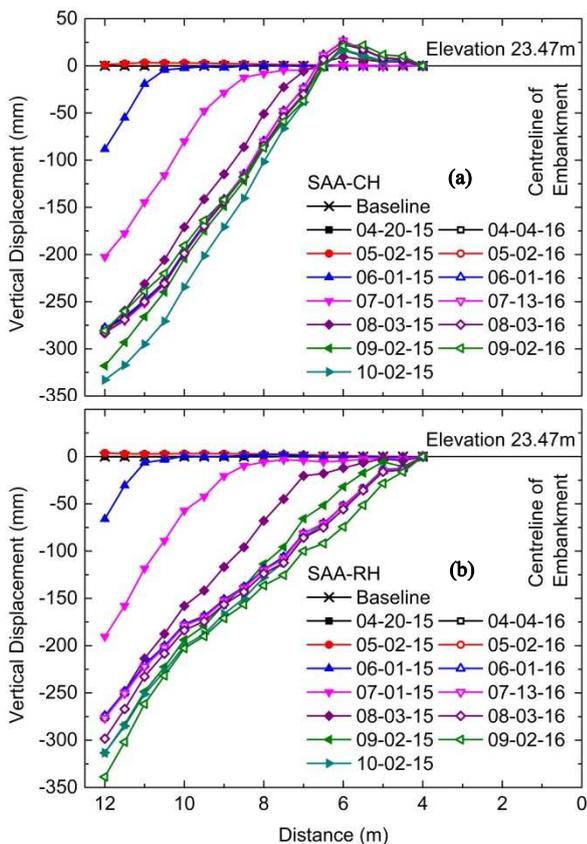
Figure 5. Vertical deformations at Elevation 23.47 in (a) control and (b) reinforced sections

The horizontal SAAs (Figure 5) show that the settlements at the slope for both sections are the same at 350 mm as of September 02, 2016. The small heaving at the control section is currently being investigated as this behaviour was not observed in the reinforced section. Both vertical and horizontal SAAs show little to no movement at all during the winter months. The progression of movement is also slower during the second year of thawing. Figure 6 shows the two test sections along the highway, with cracks noticeable in the unreinforced sections.

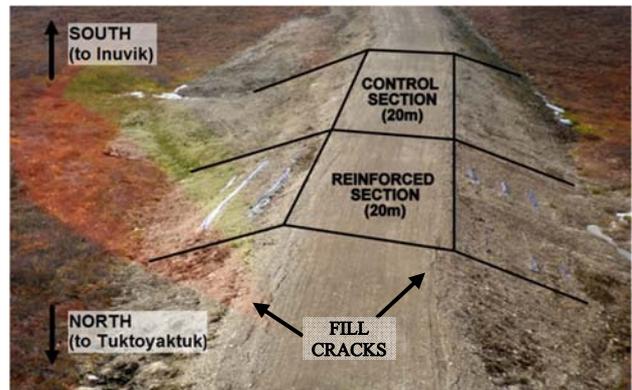
Figure 6. Reinforced and control sections along the ITH (09-16-2015)

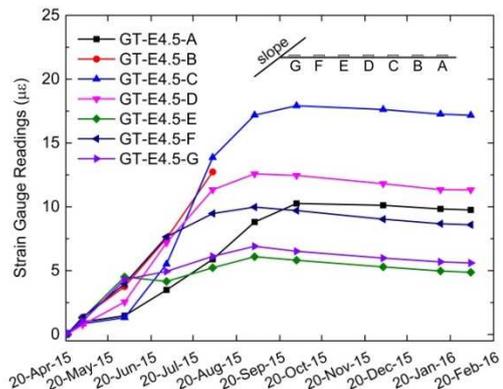
Figure 7. Strain gauge readings at GT-E4.5

Strain gauges were installed on the woven geotextile to measure the development of strains as the embankment deforms. They determine the effectiveness of the geotextiles as reinforcement and how it can reduce the lateral displacement of the slope. The strain gauges were attached to the geotextiles following the recommendations by Warren et al. (2010). The results of the geotextile close to the road surface (GT-E4.5 in Figure 3) is shown in Figure 7. The strains (loads) are generally mobilized during the thawing season after construction but the rate of straining in the winter months is minimal. Readings after February 2016 are still currently being evaluated.

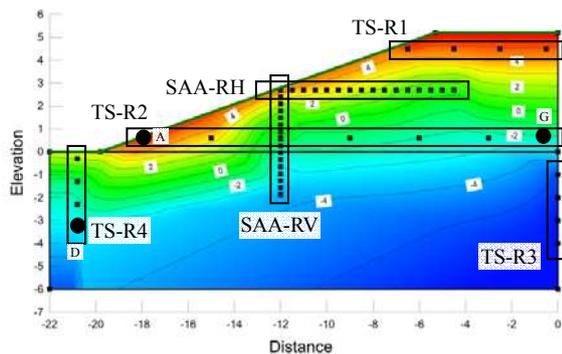
Figure 8. Thermal profile of the embankment on September 02, 2016

Recorded readings indicate that the thermistors closest to the ground surface are responding quickly to the warming air temperatures. Figure 8 shows the thermal profile of the embankments on September 02, 2016. There is little to no difference between the recorded readings of the two test sections. It is noted that the depth of penetration at the toe is about 1.5 m, with the zero temperature line at 2.5 m above the native ground at the centreline. As mentioned earlier, the SAA nodes below a depth of 2 m from the slope surface is within the zero temperature line. Temperature plots with time for select nodes (refer to Figure 8) are also shown in Figure 9.

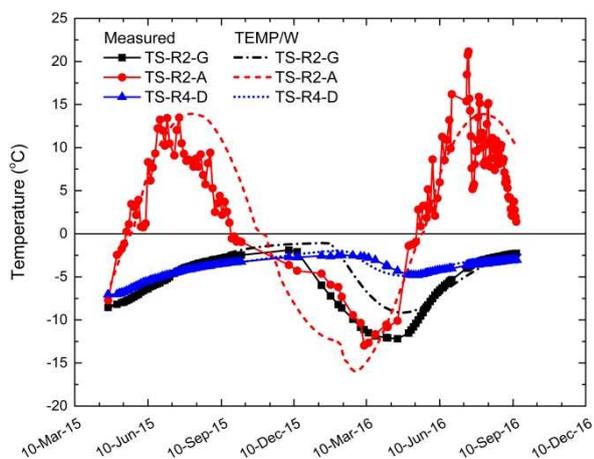
Figure 9. Measured vs. modelled temperature values for select thermistor nodes

Figure 9 shows a comparison of the modelled results against the measured values from select thermistor nodes (Figure 8) in the embankment. It can be seen that there is small difference between the measured and modelled values although the behaviour of the temperature with time is well replicated. Further calibration of the n-factors and conducting tests to determine the thermal properties of the soil obtained from the field will improve the results of the numerical modelling. The effect of the reinforcement and wicking of the geotextile fabric in Section B was not considered in the analysis. In addition, the computer programs do not have the capability to fully couple thermal (TEMP/W) and mechanical (SIGMA/W and SEEP/W) behaviour. The consolidation of the embankment during the thawing season will change the stresses internally and thus will change the thermal properties of the soil.
